PROJECT MEMORANDUM

CRESSEY-GALLO 115 kV POWER LINE PROJECT

To: Billie Blanchard, Project Manager, CPUC
From: Vida Strong, Aspen Project Manager
Date: March 20, 2015
Subject: Monitoring Report #16: March 9 to 15, 2015

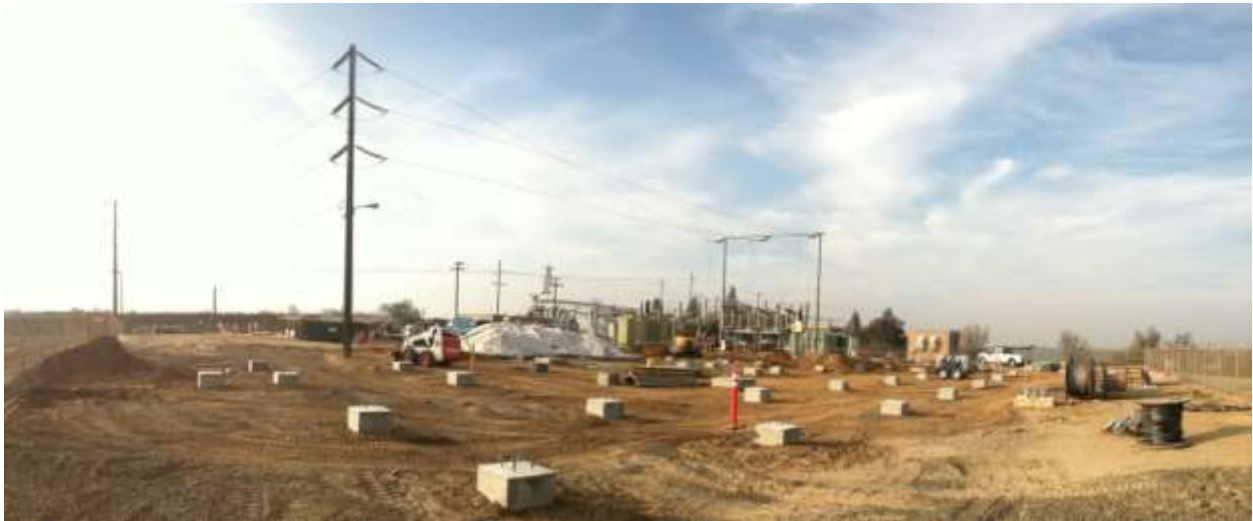
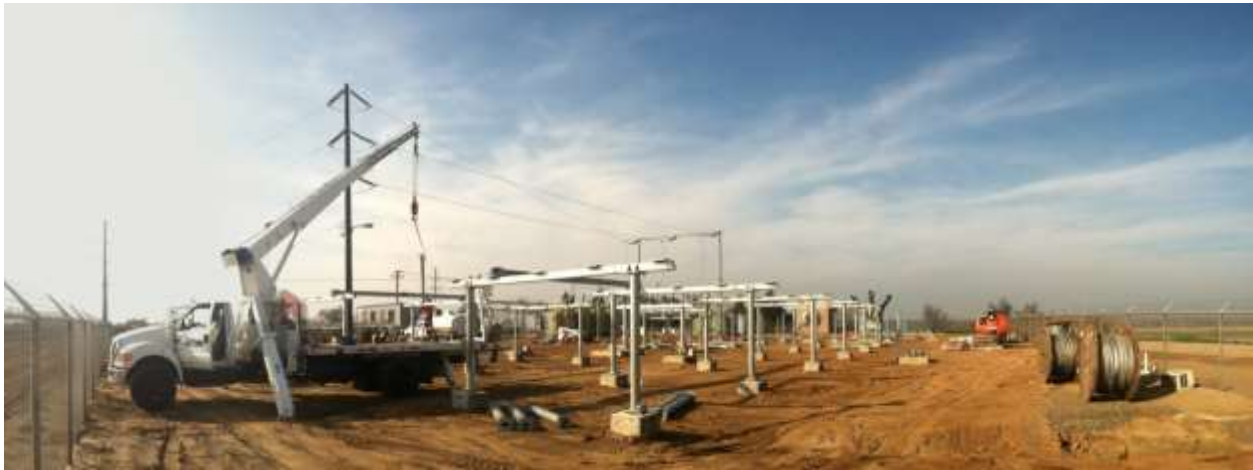
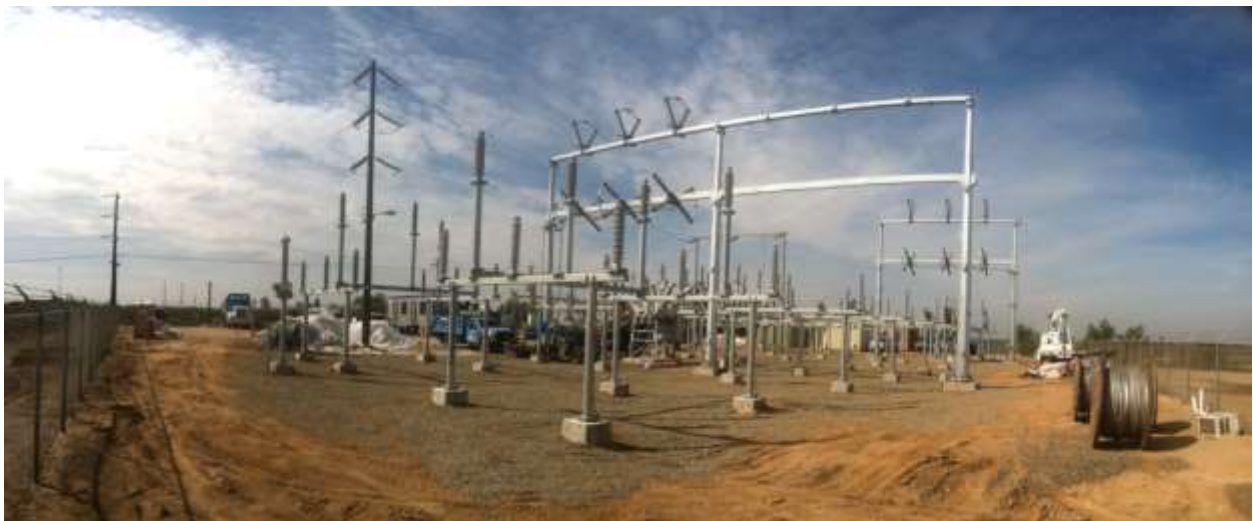
1. Construction activities continued at the Cressey Substation during the subject period. Material delivery and storage and structure installation continued (see Figure 1).
2. No work occurred at the Gallo Substation during the subject period.
3. The staging area at the Gallo Winery is being used for storing materials.
4. Crews conducted pull and tensioning activities along the alignment.

Figure 1 – Structure installation continued at the Cressey Substation during the subject period. View from southeast corner of substation facing northwest, 01/08/15 above 02/03/15 middle, 3/10/15 below.

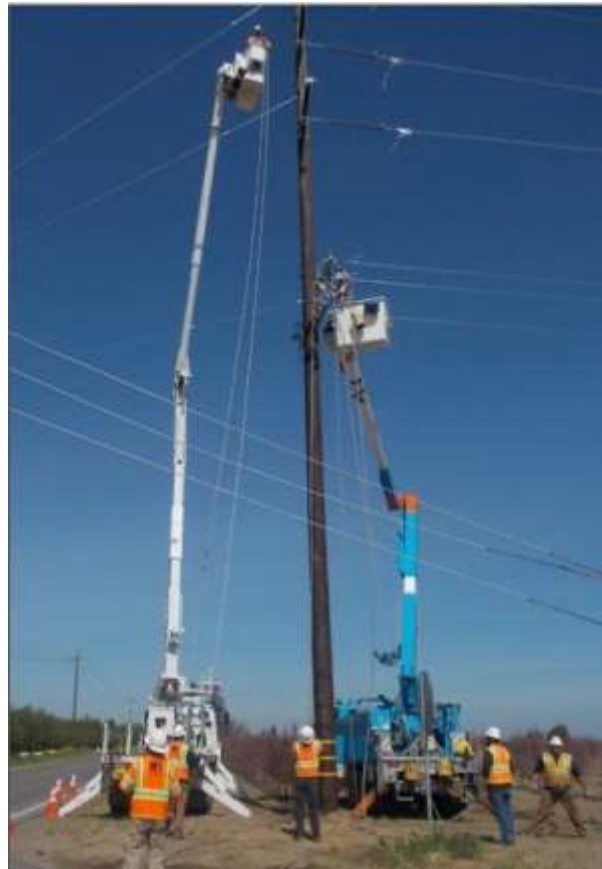
1. Crews staged wooden poles and conducted pull and tensioning activities (see Figure 2).
2. Pole site augering and pole installation work occurred during the subject period.

Figure 2 – Crews conducted pull and tensioning activities during the subject period. (Photo provided by PG&E).

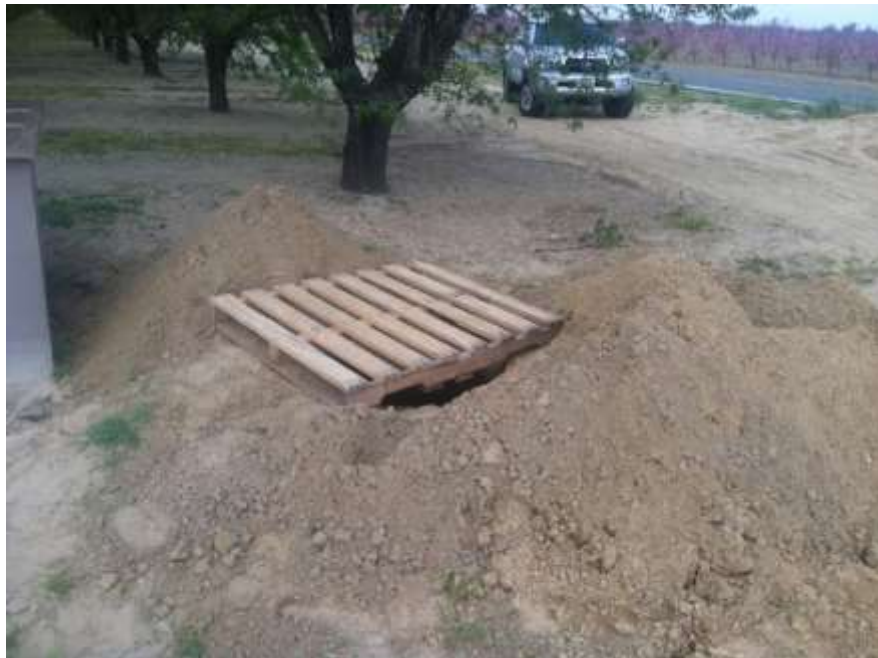
3. The CPUC EM observed augured holes, from pole installation work, that were poorly covered for wildlife exclusion at the end of work (near the corner of Magnolia Avenue and Robin Avenue) (see Figure 3). The Lead Environmental Inspector was already at the location correcting the covering methods, to meet the project biological requirement for wildlife exclusion. The CPUC EM also observed that the holes were unmarked and had no public-safety features. The CPUC EM contacted the PG&E Project Manager and inquired about PG&E’s standard hole-safety procedures. The CPUC EM also requested that the Project Manager review the specific locations to ensure that the situation was consistent with PG&E’s own standards. Subsequently, personnel erected cautionary staking and flagging around the hole sites (see Figure 4). Later that afternoon, crews positioned large bags of gravel over the holes to securely cover them. The following day, crews were reminded to ensure future excavations are covered and marked for safety.

Figure 3 – Augered pole foundations were poorly covered by crews at the end of the day; however, compliance personnel corrected deficiencies. View near the corner of Robin Ave and Magnolia Ave, facing north.

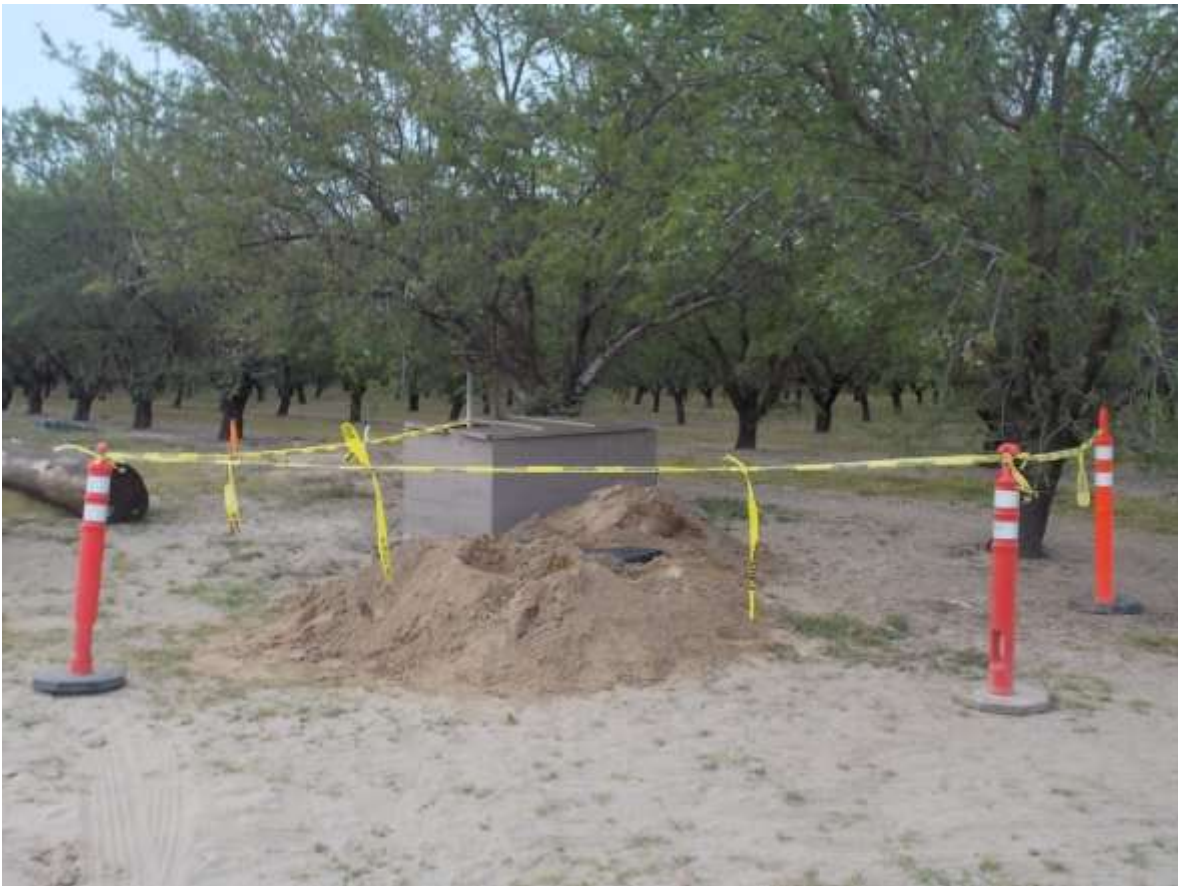
Figure 4 – To protect the public, project personnel installed safety flagging and cones around augered holes (following this photo, large gravel bags were also positioned over the holes). View near the corner of Robin Ave and Magnolia Ave, facing north east (Photo provided by PG&E).
