**PROJECT MEMORANDUM
DELTA DPA CAPACITY INCREASE SUBSTATION PROJECT**

To: Junaid Rahman, CPUC
From: Vida Strong, Aspen Project Manager
Date: February 21, 2008
Subject: Weekly Report #17: February 10, 2008 – February 16, 2008

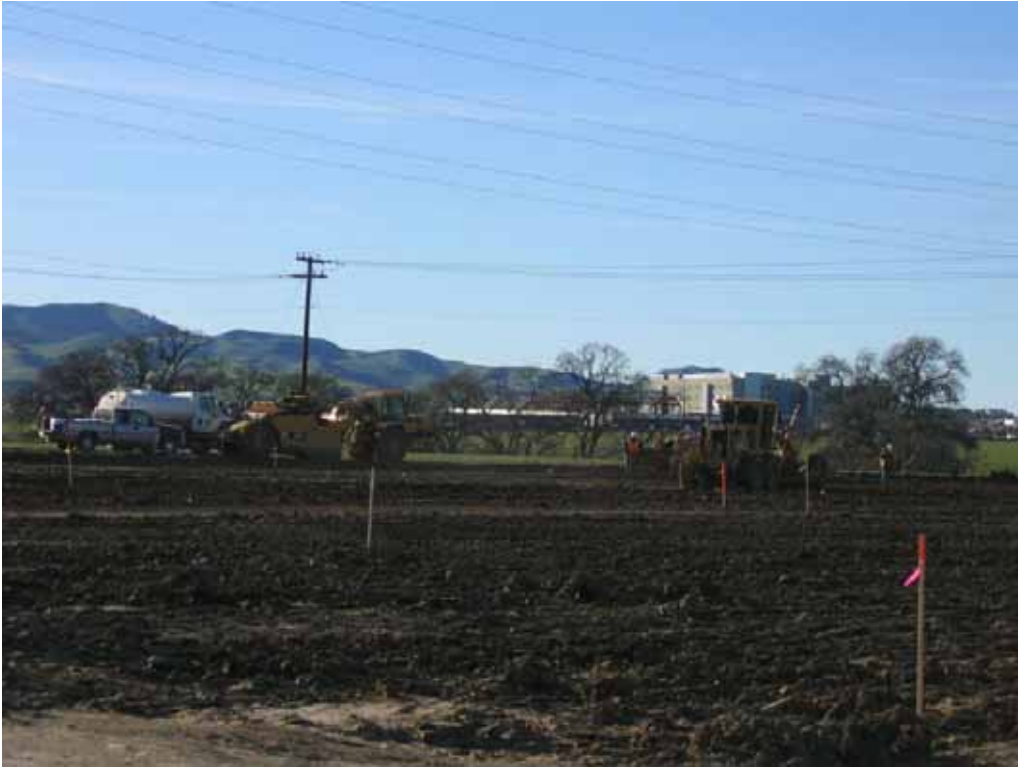
On Sunday, crews worked on “ripping” the soil of the substation pad to dry it out and then re-compacted the soil. On Monday, work resumed hauling fill from the Kaiser site to the substation area in order to build up the substation pad. The fill was picked clean of debris and was then graded and compacted to meet engineering requirements. Work stopped early on Monday afternoon due to issues at the Kaiser site. On Tuesday, work resumed hauling fill from the Kaiser site to the substation area. Sixteen trucks hauled fill continuously. Wednesday through Friday, crews continued to haul fill from the Kaiser site to the substation area where the soil was deposited, debris was removed, the soil was graded and then compacted to meet specifications (see Figure 1). On Saturday, the hauling of fill was completed.

Figure 1 – Crews working at substation grading and compacting fill, February 14, 2008.

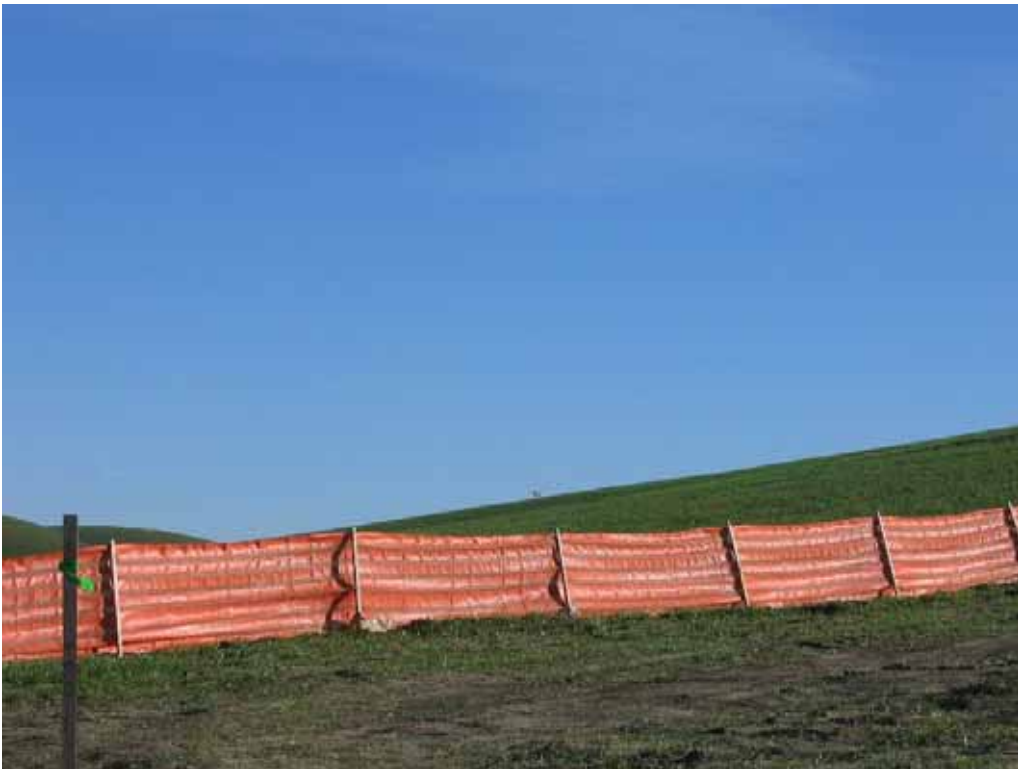
Figure 2 – Coyote in adjacent field to the south of the substation, February 14, 2008.

At the time of the CPUC EM site visit, soil was being hauled from the Kaiser site to the substation site where it was deposited, debris was removed, the soil was graded and then compacted. While at the substation site, the CPUC EM observed a coyote a couple of hundred yards away in the field to the south of the substation site (see Figure 2). The coyote was hunting ground squirrels and did not seem affected by the construction noise.

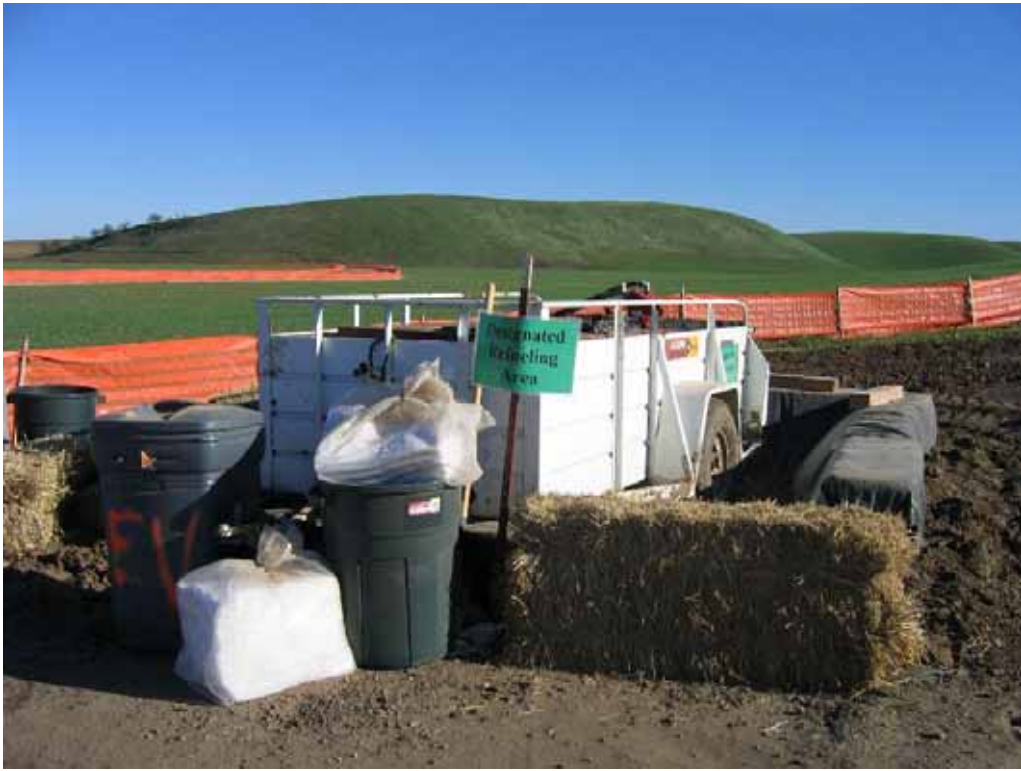
The CPUC EM confirmed that the appropriate spill kit materials had been refilled and were on site. Also, a new designated refueling area was built with straw bales and plastic sheeting (see Figure 3). The CPUC EM observed that work activities were in compliance with the approved Mitigated Negative Declaration and other permit requirements. The wildlife exclusion fencing and erosion controls were in place at all of the work areas. Straw bales and wattles were in place under the bridge for additional erosion control. A water truck continued to water the access road and the substation site throughout the week for dust control purposes. Heavy equipment was parked overnight in a designated area within the substation boundaries. The CPUC EM reviewed PG&E EI daily reports and survey reports. Environmental training of crew personnel was on-going as new crew personnel came onto the site.

Figure 3 – New designated refueling area at Substation site, February 14, 2008.
