**United States Department of the Interior Bureau of Land Management  
Scenic Quality Field Inventory**

<b>District</b> California Desert		
<b>Field Office</b> Palm Springs		
<b>Scenic Quality Rating Unit</b> <b>03</b>		
<b>Viewpoint</b> <b>5 : Thermal Canyon</b>		
<b>Evaluator(s)</b> Michael Clayton

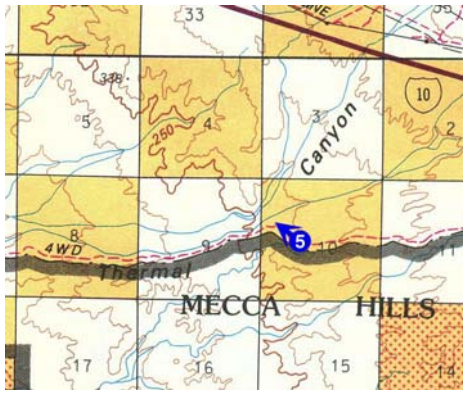
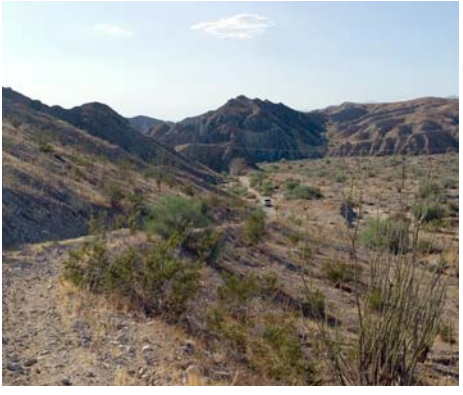
<b>LANDSCAPE CHARACTER</b>			
	<b>LANDFORM / WATER</b>	<b>VEGETATION</b>	<b>STRUCTURES</b>
<b>Form</b>	Rugged, steeply rising slopes with flat canyon bottom that widens and narrows with varying erosional patterns.	Irregular distribution of low growing grasses and shrubs interspersed with the occasional ocotillo.	Linear wood pole utility line with conductors.
<b>Line</b>	Angular ridgelines with diagonal slopes. Horizontal Canyon floor.	Irregular for individual shrubs. Vertical for ocotillo.	Vertical wood pole and horizontal conductors
<b>Color</b>	Gray to light-tan rocks and soils. Tan to brown slopes. Bluish hues at greater distance.	Tan to pale-yellow grasses with tanish-gray to green shrubs with pale green ocotillo.	Dark brown wood poles.
<b>Texture</b>	Soils in the immediate foreground appear coarse to granular. Slopes and ridges appear smooth to matte.	Smooth to medium grain to matte.	Gray to dark conductors depending on lighting.

**Narrative:** SQRU 03 includes the sloping alluvial fans and incised, rugged canyon area located between I-10 on the north and the Mecca Hills Wilderness to the south. From Viewpoint 5, the considerable topographic variation is apparent and contributes to the visual variety found within this unit. Vertical groupings of ocotillo also add visual interest and contrasts with the more common low growing shrubs and grasses. Landscape colors can be quite changeable as shadows play across rugged slopes and narrow canyons. Varying erosional patterns in drainage bottom sands also contribute to visual variety. With much of the landscape screened by berms and undulating ridges immediately adjacent to the south side of I-10. While an existing wood pole utility line is present within the canyon, its simple form and compatible color (dark weathered wood brown) do not detract substantially from the overall quality of the landscape.
