**PROJECT MEMORANDUM
SCE DPV2 TRANSMISSION PROJECT**

To: Billie Blanchard, Project Manager, CPUC
From: Vida Strong, Aspen Project Manager
Date: November 15, 2011
Subject: Weekly Report 15, October 24 to October 30, 2011

This report provides a summary of the construction and compliance activities associated with the SCE DPV2 Transmission and Red Bluff Substation Projects.

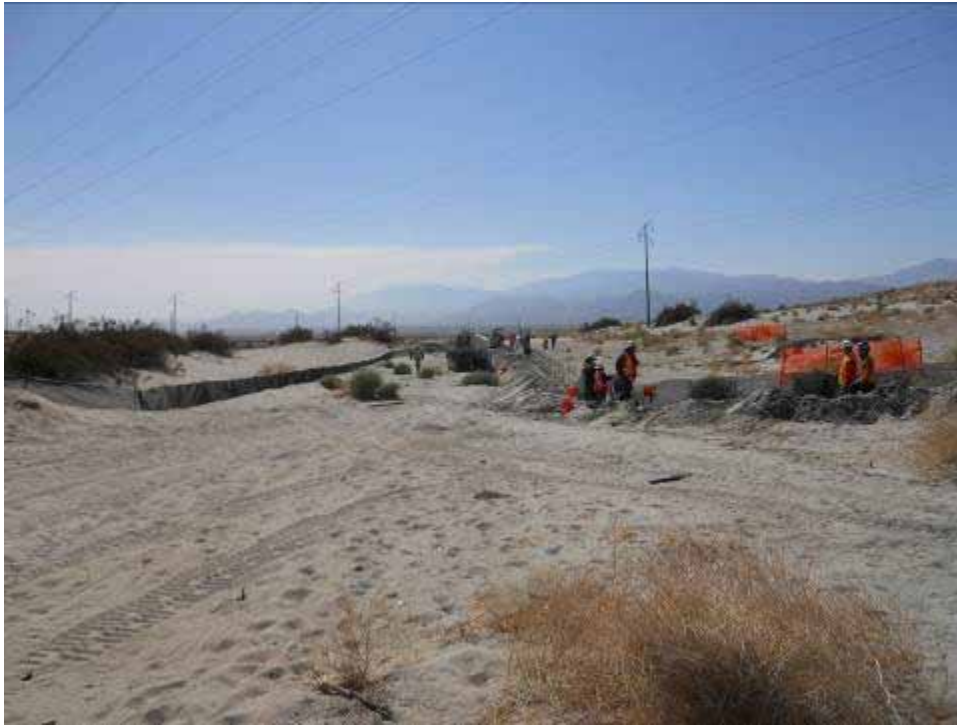
Figure 1: Exclusionary fence activities being conducted at Tower #2110. Note avoidance of ESAs marked with orange fencing.

1. During the subject period, exclusionary fencing activities were completed at several locations, including Towers #2012, #2013, #2015, #2016, #2017, #2100, #2101, #2102, #2110, and #2113. Activities at these locations included trenching, fence installation, backfilling trenches, and fence clipping (see Figure 1).

1. The CPUC EM observed work crews working around fenced Environmentally Sensitive Areas (ESAs) established for Coachella Valley milk-vetch (CVMV) at Tower #2110 on October 25. ESAs for CVMV were avoided at other tower locations as reported by SCE Biological Monitors.

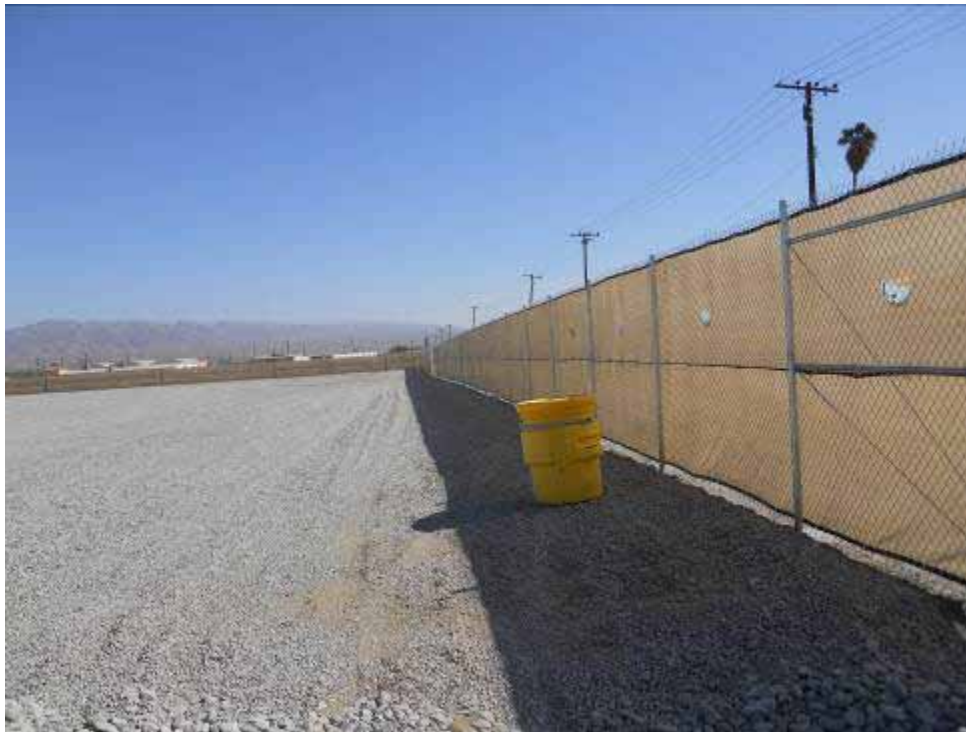
Figure 2: Activities at the Indio Construction Yard included fence installation and gravel placement.

1. Major construction activities that occurred at the Indio Construction Yard during the subject period included site grading, installation of road base, paving of driveways, and construction of perimeter fencing (see Figure 2).

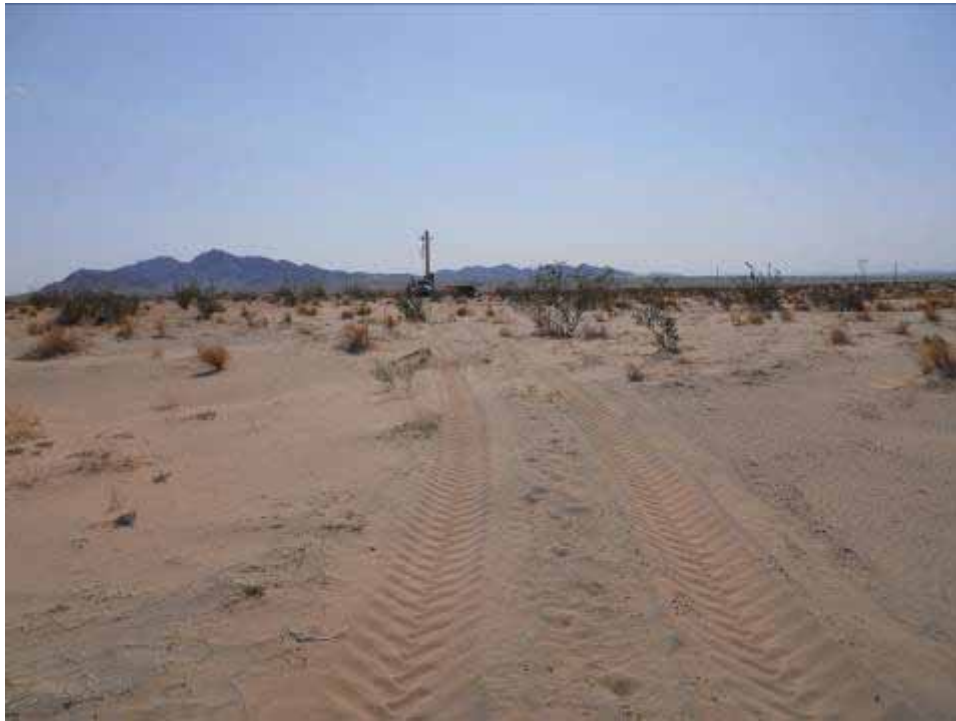
Figure 3: View south along “drive and crush” road created for Red Bluff distribution line.

1. Major construction activities associated with the CRS Distribution Line were initiated on October 26. These included the establishment of the approved “drive and crush” road, boring for wooden pole placement, and installation of wooden transmission poles (see Figures 3 and 4).

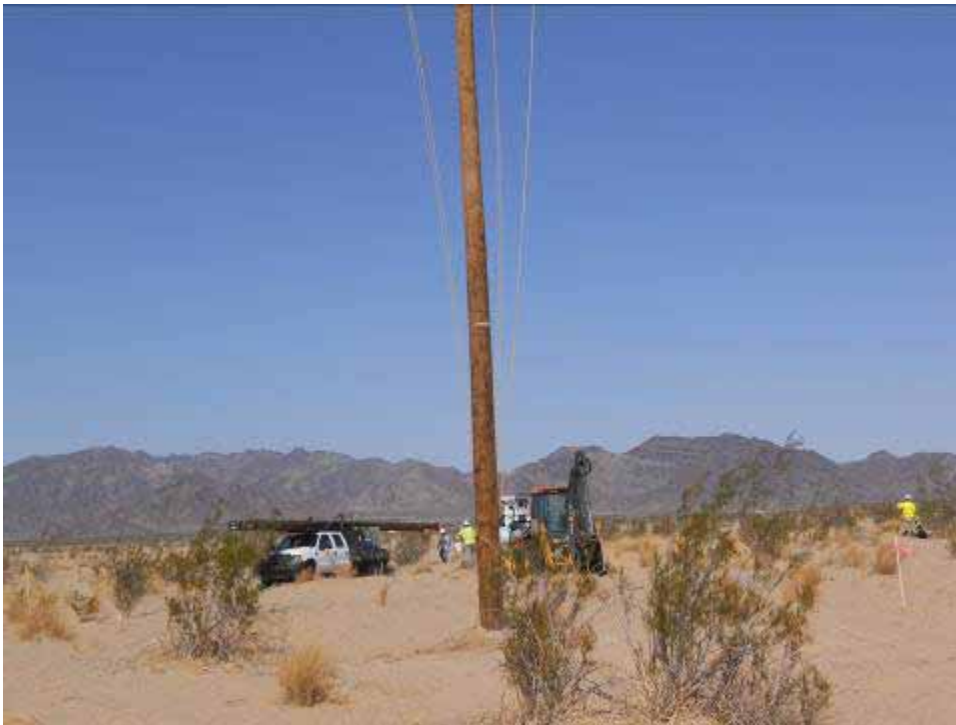
Figure 4: New pole installation along the Red Bluff distribution line.

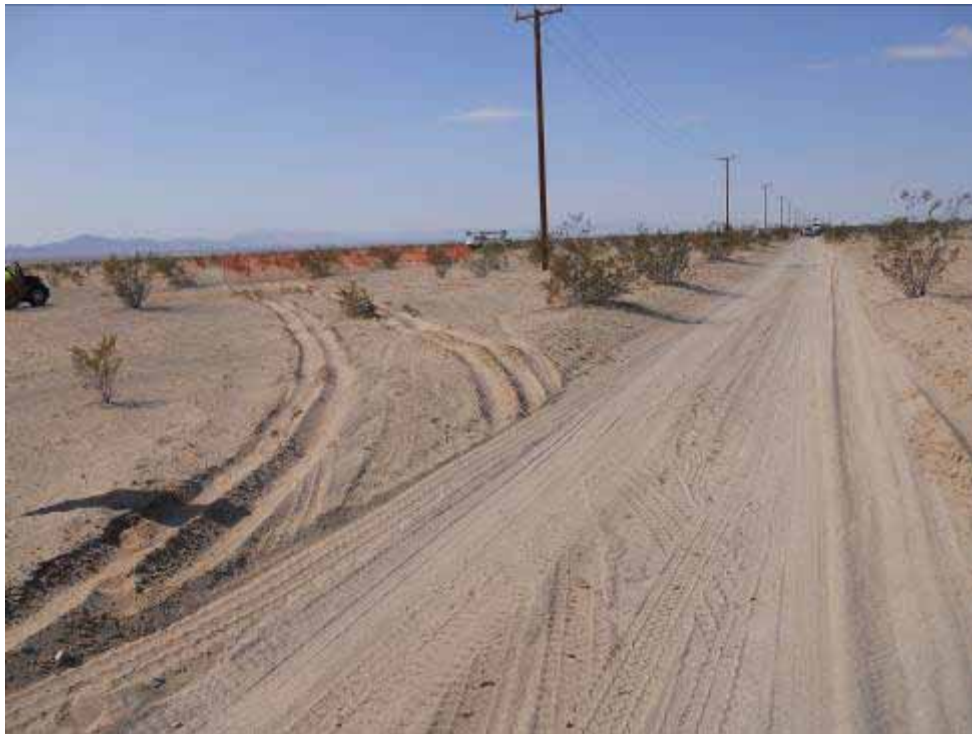
3. The CPUC EM met with the SCE Biological and Cultural Monitors onsite on October 26 to discuss the initiation of project activities. It was during this meeting that the CPUC EM was informed that one 4000-gallon water truck had become stuck in soft sandy soil off of an existing access road just east of the project area and outside of the defined disturbance limits (see Figure 5). A second piece of heavy equipment was utilized to remove the water truck from the area. Additionally, SCE monitors reported to the CPUC EM that another area adjacent to the existing access road along the northern limits of the project area and outside of the disturbance limits was being utilized. Several recent vehicle tracks were observed by the CPUC EM and it was confirmed that these were project related. This area was later flagged for avoidance with yellow caution tape by the SCE monitors (see Figure 6). Each of these areas occur within desert tortoise occupied habitat. Subsequently, a Project Memorandum was issued by the CPUC EM on October 28 after notifying SCE of these developments (see Table 4).

Figure 5: Vehicle tracks outside of disturbance limits along the Red Bluff distribution line access route. This incident resulted in the issuance of a Project Memorandum from the CPUC EM.

Type	Date Issued	Location	Description
CPUC Project Memoranda (PM)			
PM #1	10/28/11	CRS Dist. Line	Construction vehicles leaving marked disturbance limits at two locations along Red Bluff distribution line.

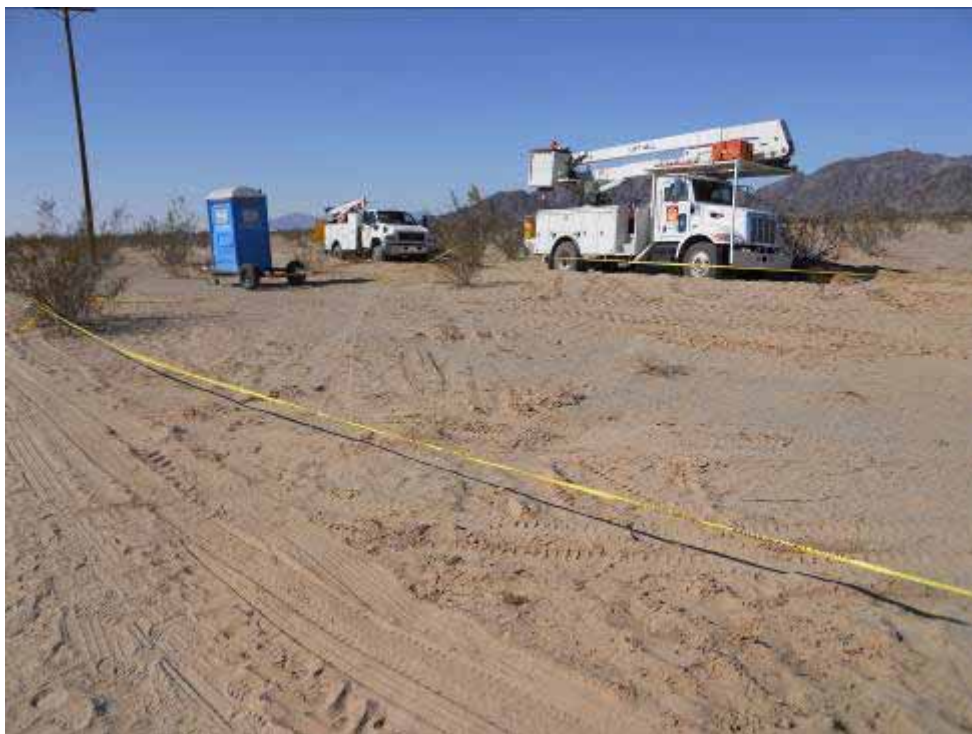
Figure 6: Area outside of approved Red Bluff disturbance limits which was repeatedly crossed by construction vehicles. The SCE Biological Monitor placed yellow caution tape around perimeter for future avoidance.

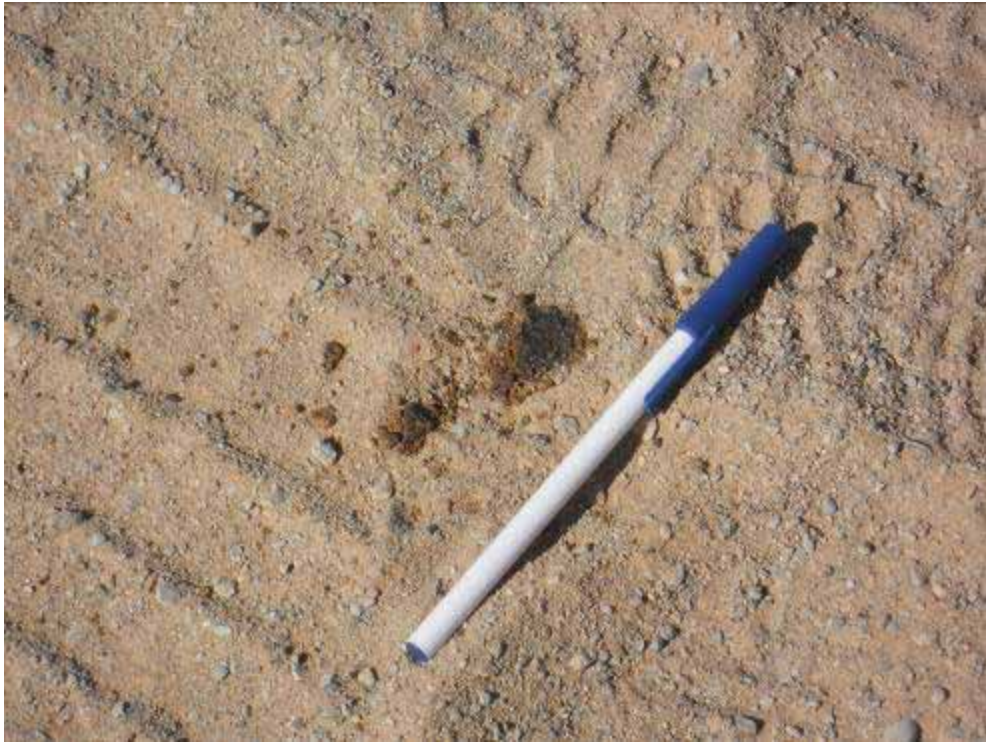
5. On October 27, the SCE General Monitor identified a small oil leak from an unknown source along the access road (see Figure 7). The CPUC EM who was onsite was notified. Work crews immediately cleaned the spill by removing the contaminated soil with a shovel and transporting offsite.

Figure 7: Minor oil spill detected by SCE General Monitor along Red Bluff distribution line site. Contaminate soil was shoveled out and removed from site.

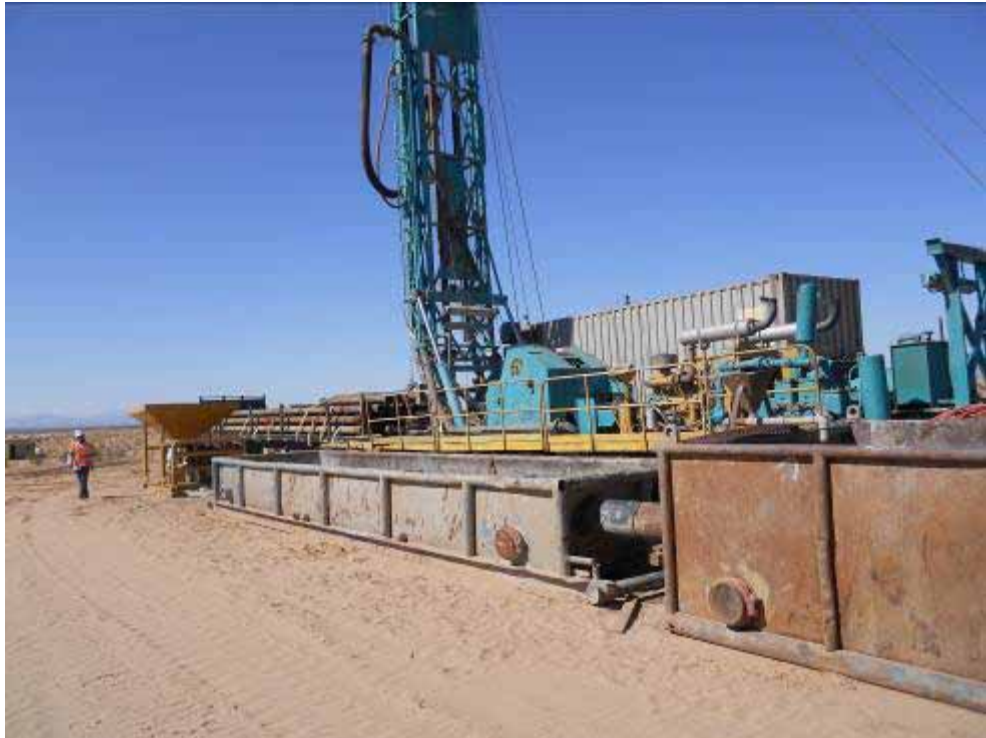
Figure 8: Drill rig assembly being conducted at CRS.

1. Major activities that occurred at the CRS site during the subject period included the installation of BMPs, set-up of the drill rig and auxiliary equipment for developing the water well, road maintenance, and mobilization of equipment and materials (see Figure 8).

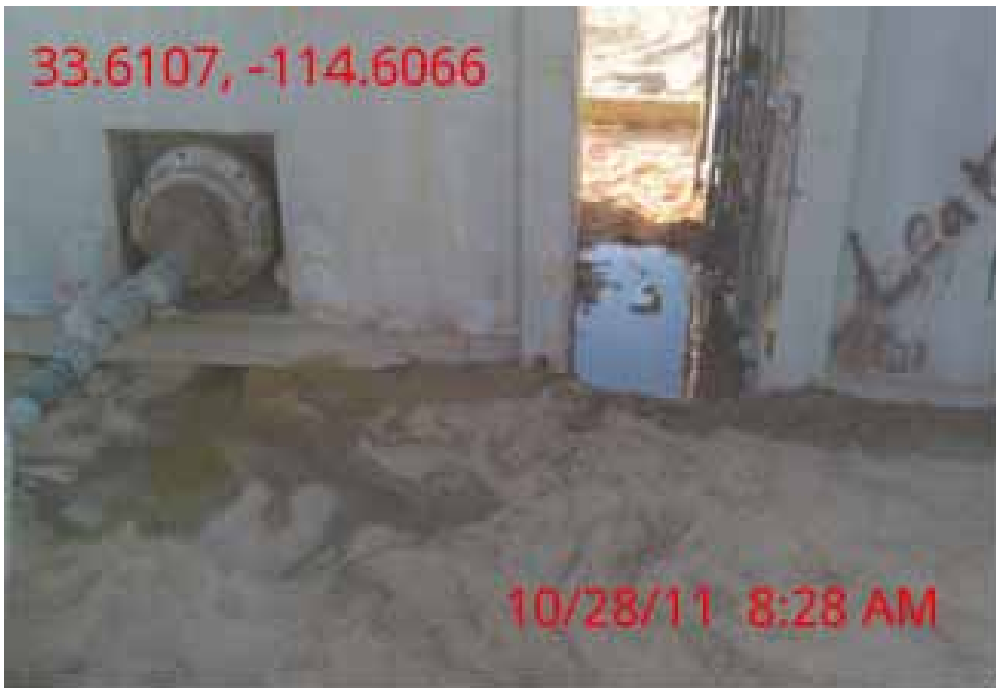
4. On October 26, the SCE General Monitor reported that an airman generator (#689) did not have a proper air regulations placard. A new generator was brought in to replace #689.
5. The SCE General Monitor reported on October 28 that high water pressure from an overfilled Baker tank caused a water leak at the doors of the tank and onto the soil resulting in a potential erosion risk (see Figure 9). The CPUC EM also noted this issue during an October 28 site visit. As a resolution, a hose was attached to the tank to drain water into the well, reducing the pressure and stopping the leak.
6. No special-status species were reported by the SCE Biological Monitors in the project area during the subject period.

Figure 9: Water leaking from Baker tank at CRS site. A hose was attached to tank to resolve any erosion issues.

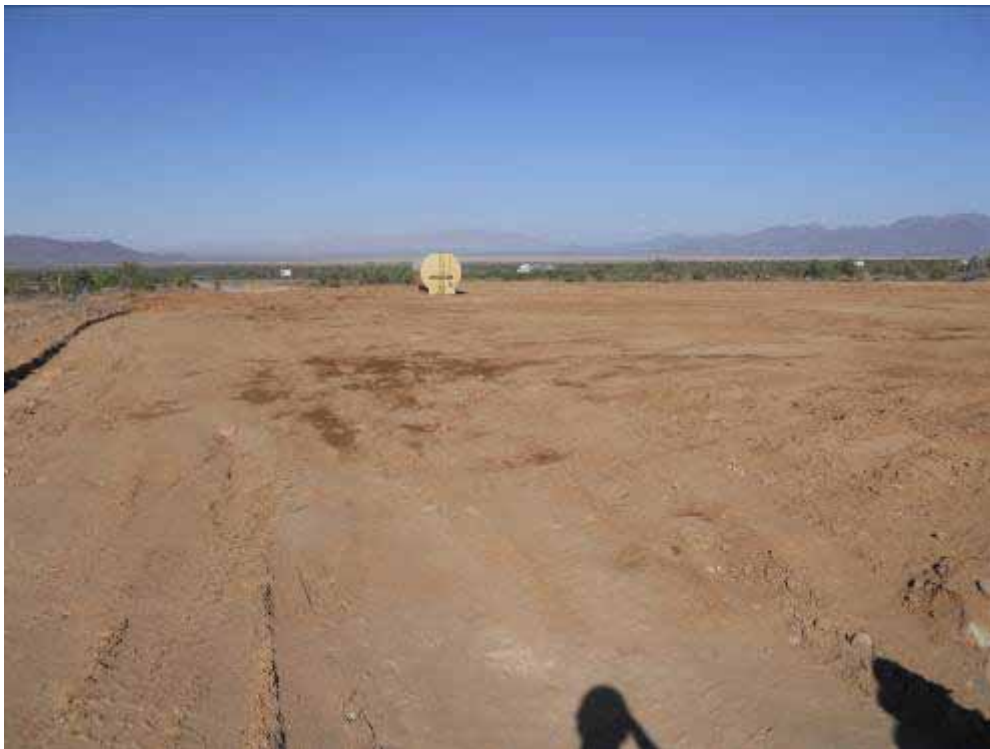
Figure 10: Area cleared and graded at Red Bluff site to accommodate well drilling activities.

1. Final grading of the eastern access road and the access road within the fenced boundaries was completed on October 25.
2. A temporary laydown area (approximately 300 square feet) for the well drilling activities was constructed within the northwest corner of the site (see Figure 10).
3. An office trailer was placed on the southwest corner of the site on October 25. The area was cleared and graded with a 140H blade prior to placement.
4. Well drillers began mobilization on October 26 and 27. The equipment brought onsite during that time included water and slurry tanks, well conductor drill rig, gravel catcher, trimming, and hoses.
