**PROJECT MEMORANDUM
SCE DPV2 TRANSMISSION PROJECT**

To: Billie Blanchard, Project Manager, CPUC
From: Vida Strong, Aspen Project Manager
Date: December 07, 2011
Subject: Weekly Report 16, October 31 to November 6, 2011

This report provides a summary of the construction and compliance activities associated with the SCE DPV2 Transmission and Red Bluff Substation Projects.

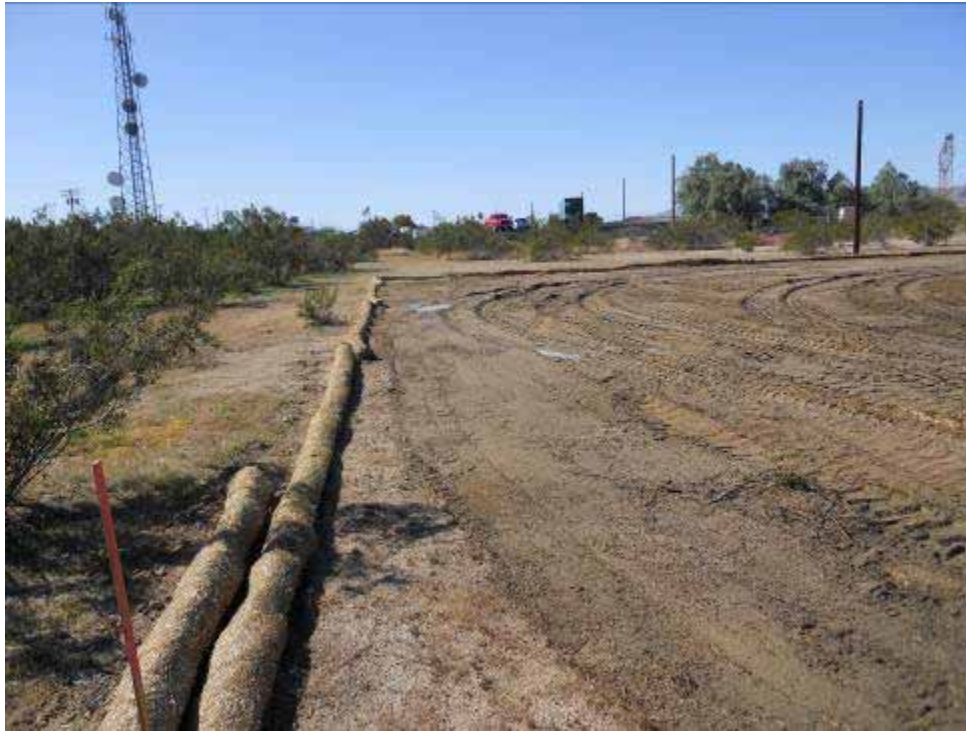
Figure 1: Installation of BMPs and grading at the Summit Construction Yard.

1. During the subject period, major construction activities were limited to the Summit Construction Yard and included delineating site boundaries, installation of BMPs, vegetation removal, gravel delivery and placement, and site grading (see Figure 1).
2. Activities at the remaining yards consisted of ongoing dust suppression, material deliveries, office trailer maintenance, and general site maintenance.

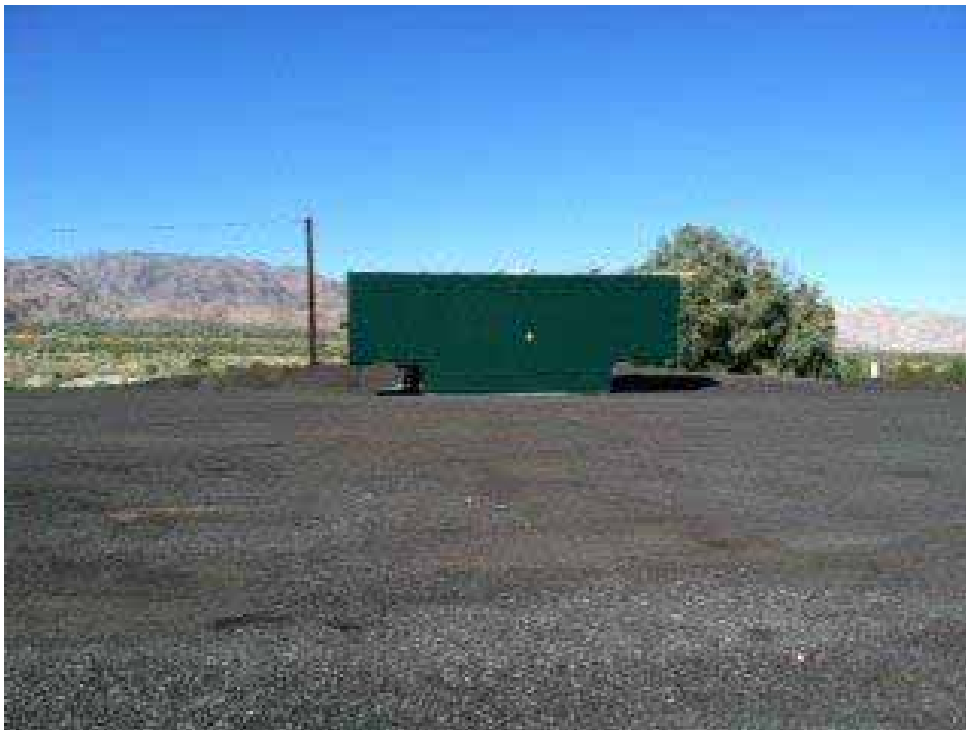
1. On November 1, the CPUC EM observed that a large water tank had been placed in the barren lot just adjacent and west of the Summit Construction Yard (see Figure 2). It was noted that this area was not within the defined disturbance limits previously approved for the Summit Yard. The contractor informed the CPUC EM that because they could not use the water source approved under Variance #10 (see Table 2), they would be transporting water via tanker from the approved Desert Center water source location to the water tank brought on site. Water trucks would then utilize water from the water tank for activities at the Summit Construction Yard. According to the contractor, this was approved by SCE, but was not approved by CPUC; therefore, it was decided that the contractor would just move the tanker and associated equipment inside the construction yard limits the following day. During a site visit on the following day, the CPUC EMs observed a temporary J-stand that was set up along the existing paved access road just south of the Summit Construction Yard (see Figure 3). When asked, the Kindness Construction foreman informed the CPUC EMs that they were only temporarily using this area because they had to stabilize the construction yard driveway to a level that could support equipment that would haul in the water tank without sinking. The CPUC EM issued a verbal warning to SCE reminding them that use of temporary extra work space areas require CPUC

Figure 2: Water tank located in barren lot adjacent to western boundary of the Summit Construction Yard. This area was outside of the approved disturbance limits and the tank was relocated the following day.

notification and approval. All equipment associated with water storage was ultimately moved into the construction yard limits by November 3.

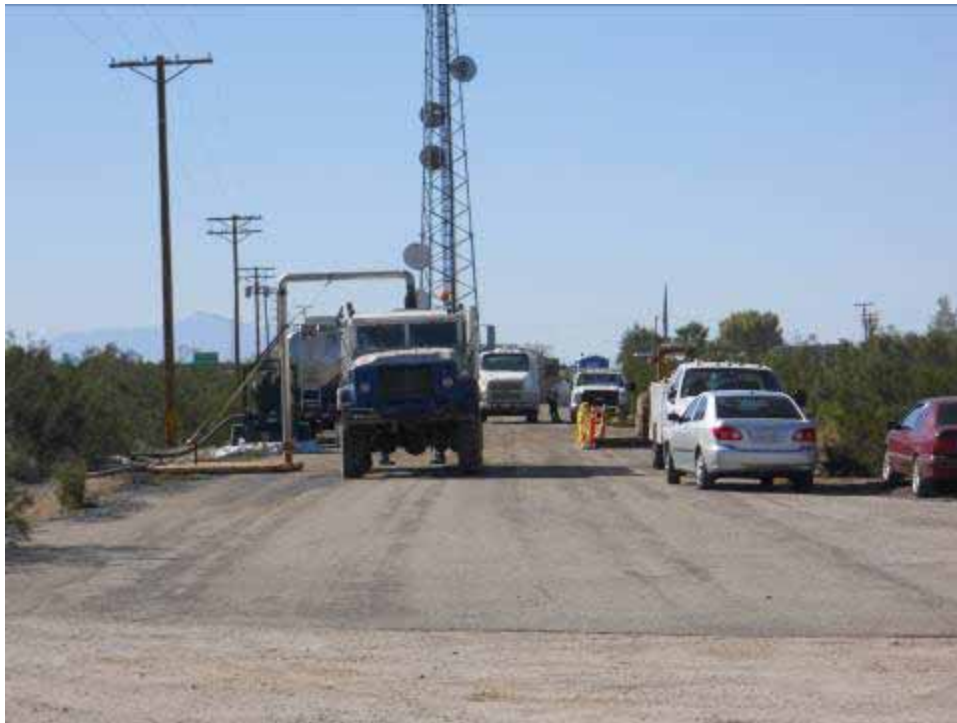
Figure 3: J-stand water tower installed along access road south of Summit Construction Yard. A verbal warning was issued by the CPUC EM because this was not an approved water source location.

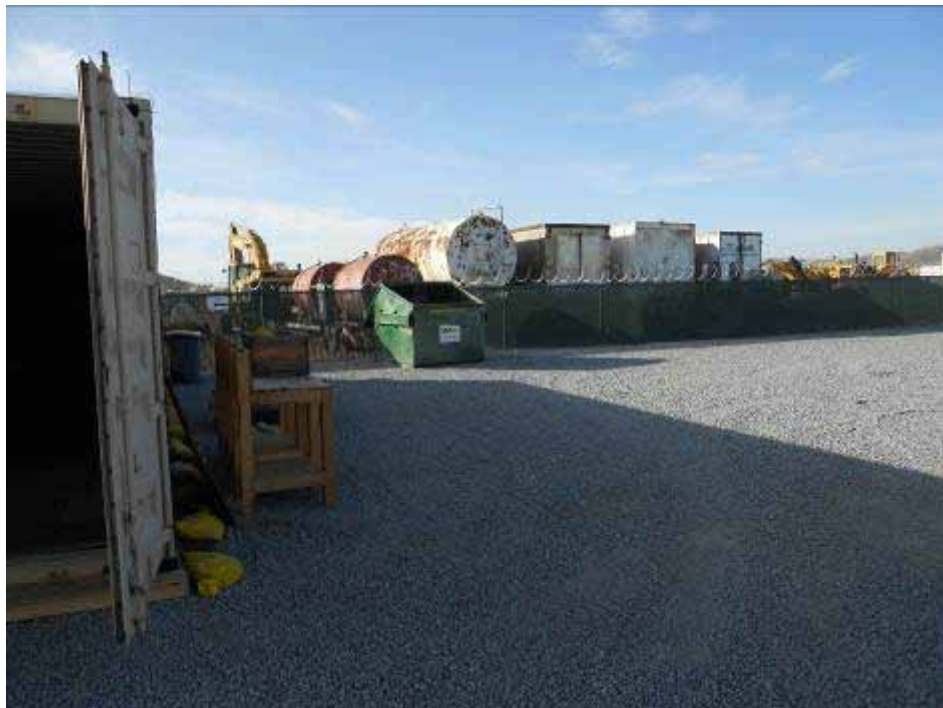
2. On November 3, the CPUC EM observed an open trash container at the Meniffee Construction Yard. The Kenney Site Representative was notified immediately that all trash containers must be closed at all times when not in use (see Figure 4).
3. The CPUC EMs confirmed that BMPs, including dust suppression, secondary containment, and adequate vehicle and equipment parking areas were implemented throughout the subject period at all active construction yards.
4. SCE Biological Monitor reported one loggerhead shrike individual calling from the adjacent property just west of the Summit Construction Yard on October 31.

Figure 4: Open trash container at the Meniffee Construction Yard. The Kenney site representative was made aware by the CPUC EM and immediately closed the container.

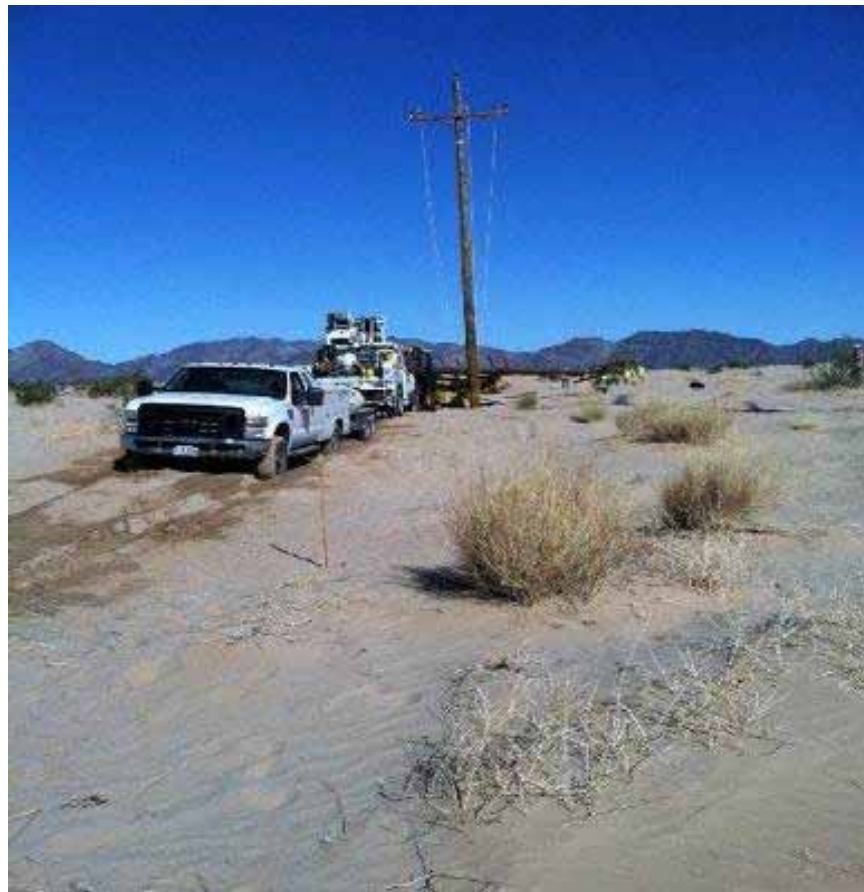
Figure 5: Installation of wooden poles along the CRS distribution line.

1. Throughout the subject period, construction activities included the setting of wooden distribution and anchor poles, and stringing and pulling wire. These activities were performed by two separate crews working from the east and west along the distribution line alignment (see Figures 5 and 6).
2. Two wire pulling sites were established adjacent to access road and dimensions were reduced from 150' x 50' to 70' by 70'.

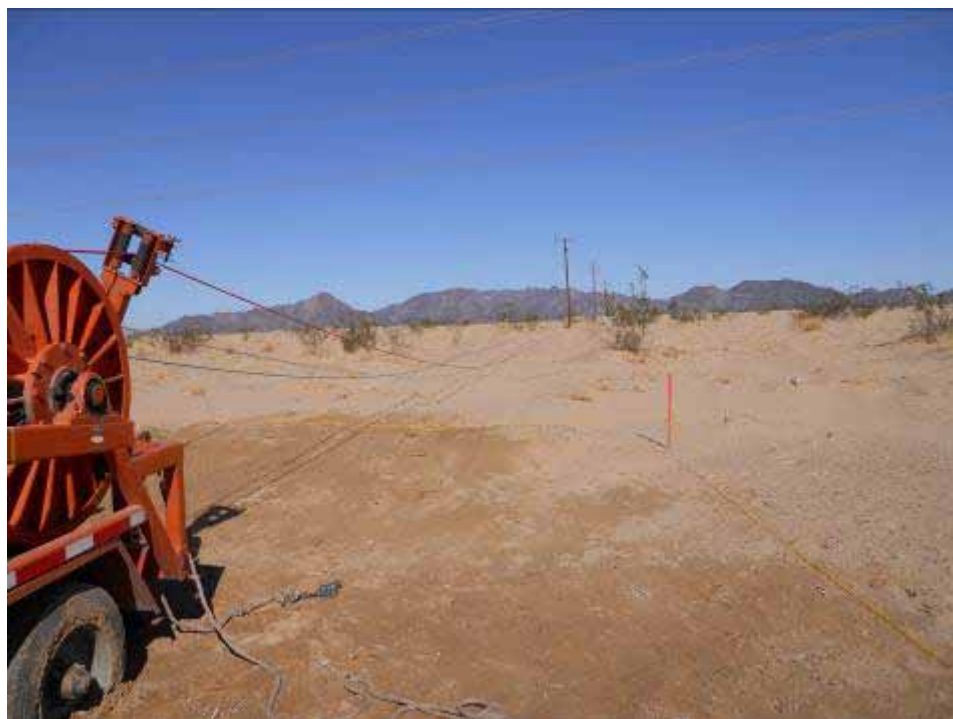
Figure 6: Wire stringing activities occurring along the CRS distribution line.

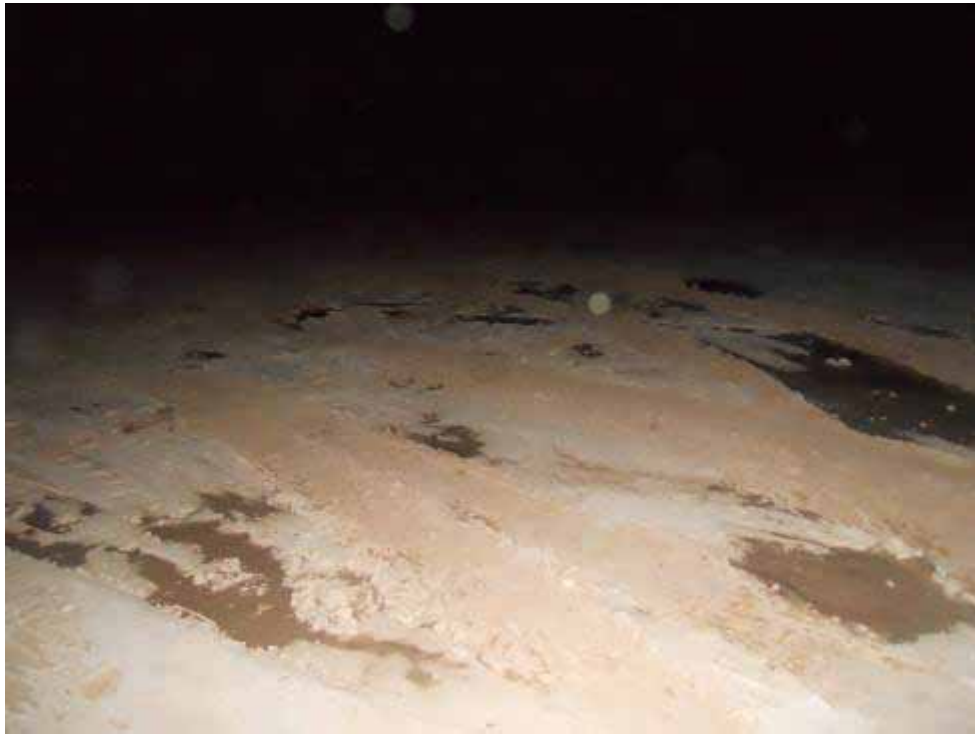
5. The CPUC EM conducted a site visit during evening drilling operations on November 3. Upon walking the site, the CPUC EM observed mud cracks and small puddles of water just outside the straw wattles along the northern boundary of the drill site (see Figure 7). Assuming that water had recently settled at that location, the CPUC EM questioned the ULM site representative about the source of the water. The ULM site representative stated that one of the drilling crew operators dumped water excess from the de-sanding area outside of the wattles the previous night. The SCE General Monitor had identified the same issue earlier in the day and had immediately notified up the chain of command. Instructions were given by Brian Clayton (SWPPP Monitor) to stop moving water into this area and to thereafter dump it in an area that would be lined with plastic sheeting for cuttings and release water placement. Additionally, instructions were given by SCE to the drilling crew to clean the area within 24 hours. Subsequently, the area was cleaned the following day and the remaining cuttings were placed upon plastic sheeting.

Figure 7: Area just outside of drill site at CRS where mud cracks and small puddles were observed by CPUC EM. Drilling crew had dumped water from de-sander pit here and was instructed to clean within 24 hours.

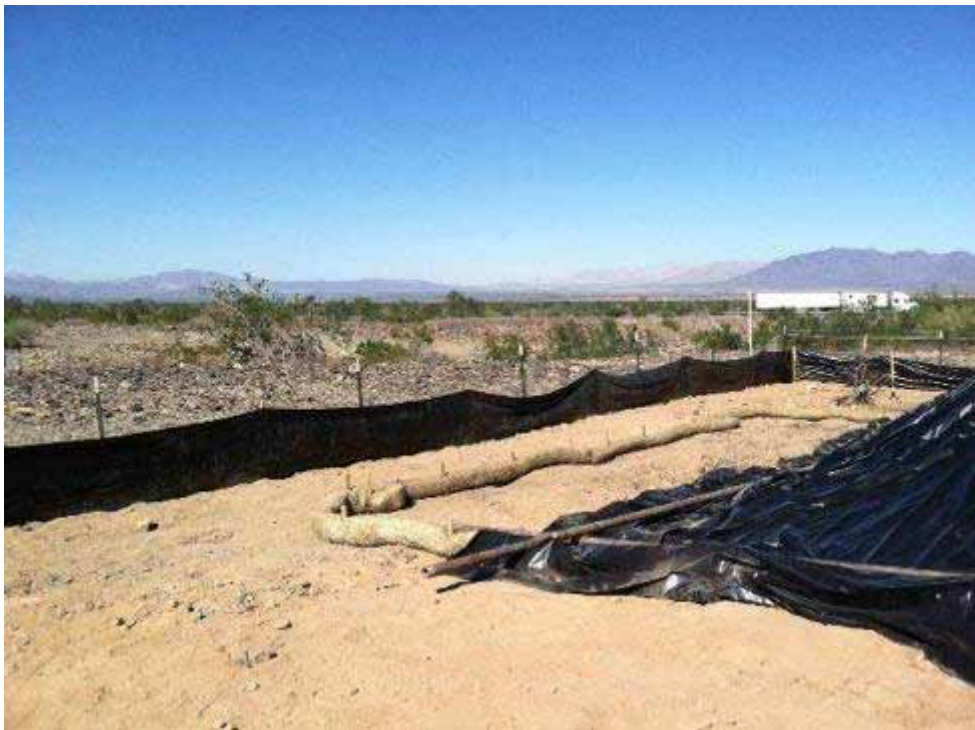
Figure 8: Silt fence installation around Red Bluff drill site.

1. Delivery of well drilling equipment began on November 1. On this same day, the contractor began installation of a silt fence barrier around the downgrade portion of the graded well site. Silt fence installation was completed on November 4 (see Figure 8).
2. Construction crews continued grading the area in northwest corner of site in preparation of anticipated drill rig mobilization and activities.
