## PROJECT MEMORANDUM SCE DPV2 TRANSMISSION PROJECT

**To:** Billie Blanchard, Project Manager, CPUC  
**From:** Vida Strong, Aspen Project Manager  
**Date:** April 11, 2012  
**Subject:** Weekly Report 34, March 5 to March 11, 2012

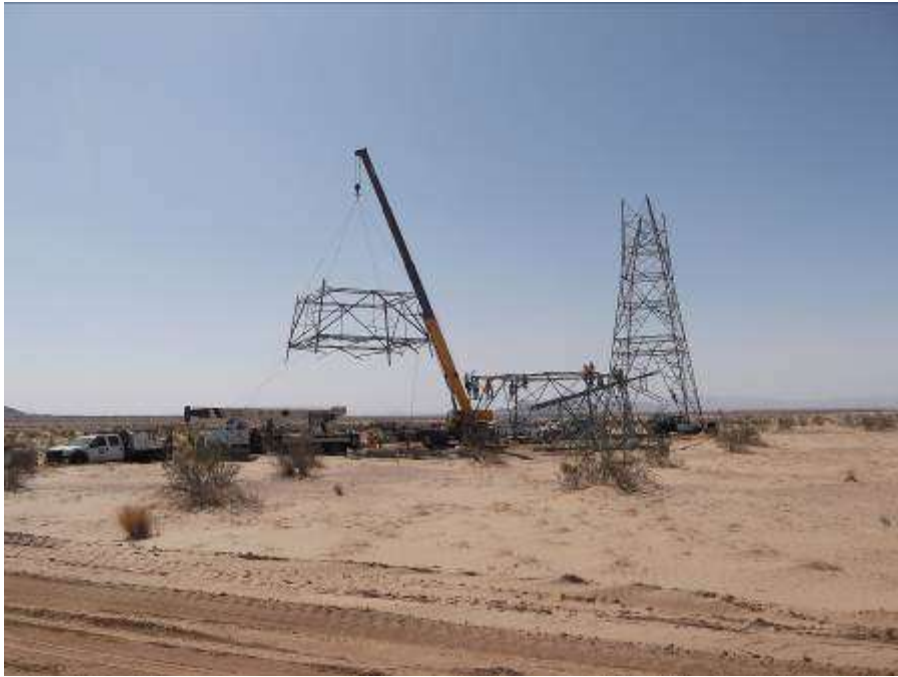
- Tower assembly crews worked at Towers 2649 and 2650 and CRS Loop-in Towers CR1-2E, CR1-3E, CR1-4E, CR1-5E, CR1-2W, CR1-3W, and CR1-4W. Tower erection activities were conducted at Tower 2649 and CRS Loop-In Towers CR1-3E and CR1-2W (see Figure 1).
- Foundation concrete pouring occurred at Tower 2650 and CRS Loop-in Towers CR1-2E, CR1-3E, CR1-4E, CR1-5E, CR1-2W, and CR1-3W.
- Foundation drilling activities occurred at Tower 2650 and CRS Loop-in Towers CR1-1E, CR1-2E, CR1-3E, CR1-3W, and CR1-4W (see Figure 2).
- Vegetation clearing activities were conducted at CRS Loop-In Tower CR1-2E.
- BMPs were installed and/or maintained at CRS Loop-In Towers CR1-1W, CR1-2W, CR1-3W, CR1-3E, CR1-4E, and CR1-5E. Installation and/or maintenance of BMPs also occurred along the access roads associated with these locations.

**Figure 1.** Tower assembly and erection activities at Towers 2649 and CR1-2W.

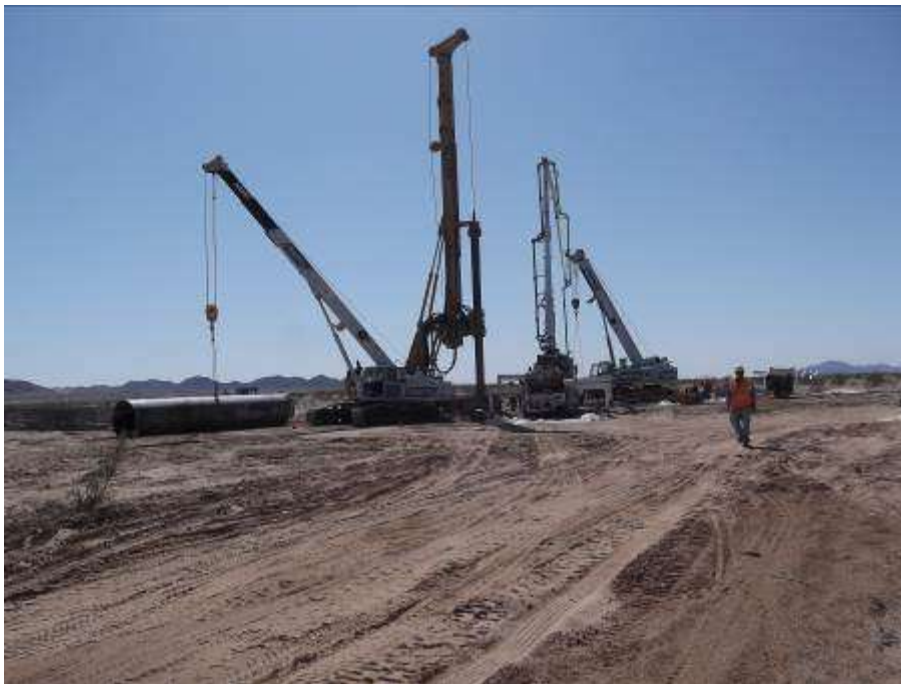
**Figure 2.** Foundation drilling at Tower CR1-2E.

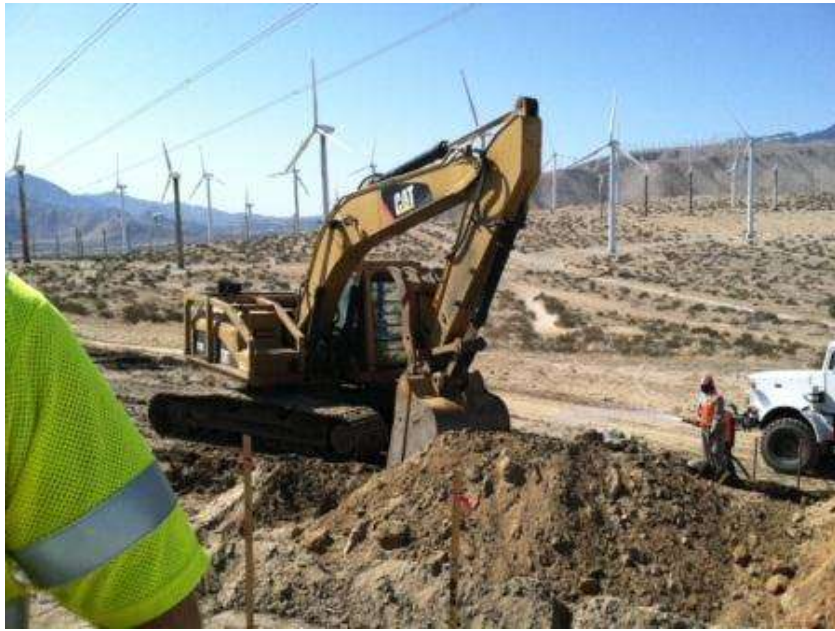
- BMP installation occurred at Towers 1004-1006, 1059, 1060, and 1062.
- Vegetation clearing occurred at Towers 1004 – 1006, 1011, 1014, and 1015.
- Spur road and crane pad grading occurred at Tower 1012 and 1014 (see Figure 3).
- Foundation drilling occurred at Towers 1057, 1058, 1059, and 1060 (see Figure 4).
- Foundation concrete pouring occurred at Towers 1059, 1060, 1061, and 1062.
- Tower assembly and steel deliveries occurred at Tower 1061 and R1.
- Site verification surveys occurred at Towers 1025, 1026, 1055, 1056, and 1071-1091.

**Figure 3.** Spur road and crane pad grading at Tower 1014

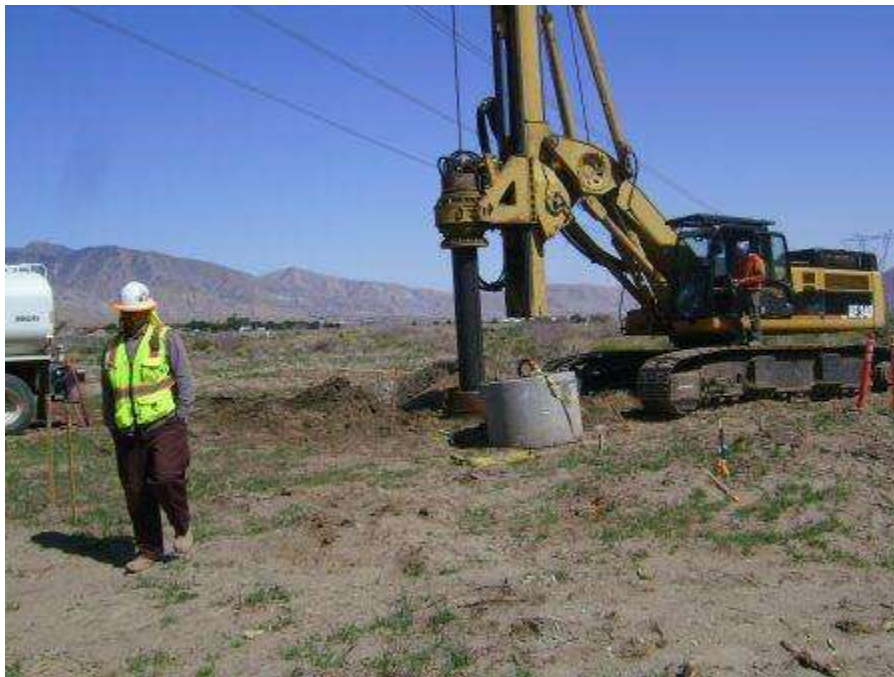
**Figure 4.** Foundation drilling at Tower 1059

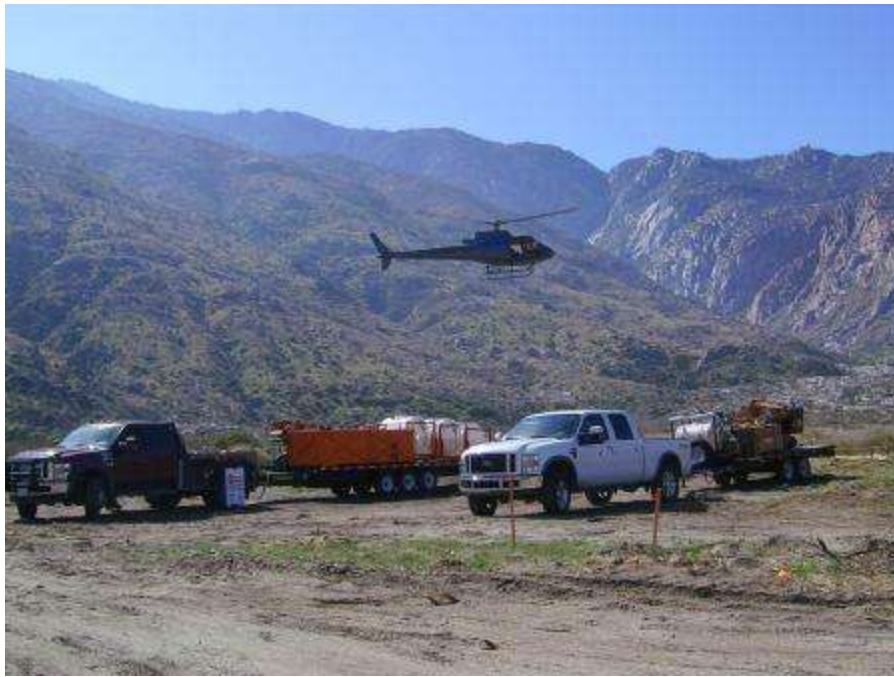
- Fugitive dust control was also noted at the H2 Landing Zone for helicopter work for temporary platform installation on USFS land by the CPUC EM (see Figure 5).

**Figure 5.** Adequate dust control during helicopter operations at the H2 Landing Zone

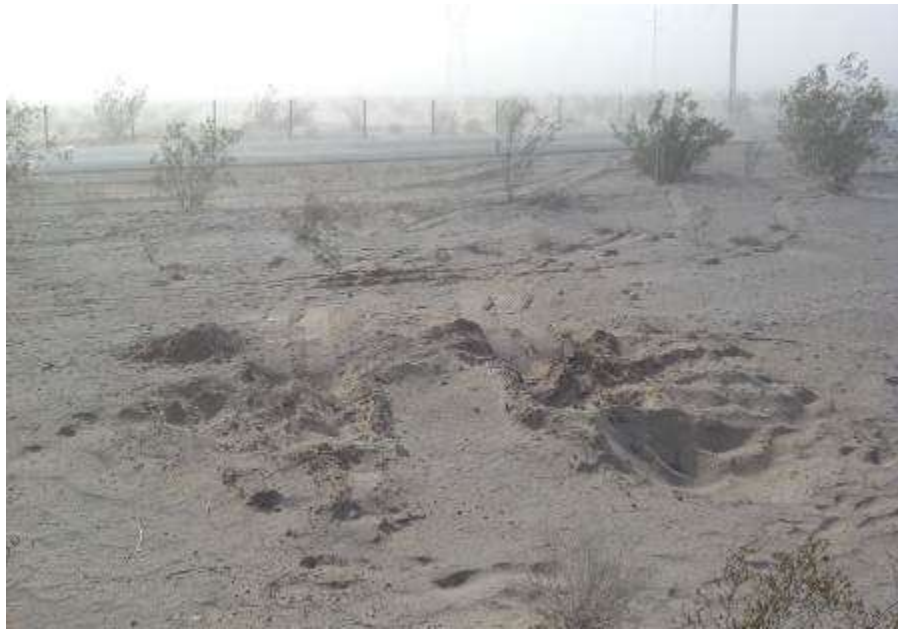
- On March 6, SCE Biological and Cultural Monitors reported that a mechanic for subcontractor Professional Electric became stuck in sand approximately 50 feet outside of the approved disturbance limits associated with the CRS primary access road (see Figure 7). One creosote bush was slightly damaged and there were no other impacts to biological or cultural resources.

**Figure 7.** Area near entrance to CRS primary access road where subcontractor truck drove outside project disturbance limits (photo courtesy of Ethan Ripperger).

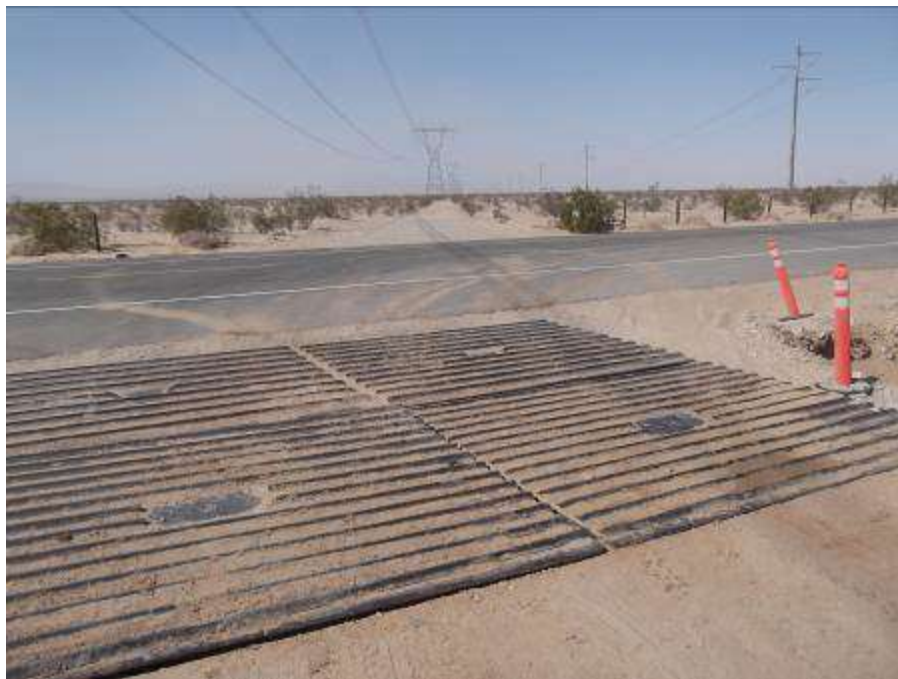
- On March 7, the CPUC EM identified excessive amount of track-out while entering the CRS primary access road from Wiley's Well Road (see Figure 8). The SCE General Monitor was notified and the track-out was removed the same day.

**Figure 8.** Excessive track-out observed by CPUC EM at ingress/egress to CRS primary access road.
