## PROJECT MEMORANDUM SCE DPV2 TRANSMISSION PROJECT

**To:** Billie Blanchard, Project Manager, CPUC  
**From:** Vida Strong, Aspen Project Manager  
**Date:** April 17, 2012  
**Subject:** Weekly Report 36, March 19 to March 25, 2012

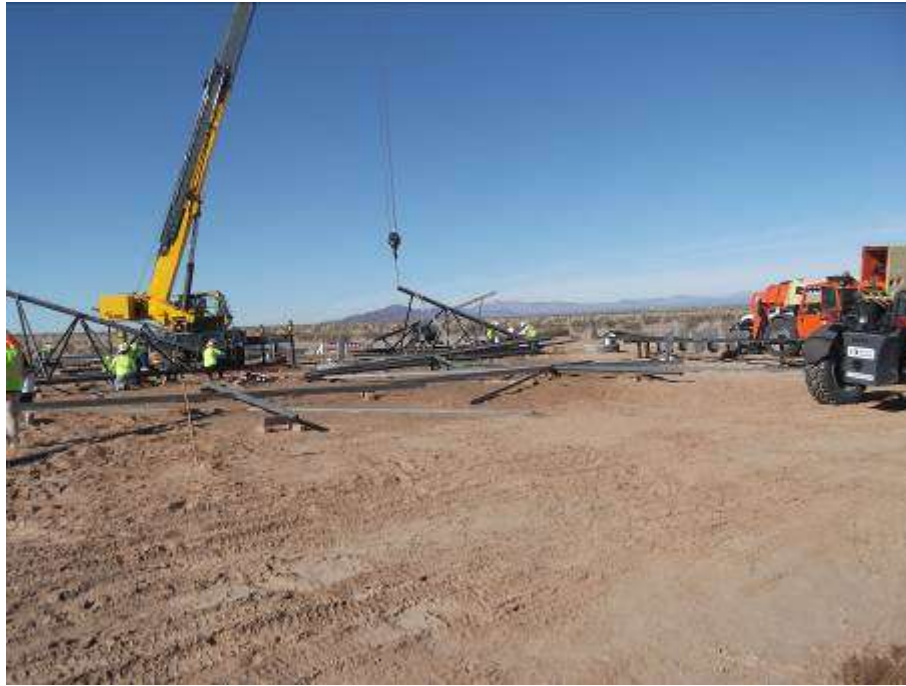
**Figure 1.** Assembly crews working at Tower CR1-4W.

1. Colorado River Substation (CRS) to Red Bluff Substation
  - Tower assembly crews worked at Towers 2648-2652 and CRS Loop-in Towers CR1-3E, CR1-4E, CR1-5E, CR1-1W, CR1-2W, CR1-3W, CR1-4W, and CR1-5W (see Figure 1).

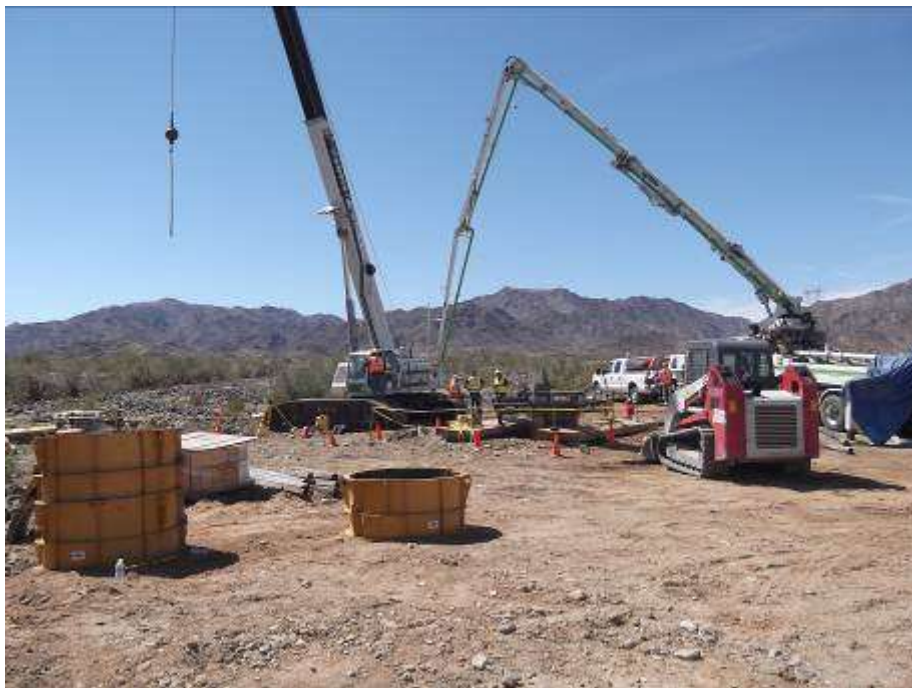
**Figure 2.** Concrete pouring at Tower RB2-2W.

2. Red Bluff Substation to Devers Substation
  - Foundation concrete pouring occurred at Red Bluff Loop-In Towers RB2-1W and RB2-2W (see Figure 2).
  - Foundation drilling activities were conducted at Red Bluff Loop-In Towers RB1-5E, RB2-5E, RB1-1W, RB1-2W, RB2-1W, and RB2-2W.

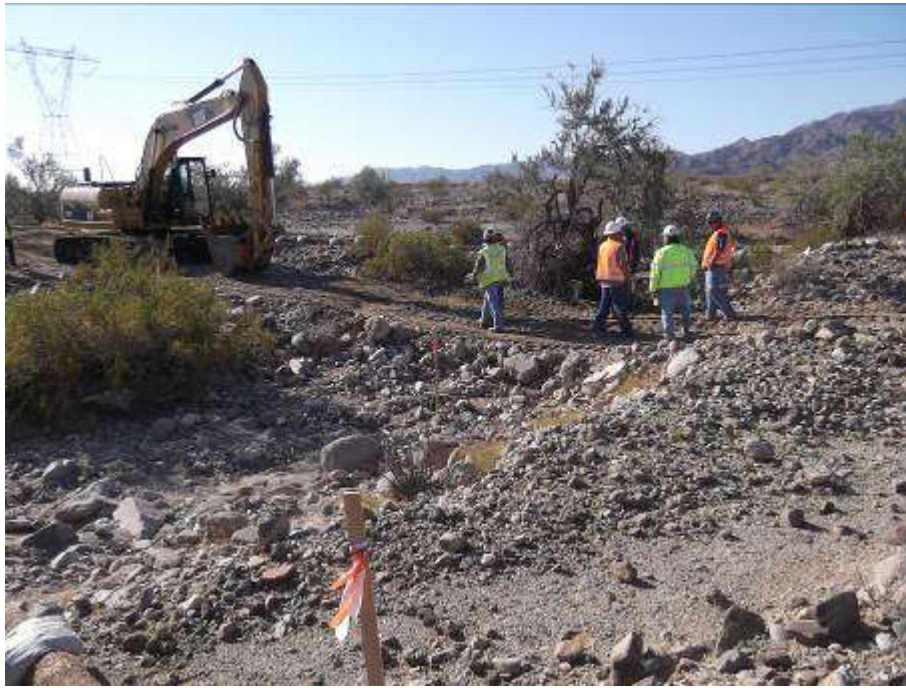
**Figure 3.** Construction of wet crossing along spur road to Towers RB1-5E and RB2-5E.

- Road grading activities, including the installation of a wet crossing, occurred along the spur road to Red Bluff Loop-In Towers RB1-5E and RB2-5E (see Figure 3).
- BMPs were installed at Towers 2517, 2520, 2522, and 2526 and maintained at Towers 2513 and 2515. BMPs were also installed at Red Bluff Loop-In Towers RB1-4E, RB1-5E, RB2-5E, RB1-1W, and RB2-1W and their associated access and spur roads.
- Potholing activities associated with identifying the location of existing utilities infrastructure were conducted along the access road between Towers 2527 and 2533 and along the access road near Red Bluff Loop-In Tower RB2-1W.

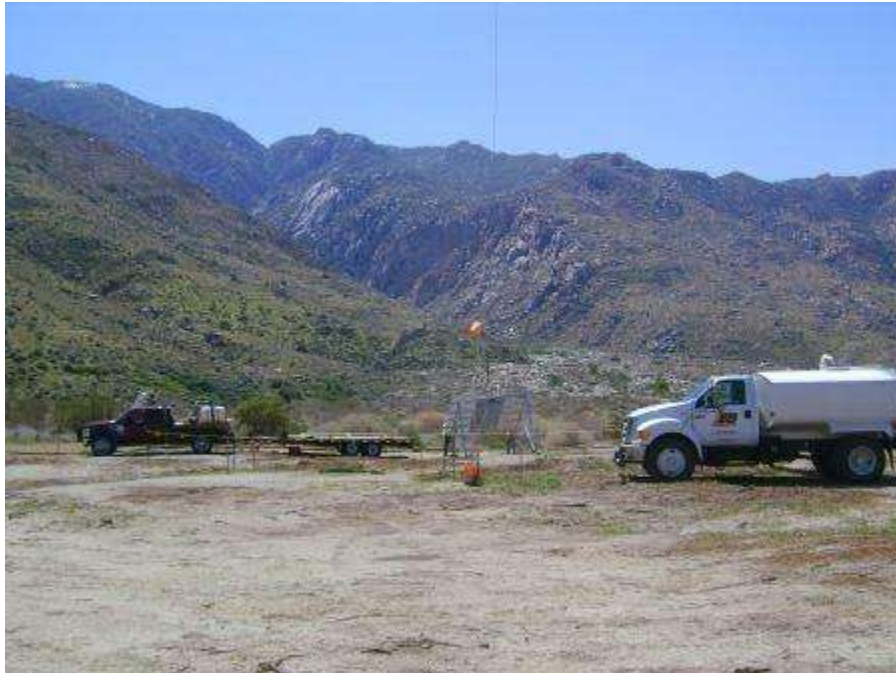
**Figure 4.** Helicopter operations at Landing Zone H2-DV. The helicopter is lifting a temporary platform to be placed on USFS land.

- Helicopter temporary platforms were installed between Towers 1036 and 1048 (see Figure 4).
- Existing wooden platforms were removed from 3 tower locations.

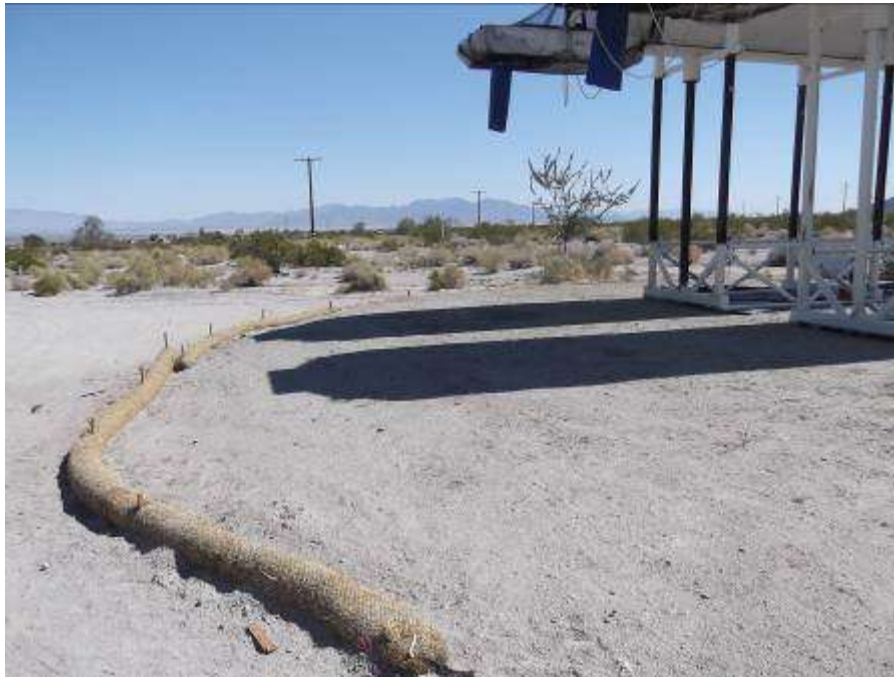
**Figure 5.** BMPs and bird netting installed at water stand tank at Rice Road location.

- On March 20, the CPUC EM confirmed that BMPs and bird netting had been installed at the water stand tank location at Rice Road (see Figure 5).
- All work associated with the wet crossing between Red Bluff Loop-In Towers RB1-5E and RB2-5E was halted on March 23 due to the discovery of an active hummingbird nest within 300 feet of project activities.

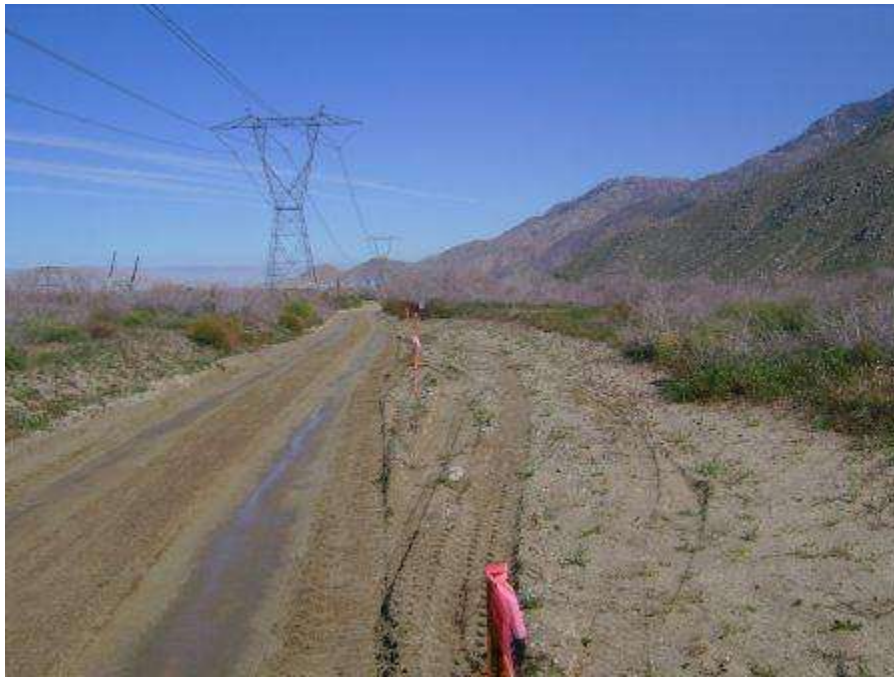
**Figure 6.** Additional staking was placed in areas where vehicles were driving off of the approved access road between Towers 1061 and 1063.

- On March 21, 2012, a contractor vehicle drove off of the approved access road between towers 1061 and 1063 within a Jurisdictional waterway. He was allowing an oncoming concrete truck to pass. His vehicle became stuck in the sand and was pulled out by forklift. The onsite biological monitor inspected the area and found that no sensitive resources were impacted. The disturbance area outside of roadway (approximately 30 feet long and 10 feet wide) was recorded in a Trimble GPS unit. Additional staking was added to keep other vehicles from driving off of the road (See Figure 6).

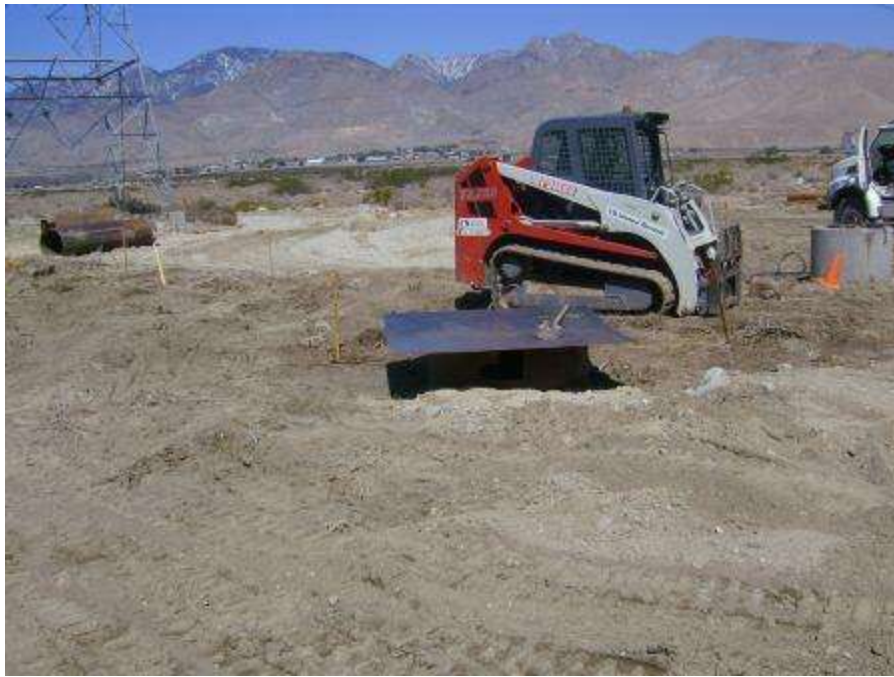
**Figure 7.** Covered foundation hole with a gap where animals could potentially fall into.

- On March 22, 2012, the onsite biological monitor at Tower 1028 arrived onsite and discovered that the boards covering the foundation holes left a gap between the top of the casing and the wood. The casing only extended a few inches above ground level. The monitor informed the crew and follow-up actions were taken to cover the gaps to prevent wildlife from falling into the excavated hole (See Figure 7).

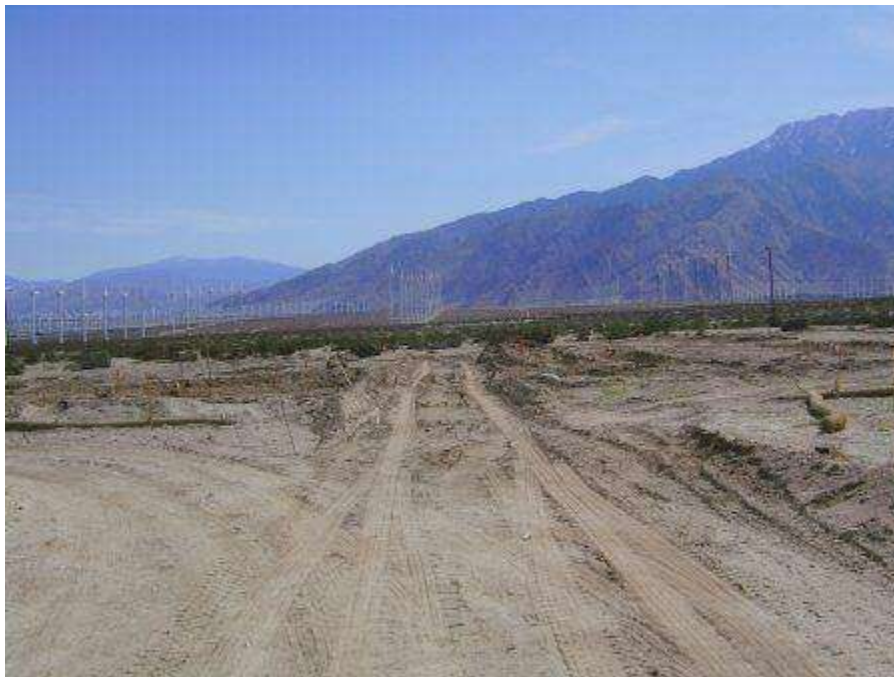
**Figure 8.** Grading that occurred at Tower 1006 without an archaeological monitor.

- On March 23, 2012, Audry Williams (SCE Cultural/Paleo Subject Matter Expert) notified Applied Earthworks that a Phillips & Jordon grading crew had moved to Tower 1006 without notifying SCE (See Figure 8). Tower 1006 was scheduled to be worked on Wednesday March 14. Per the HPMP, the tower required the presence of an archaeological monitor during all ground disturbing activities. Work was stopped at the site and an archaeological monitor was sent to evaluate the site. No significant resources were disturbed.

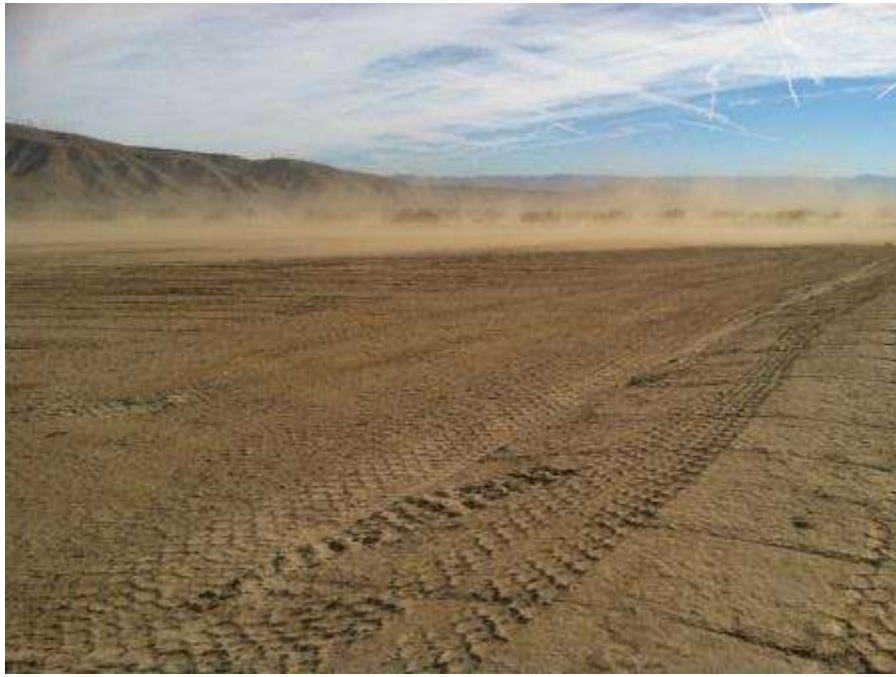
**Figure 9.** Fugitive Dust leaving the H1X-DV Landing zone

- On March 24, 2012, a dust cloud was observed blowing from Helicopter Landing Zone H1X-DV leaving the project site (see Figure 9). Wind gusts were in excess of 30 mph, with sustained winds around 21 mph.

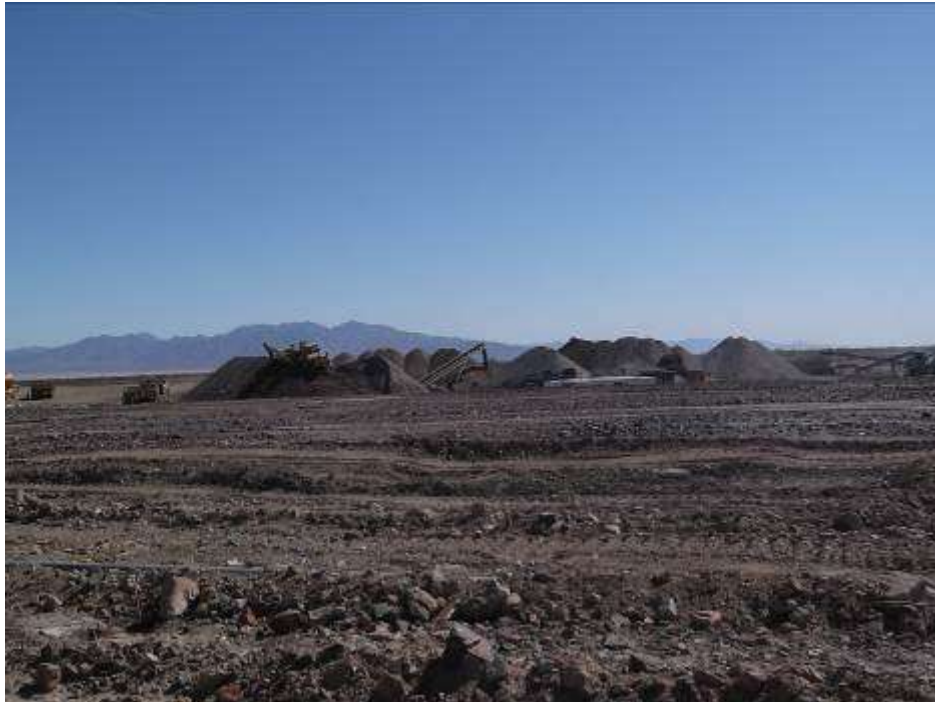
**Figure 10.** Ongoing rock crushing of native fill at Red Bluff Substation.

3. Series Capacitor (BLM Lands) – No major activities were conducted at the Series Capacitor site during the subject period.
4. Red Bluff Substation (BLM Lands) – Grading of cut and fill material continued at the Red Bluff Substation site and laydown area throughout the subject period. Rock crushing of native fill material also occurred (see Figure 10). Activities associated with the distribution line to provide power to the office trailers were completed. Pumping activities associated with development of the water well were continuous throughout the subject period. Construction crews staked work limits and installed BMPs along the primary access road.
