PROJECT MEMORANDUM SCE DPV2 TRANSMISSION PROJECT

To: Billie Blanchard, Project Manager, CPUC
From: Vida Strong, Aspen Project Manager
Date: April 23, 2012
Subject: Weekly Report 38, April 2 to April 8, 2012

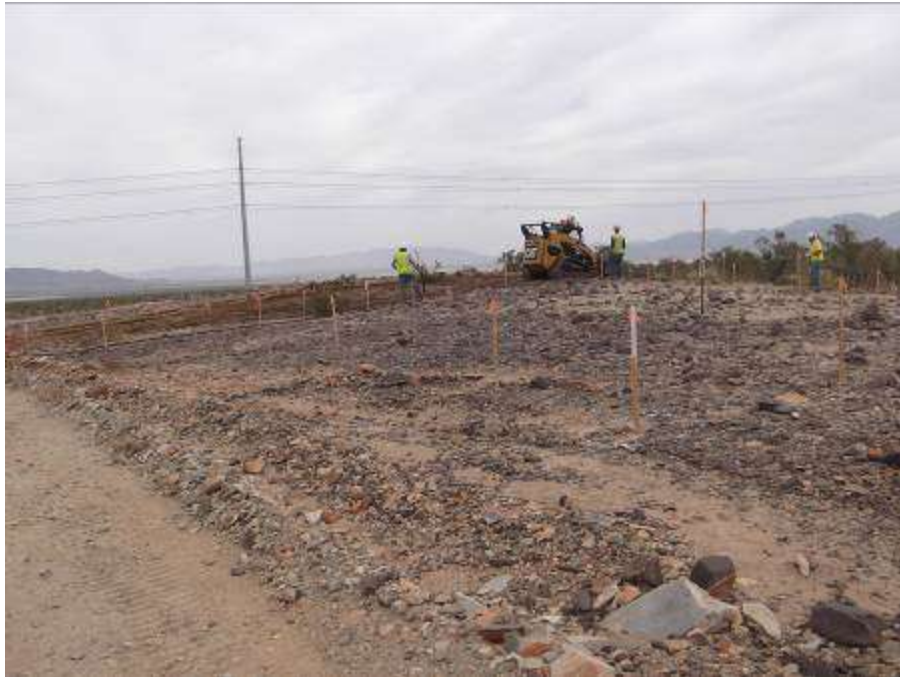
Figure 1. Initiation of desert pavement removal at Tower 2529.

- Foundation drilling occurred at Red Bluff Loop-In Towers RB1-5E and RB2-5E.
 - Rough grading was initiated and desert pavement salvage was conducted at Towers 2529 and 2531 (see Figures 1 and 2).

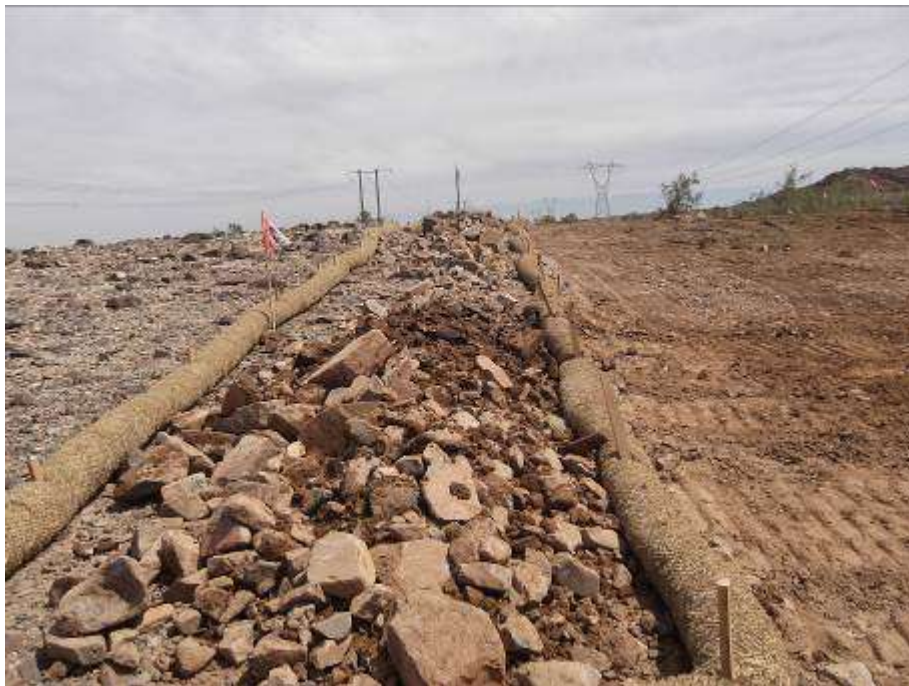
Figure 2. Area defined by BMP boundaries for desert pavement salvage at Tower 2529.

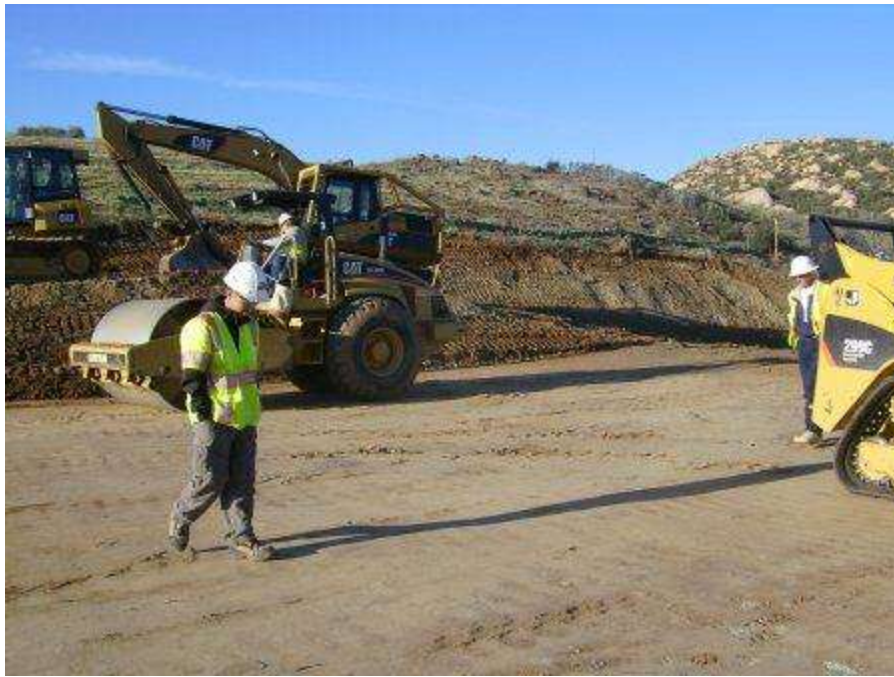
Figure 3. Spur road and crane pad grading at Tower 1091.

- BMP installation occurred at Towers 1028, 1054, 1083, 1089, 1091, and 1095.
- Vegetation clearing occurred at Towers 1073, 1076, 1083, 1088, 1089, 1091, and 1095.
- Spur road and crane pad grading occurred at Towers 1063, 1076, 1083, 1085, 1088, 1089, and 1091 (see figure 3).
- Foundation drilling occurred at Towers 1027 and 1055.
- Foundation concrete pouring occurred at Towers 1028, 1052, and 1055.
- Tower assembly and steel deliveries occurred at Tower 1061/R1, 1062/R2, and 1064/R4 (see Figure 4).

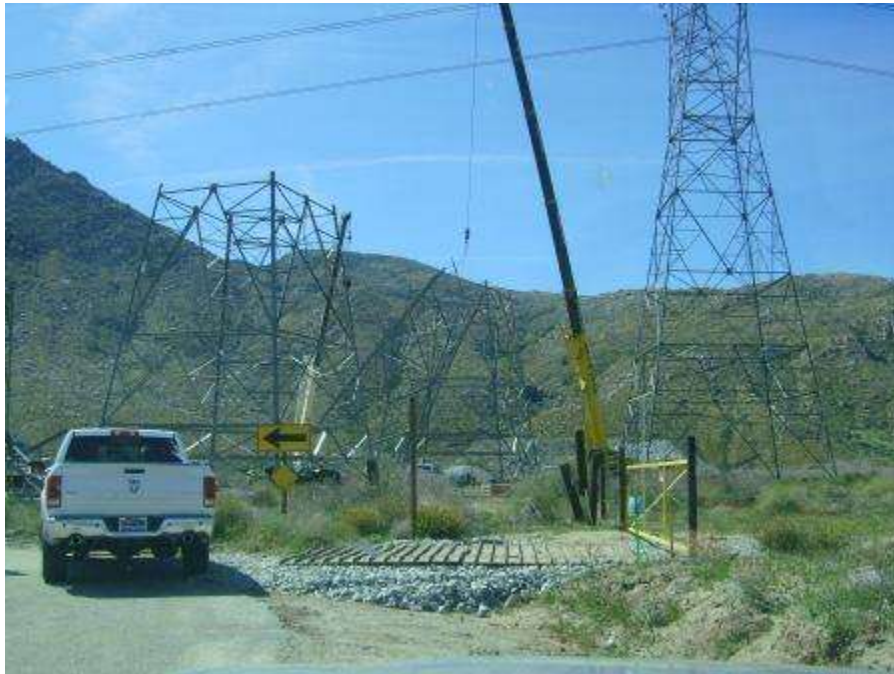
Figure 4. Tower Assembly at Tower 1062 using large crane.

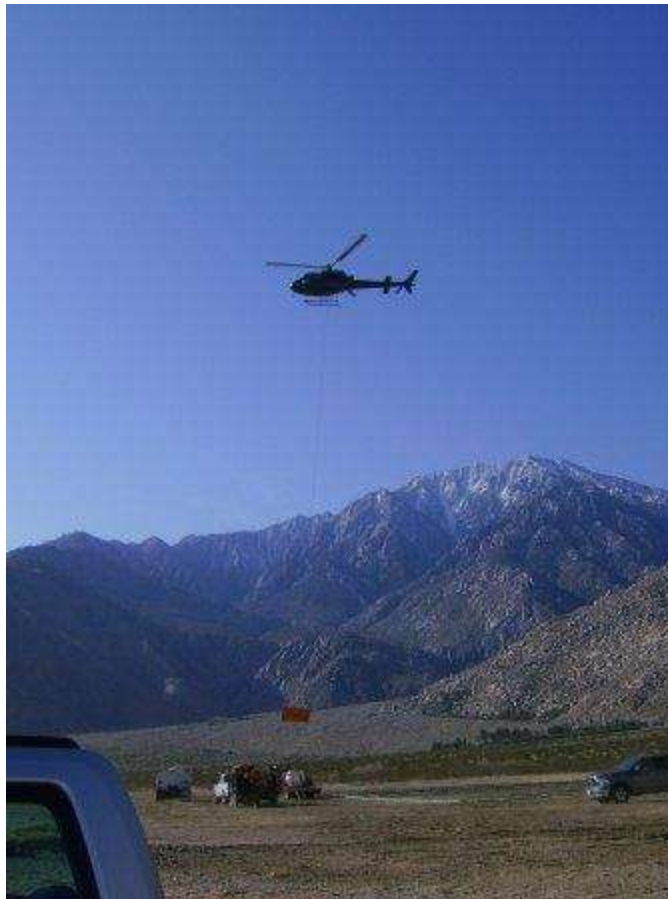
- Coachella Valley Milk-vetch approved biologists conducted biological sweeps in the morning prior to construction at all applicable tower sites.
- CPUC EMs observed adequate dust control measures being implemented during helicopter operations at landing zone H1X-DV (see Figure 5).

Figure 5. Adequate dust control measures being implemented during helicopter operation at landing zone H1X-DV.

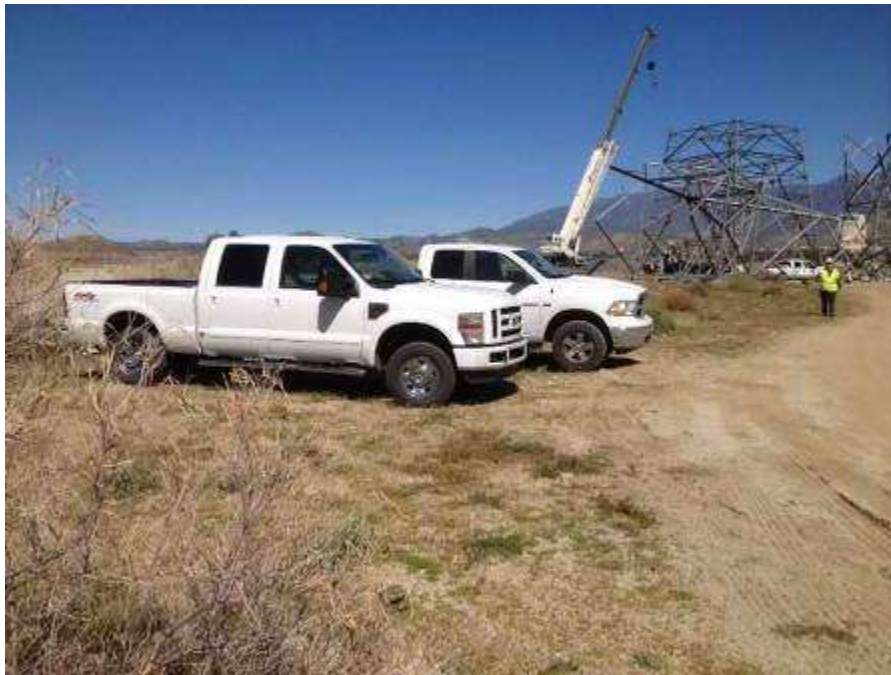
- On April 2, a SCE Biological Monitor observed two contractor vehicles parked on the edge of the access road to tower site 1062/R2 (see Figure 6). Their vehicles were parked on an unapproved location perpendicular to the access road to allow two tractor trailer trucks to pass. The monitor addressed the issue with the drivers and the vehicles were immediately moved onto the approved project limits. No impact to biological resources was observed.

Figure 6. Contractor vehicles parked off the approved access road and project disturbance limits at Tower 1062/R2.

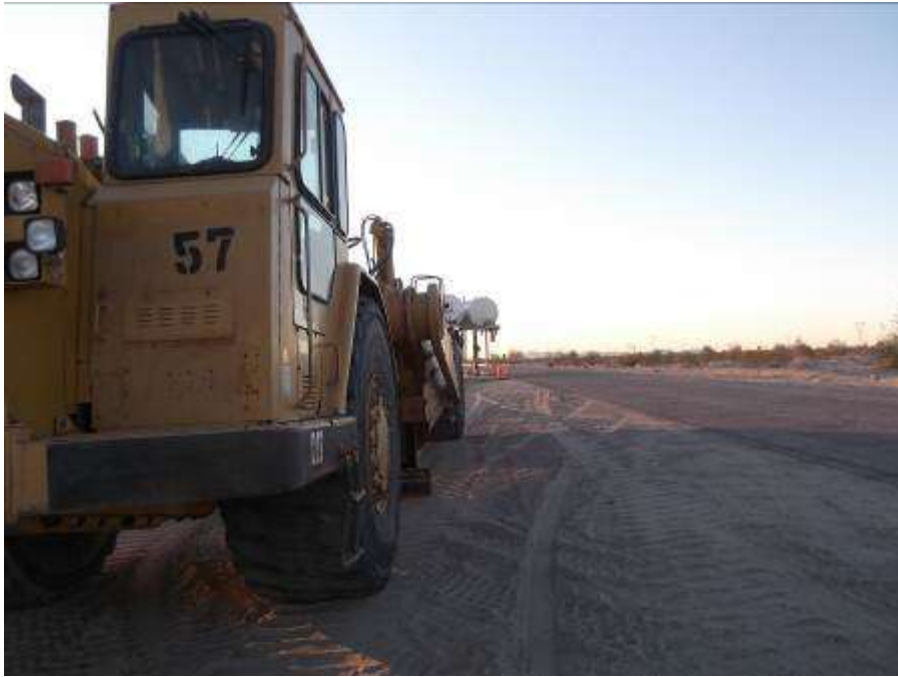
- On April 3, the CPUC EMs noted an articulated water truck parked along an unapproved section of Chuckwalla Road near the water stand tank location (see Figure 7). The CPUC EM notified the SCE General Monitor and the equipment was immediately removed.

Figure 7. Articulated water truck parked in unapproved area near water tank stand location on Chuckwalla Road. Note the absence of drip pan.

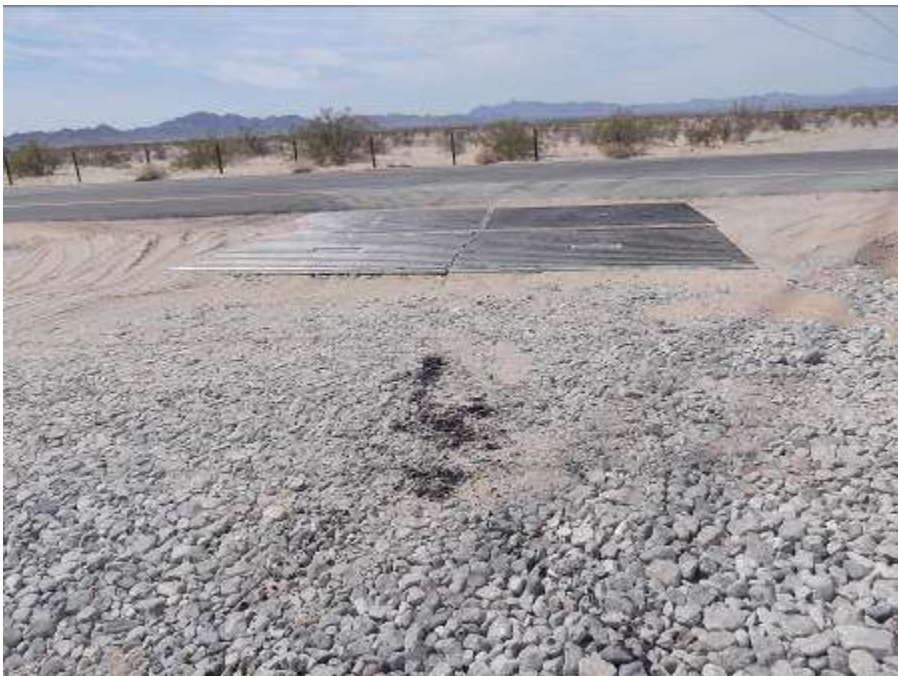
- As the CPUC EM was entering the CRS primary access road on April 4, he was informed by the SCE Cultural Field Lead and the SCE General Monitor of a spill that had occurred at that location moments earlier. The spill of asphalt emulsion was dispersed from the entry to the access road off Wiley's Well Road east approximately 200 feet (see Figure 8). There were several drops scattered across the road within an ESA site established at the road entrance. While the CPUC EM was onsite, a spill kit was brought from the substation and crews immediately began removing contaminated soils and rocks (see Figure 9). SCE General, Archeological, and Native American Monitors were onsite throughout the cleanup efforts and no resources were impacted.

Figure 8. Asphalt emulsion spill scattered along CRS access road near ingress/egress.

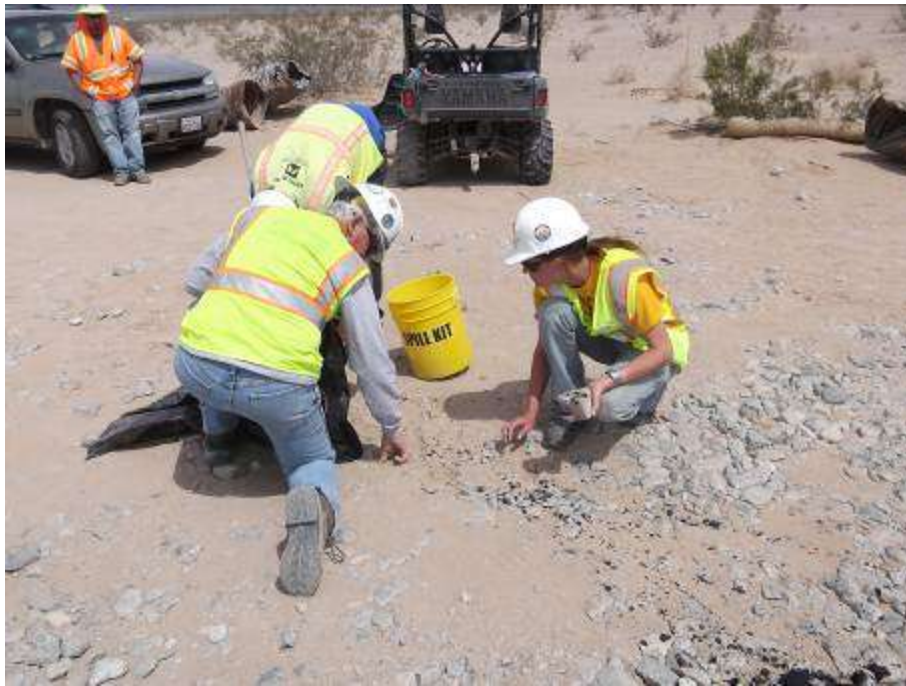
Figure 9. Construction and monitoring personnel removing contaminated soil and rocks from asphalt emulsion spill site along CRS access road.

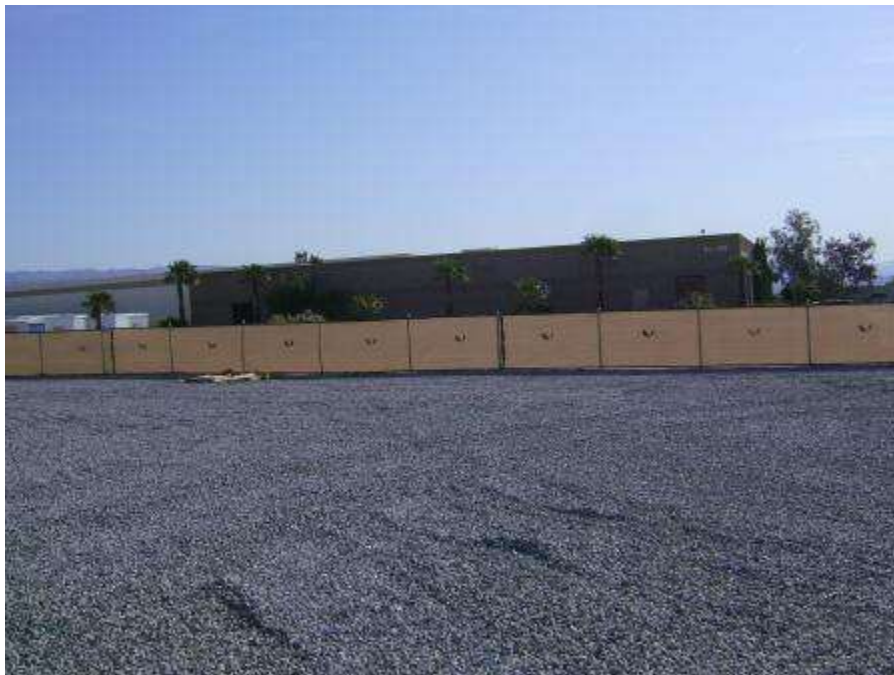
- Biological sweeps of the construction yards were conducted by the SCE Biological Monitors throughout the subject period.
- CPUC EMs observed adequate measures, including bird netting, secondary containment, and BMPs in place at all construction yard locations.
- On April 6, CPUC EM noted that the construction yard screening at Devers 2 yard had been replaced and fixed along the eastern edge of the yard (see Figure10).

Figure 10. Construction yard screening replaced at Devers 2 Yard.
