PROJECT MEMORANDUM SCE DPV2 TRANSMISSION PROJECT

To: Billie Blanchard, Project Manager, CPUC
From: Vida Strong, Aspen Project Manager
Date: May 3, 2012
Subject: Weekly Report 39, April 9 to April 15, 2012

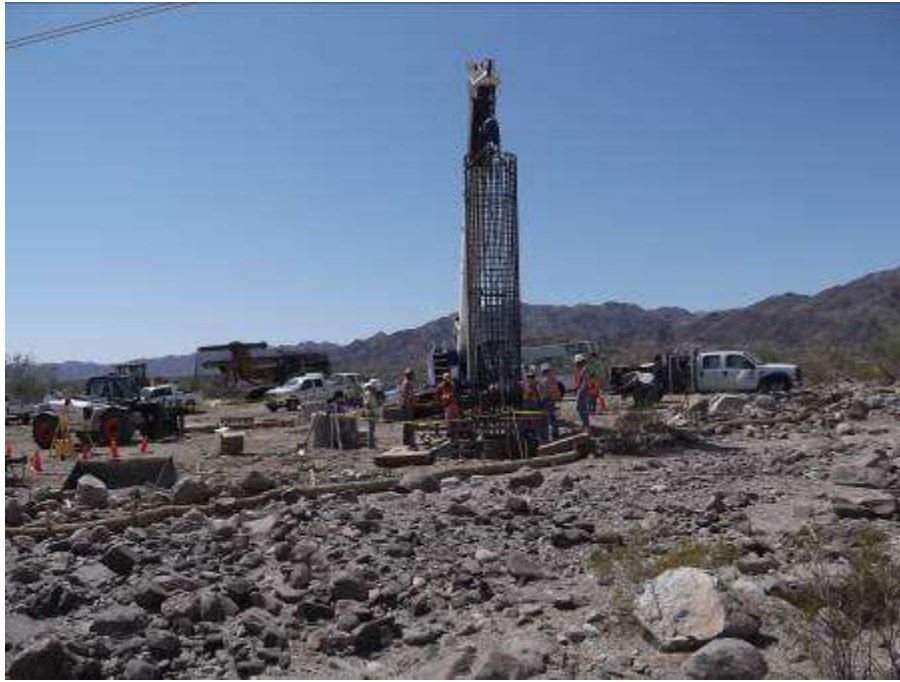
- There were no major ground-disturbing activities that occurred during the subject period.
2. Red Bluff Substation to Devers Substation
 - Concrete foundation pouring was conducted at Red Bluff Loop-In Towers RB1-5E, RB1-5W and RB2-5W (see Figure 1).

Figure 1. Concrete pouring activities at Tower RB1-5E.

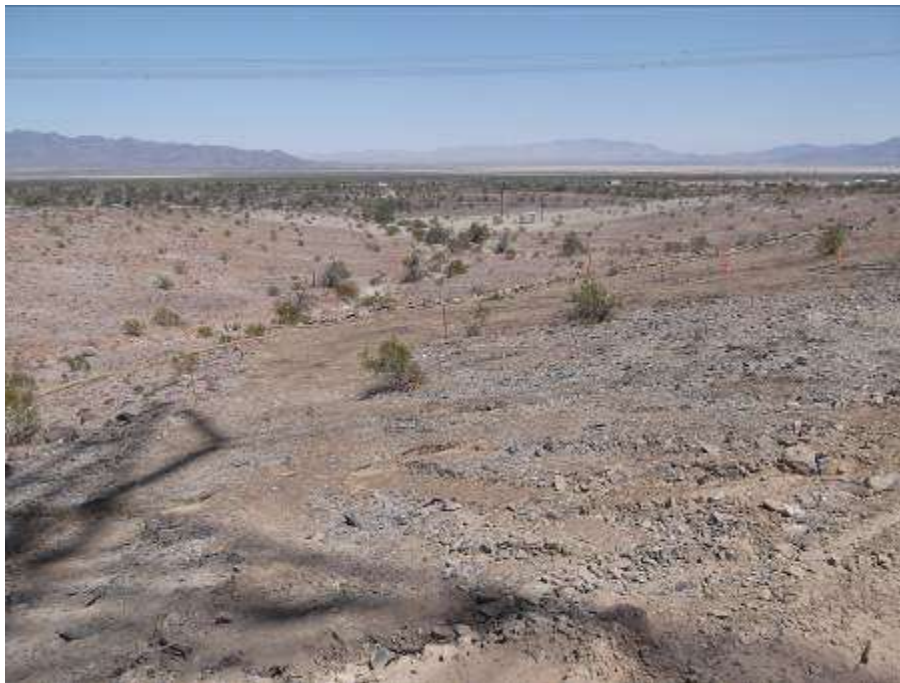
- Vegetation was cleared at Towers 2426-2428, 2433-2436, 2441, 2443, 2445, 2447, 2456, and 2541.
 - Rock mulching and desert pavement salvage activities were conducted at Towers 2511, 2518-2521, 2523, 2524, 2527, and 2530-2532 (see Figure 2).

Figure 2. Desert pavement removal nearly completed at Tower 2530.
Note areas of desert pavement left onsite for avoidance.

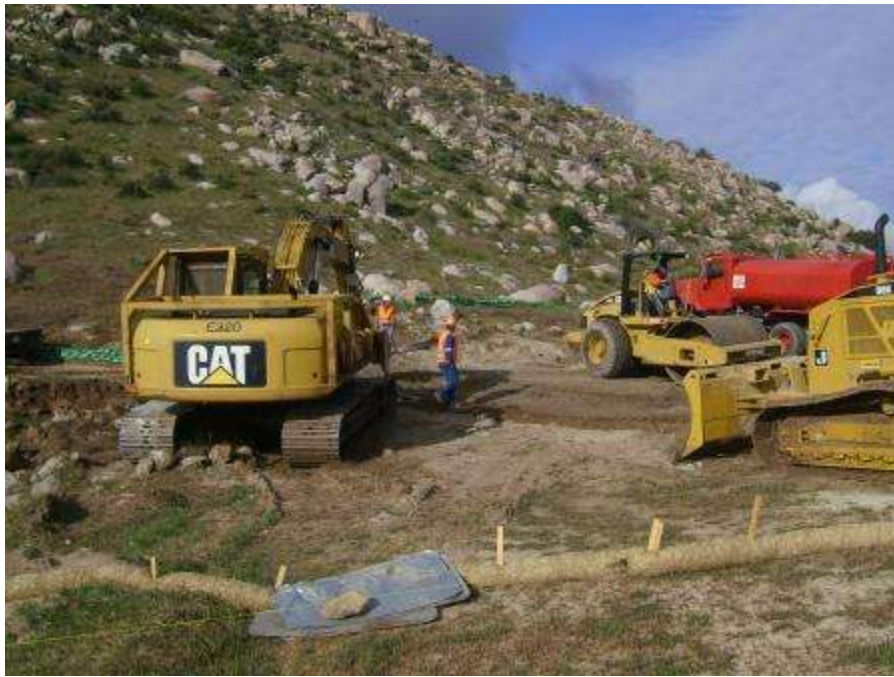
- Spur road and crane pad grading occurred at Towers 1073 and 1095 (see Figure 3).
- Tower assembly and steel deliveries occurred at Tower 1052, 1053, 1054, 1055, 1057, 1058, 1059, 1060, 1061, 1063, and 1064.

Figure 3. Crane pad grading at Tower 1073.

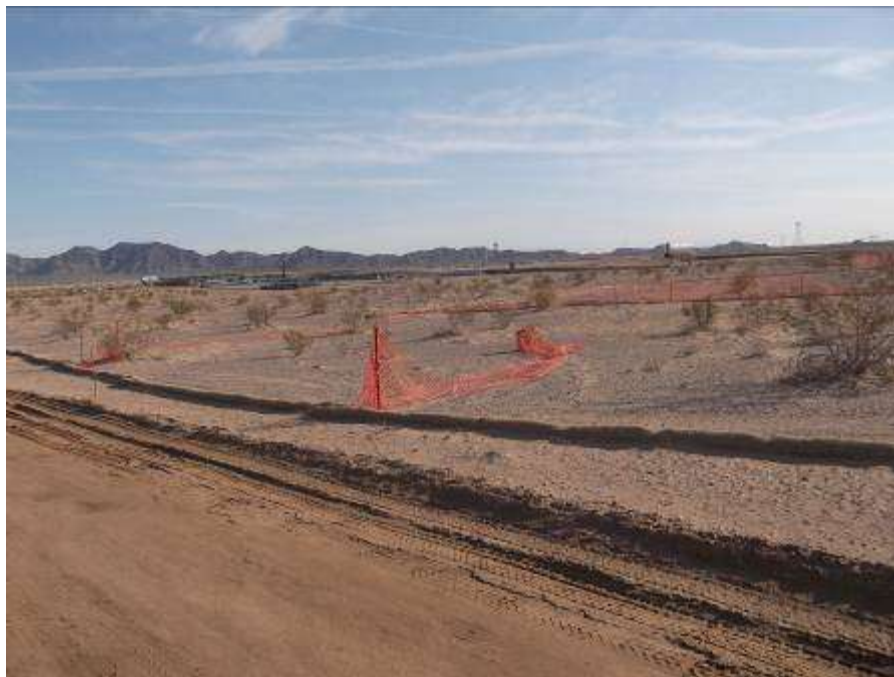
- On April 10, the CPUC EM observed the avoidance fencing associated with a cultural site along the western CRS Loop-In access road in need of repairs. The CPUC EM notified the SCE Cultural Monitor that was onsite (see Figure 4).

Figure 4. Damaged ESA fencing along CRS Loop-In access road.

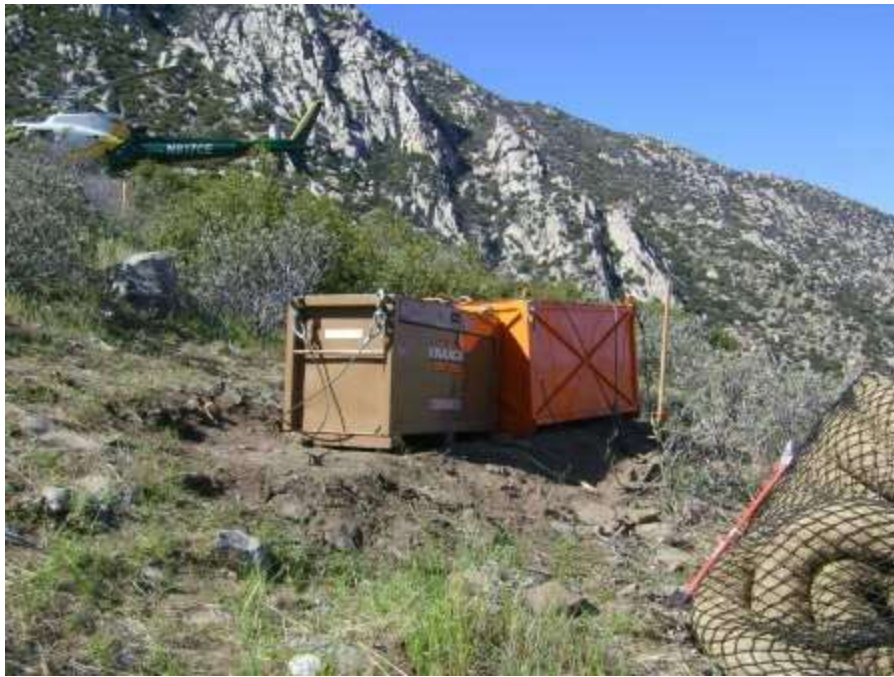
- On April 10, the CPUC EMs observed that the vegetation clearing crew working on USFS lands were in compliance with the USFS Fire Plan and PAL level requirements (see Figure 5).

Figure 5. Appropriate fire tools per USFS Fire Plan onsite at Tower 1042 during vegetation clearing activities.

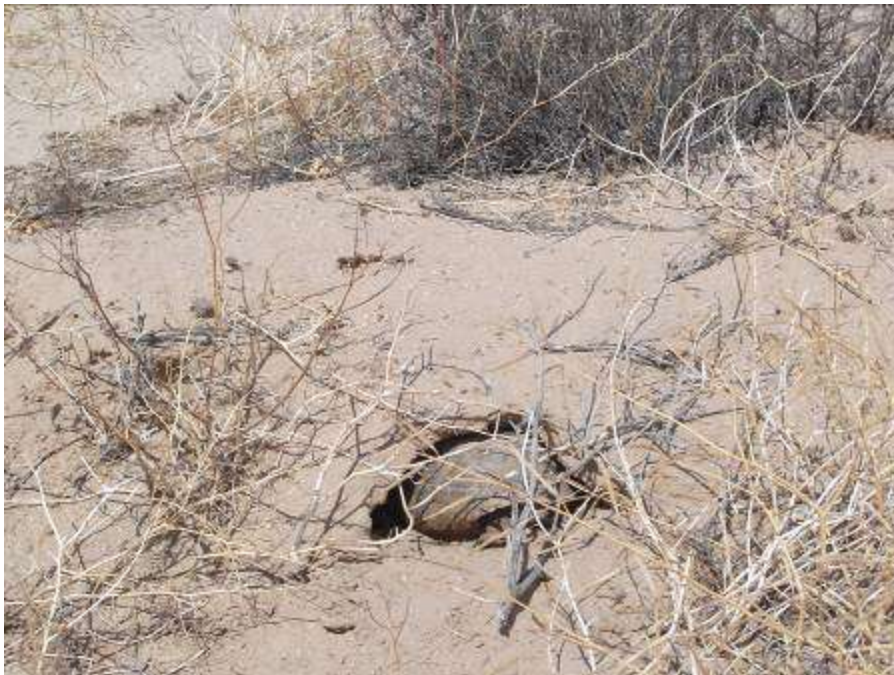
- Orange construction fencing was installed during the subject period to avoid the active tortoise burrow that had been previously identified just south of the access road at Tower 2441. During a visit to that site on April 13, the CPUC EM was notified by construction crews of a tortoise in a burrow on the north side of the access road approximately 40 feet east of the tower disturbance limits (see Figure 6). The CPUC EM immediately informed the SCE Biological Subject Matter Expert of the discovery. It was determined by the SCE Biological Subject Matter Expert and SCE Biological Field Lead that monitoring of the location would be adequate and no additional fencing was necessary.

Figure 6. Tortoise observed within burrow along access road near Tower 2441.

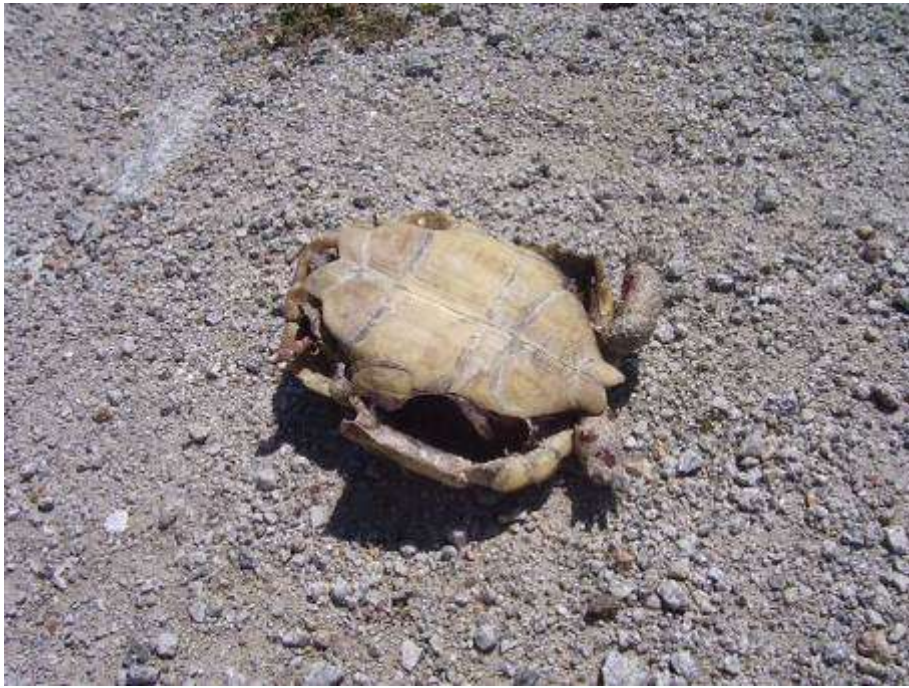
- On April 10, the CPUC EMs were notified of a desert tortoise mortality that was discovered during surveys at Tower 2412 the previous day (see Figure 7). Upon arriving at the site, the carcass was no longer present and was assumed to have been removed by an animal scavenger. Two broken scutes were detected at the site by the CPUC EMs. Through coordination between the SCE Biological Subject Matter Expert, the CPUC EMs, and the BLM, it was determined that the mortality was not project related. There were several additional observations of active desert tortoises reported by the SCE Biological Monitors during the subject period. On April 10, a tortoise was encountered along the access road while the SCE Biological Monitor was escorting the construction crew between Towers 2447 and 2445. After monitoring from a distance, protocols in accordance with the Biological Opinion (BO) were subsequently followed and the tortoise was relocated by an Authorized Biologist to suitable habitat approximately 150 feet south of the access road.

Figure 7. Desert tortoise mortality near Tower 2412 reported by SCE Biological Monitors, determined to be non-project related (photo courtesy of U. Carliss).

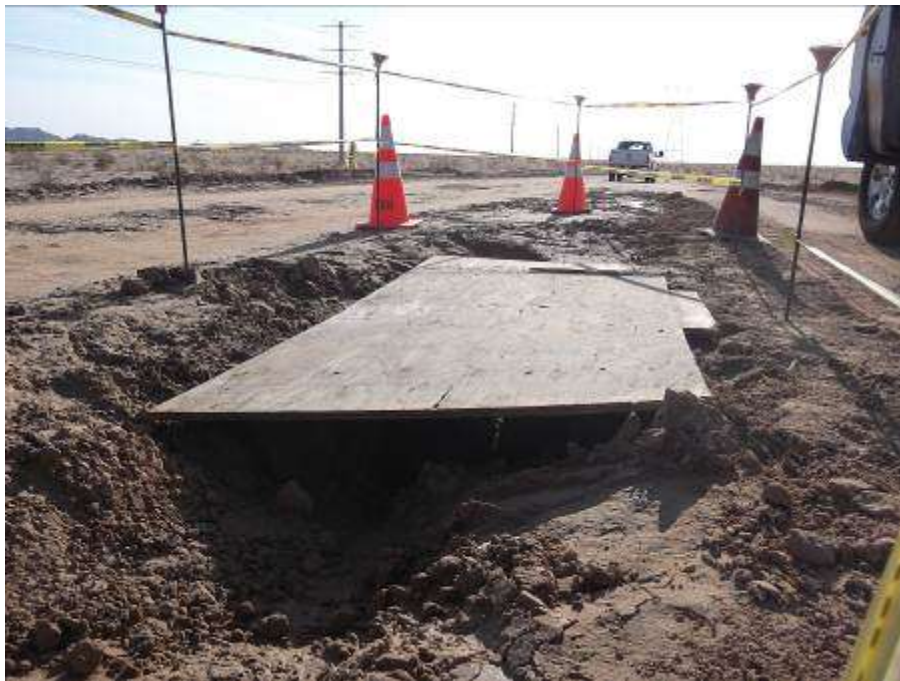
- The CPUC EM notified the SCE Biological Monitor of improperly covered concrete washout tubs and trenches observed along the CRS primary access road on April 10 (see Figure 8). The CPUC EM received an email from SCE the following day with photos showing that the issues had been resolved.
- The CPUC EM observed well-maintained BMPs and Environmentally Sensitive Area (ESA) boundaries along the CRS primary access road during the subject period.
- A total of three Mojave fringe-toed lizard mortalities, all associated with construction activities at the CRS site, were reported by SCE during the subject period. Since the Mojave fringe-toed lizard is not a listed species, there is not an incidental take statement and no take threshold.

Figure 8. Inadequate trench covering observed by CPUC EM along CRS primary access road.

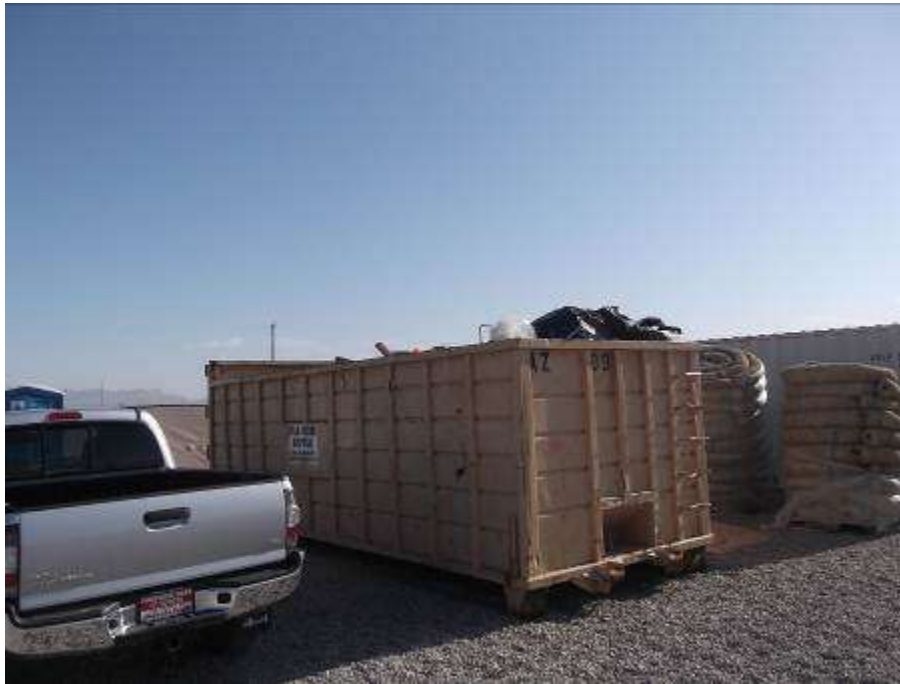
- The SCE General Monitor reported multiple observations of inadequate and/or missing BMPs, secondary containment, and housekeeping at the Blythe, Summit, and Indio 2 Yards during the subject period. The CPUC EM confirmed inadequate practices, including lack of secondary containment and improper covering on trash receptacles at the Blythe and Summit Yards on April 9 (see Figure 9). The SCE General Monitor informed the contractor that the appropriate measures to rectify these issues needed to be implemented immediately.

Figure 9. Large trash receptacle with no covering at Blythe Construction Yard.

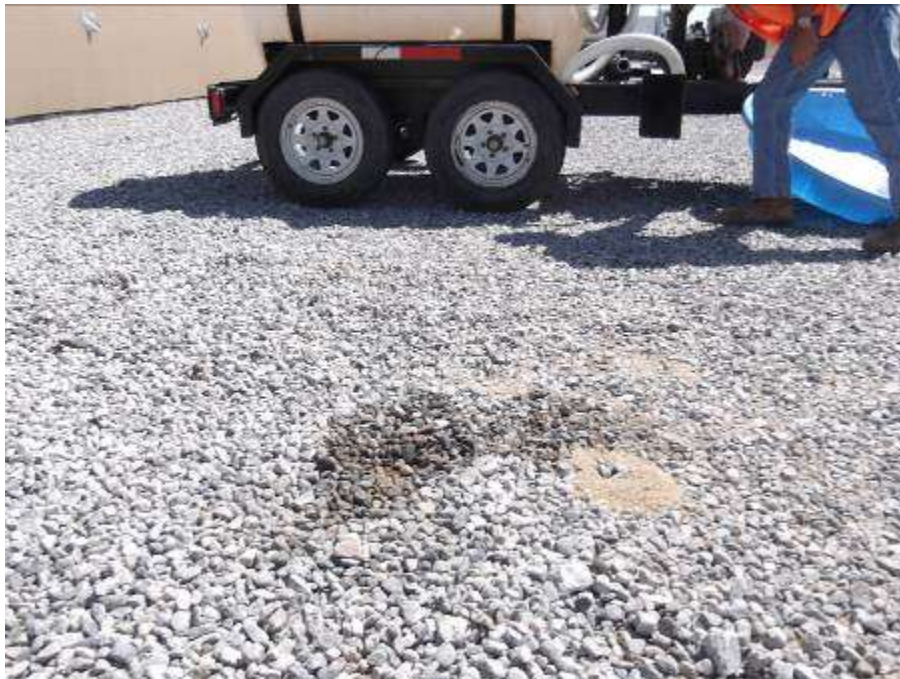
- While onsite with the SCE General Monitor, the CPUC EM observed a small motor oil spill (less than ½ gallon) that had not been removed from the northwest corner of the Summit Yard on April 9 (see Figure 10).

Figure 10. Minor motor oil spill that had not been removed at the Summit Construction Yard.
