PROJECT MEMORANDUM SCE DPV2 TRANSMISSION PROJECT

To: Billie Blanchard, Project Manager, CPUC
From: Vida Strong, Aspen Project Manager
Date: May 14, 2012
Subject: Weekly Report 40, April 16 to April 22, 2012

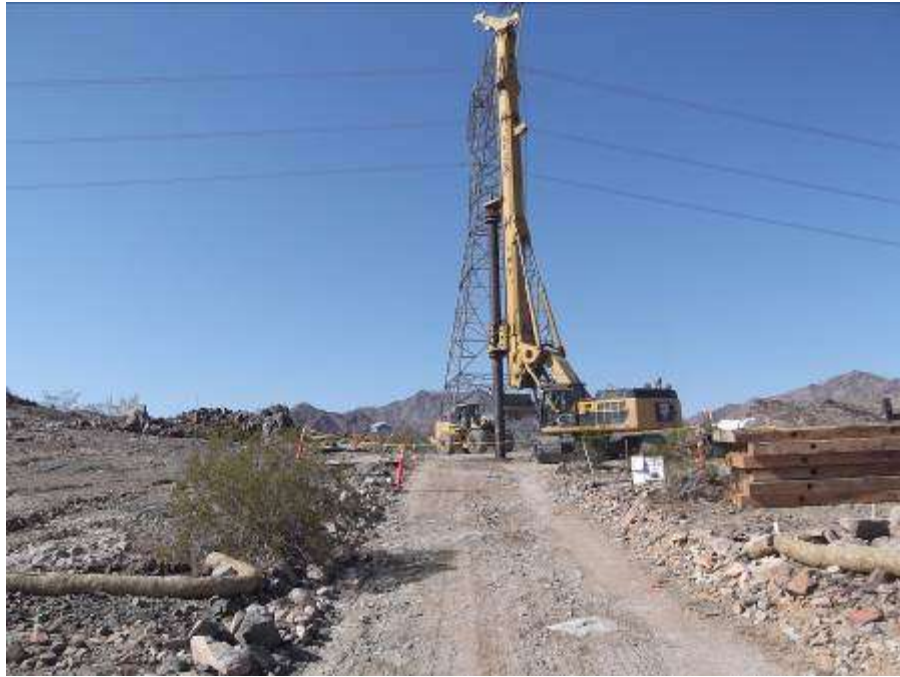
Figure 1. Foundation drilling at Tower 2531.

- Concrete foundation pouring was conducted at Towers 2523, 2526, 2527, 2529, and 2531, and Red Bluff Loop-In Towers RB1-2E and RB2-3W.
 - Foundation drilling activities were conducted at Towers 2526, 2527, 2529, 2531, and 2532, and Red Bluff Loop-In Towers RB1-2E, RB1-3E, RB1-2W, and RB2-3W (see Figure 1).

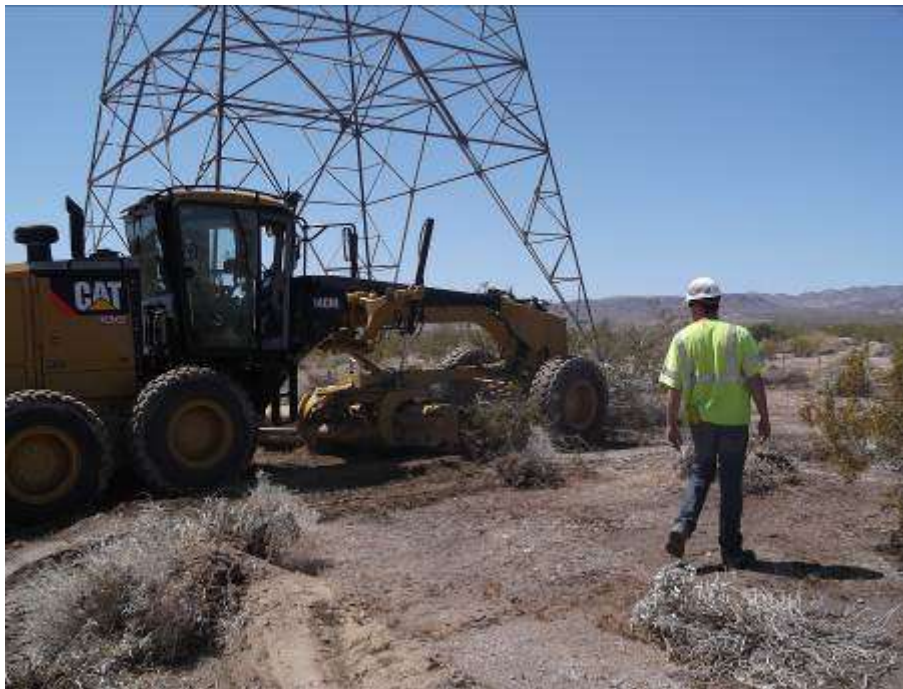
Figure 2. Vegetation clearing activities at Tower 2409.

- Grading of associated access roads and tower pad recontouring activities were conducted at Towers 2408-2411, 2426-2428, 2433, 2509-2511, and 2530.
 - Vegetation was cleared at Towers 2409, 2410, 2437, 2444, 2516, 2518, and 2532 (see Figure 2).

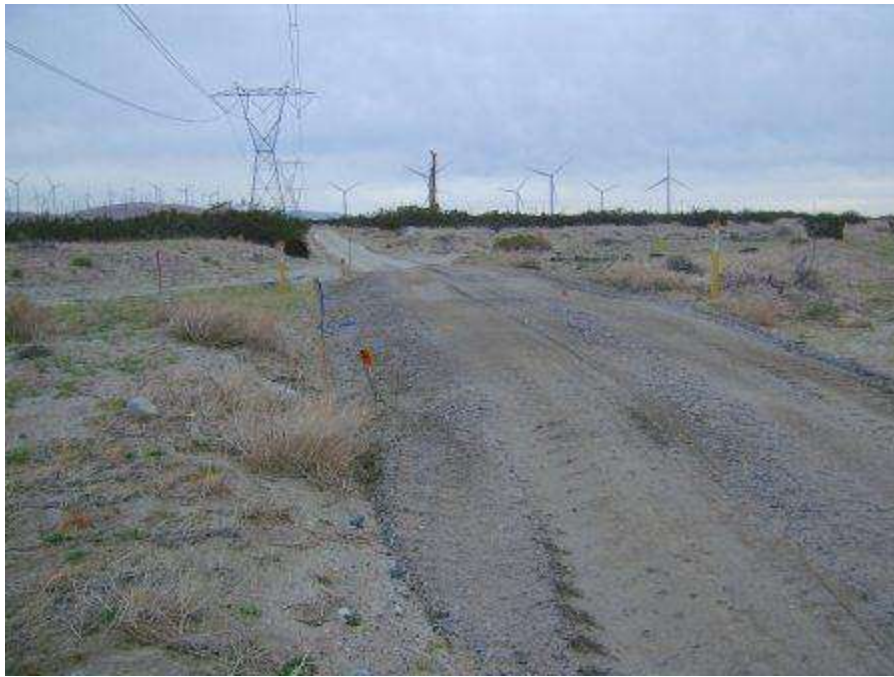
Figure 3. Base material within the limits of the access road used to properly cover a pipeline crossing between Towers 1023 and 1022.

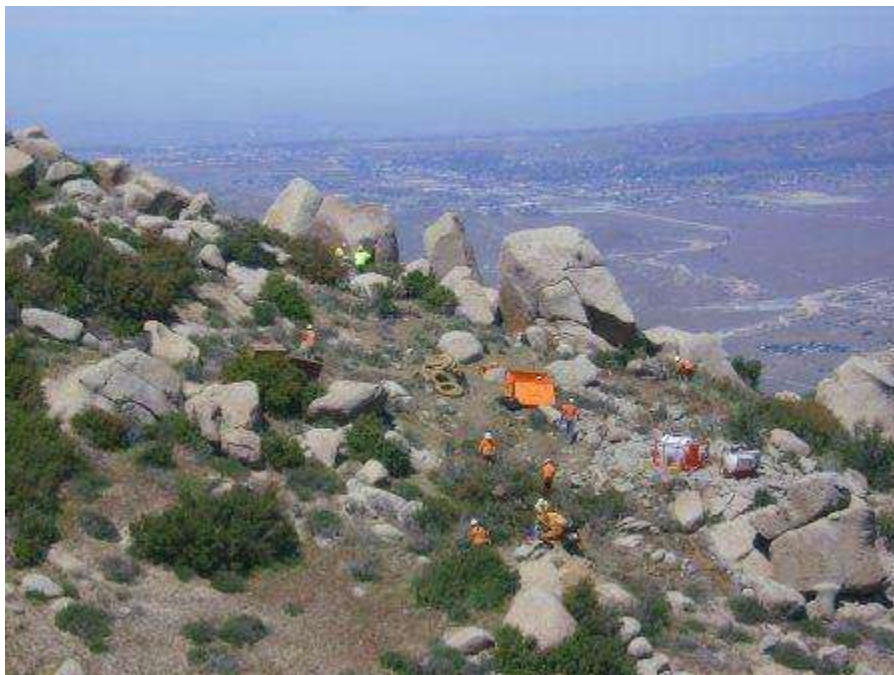
Figure 4. Vegetation clearing at Tower 1046 (as seen from hovering helicopter).

- Staking for walking paths from the temporary helicopter landing platform to the tower site occurred at Towers 1040, 1045, 1046, and 1047.
- Vegetation clearing and BMP installation occurred at Towers 1045, 1046, and 1047 (see Figure 4).
- Vegetation clearing for permanent maintenance pads occurred for Towers 1042, 1045, and 1046.
- BMP maintenance occurred at Towers 1037, 1038, 1039, 1041, 1042, 1045, 1047, and 1048.

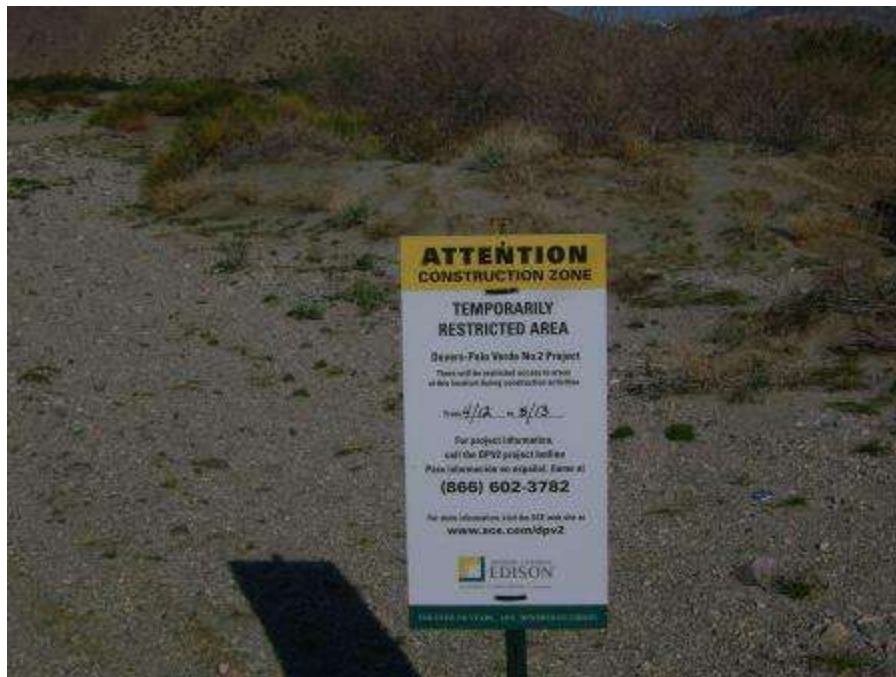
- On April 16, CPUC EM observed “Temporary Restricted Area” signs at all entrances to the H1X Landing Zone to discourage the public from entering the helicopter use area (see Figure 5).

Figure 5. “Restricted Area” signs placed at right-of-way entrances that led to helicopter landing zone H1X-DV.

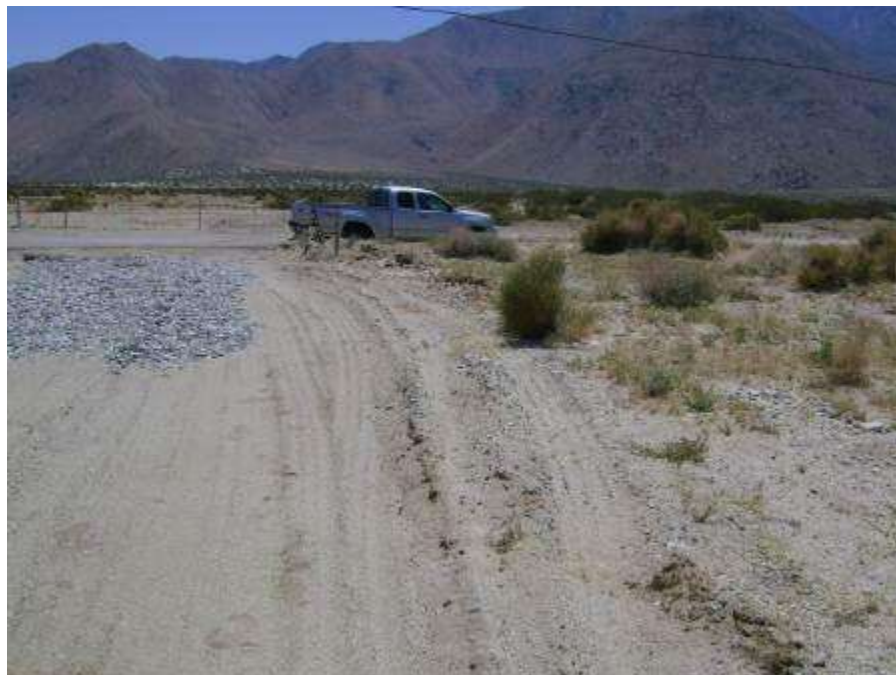
- On April 18, a tracked crane with Aldridge Electric (pour crew at 1027) tracked outside of the approved access road. The incident was at the beginning of the access road to Tower 1027 at Snow Creek Road (see Figure 6). The south side of the road had track marks approximately 5 feet wide and about 35 feet long. When the incident was discovered by the onsite Biological Monitor the crane was parked back in the road. Reminders to stay on approved access routes were issued at subsequent tailboards.

Figure 6. Area of off access road travel at the entrance to Tower 1027.

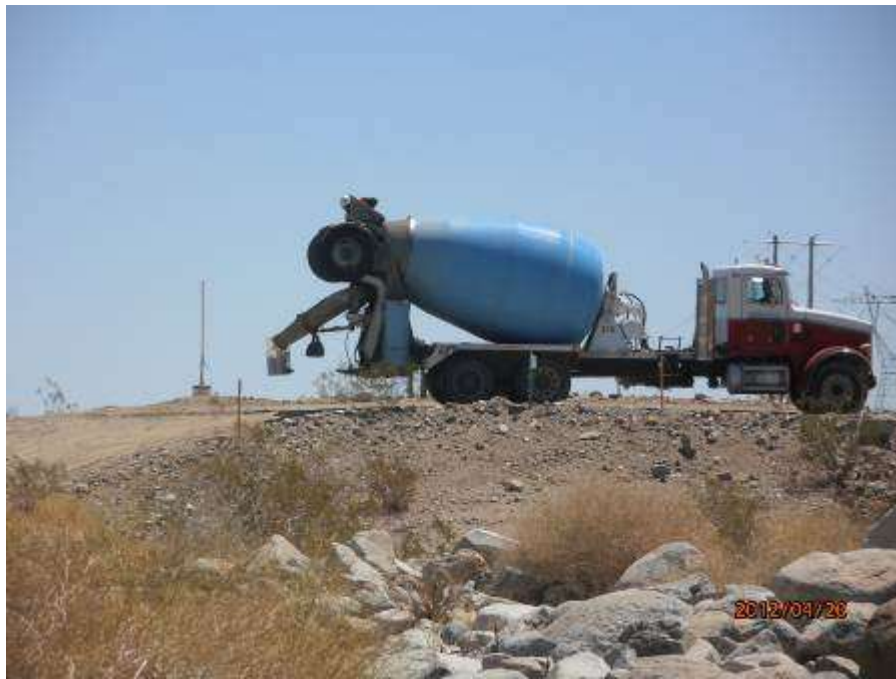
- On April 20, the SCE General Monitor reported observing a concrete truck driver washing the trough and chute of the concrete truck along the right-of-way access road near Tower 2530, outside of the limits for this type of activity (see Figure 7). All materials were washed into a plastic container below the trough; however, no secondary containment was utilized. The SCE General Monitor notified the Aldridge Drilling foreman who stated that he would inform the concrete company of the issue.

Figure 7. Concrete truck trough was cleaned outside of approved work limits near Tower 2530 (photo courtesy of John Bortle).

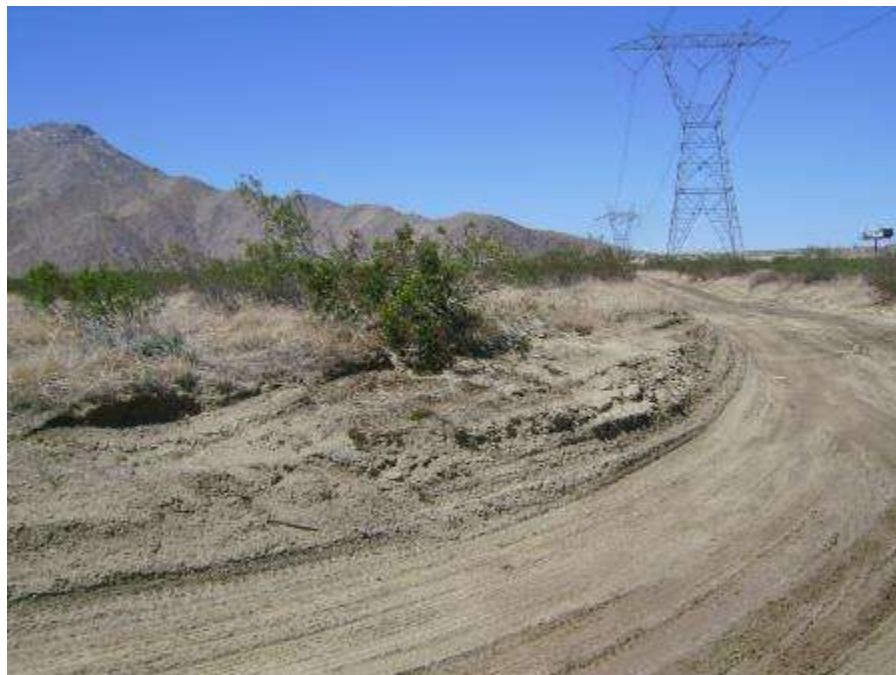
- On April 20, the CPUC EM observed that at the access road entrances for Towers 1024 and 1025 equipment had traveled outside of the approved access road limits and damaged the access road banks and impacted vegetation (see Figure 8). The issue was brought to the attention of the onsite Biological Monitor and the SCE General Monitor. The SCE General Monitor indicated he would inspect the area and speak with the foreman of the foundation crews currently working at both sites.

Figure 8. Area where equipment went off of the access road and impacted the road berm and native vegetation at the access road entrance to Tower 1025.

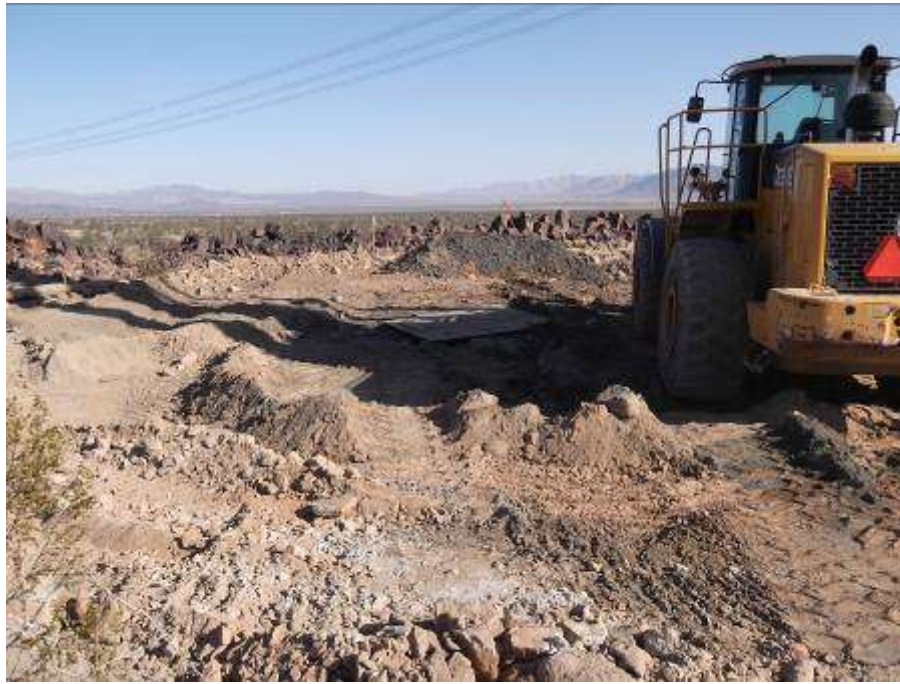
- The CPUC EM observed improperly covered foundation holes at Tower 2531 on April 17 (see Figure 9). The SCE Biological Monitor was notified and stated that the issue would be resolved the same day.

Figure 9. Improperly covered foundation hole at Tower 2531.

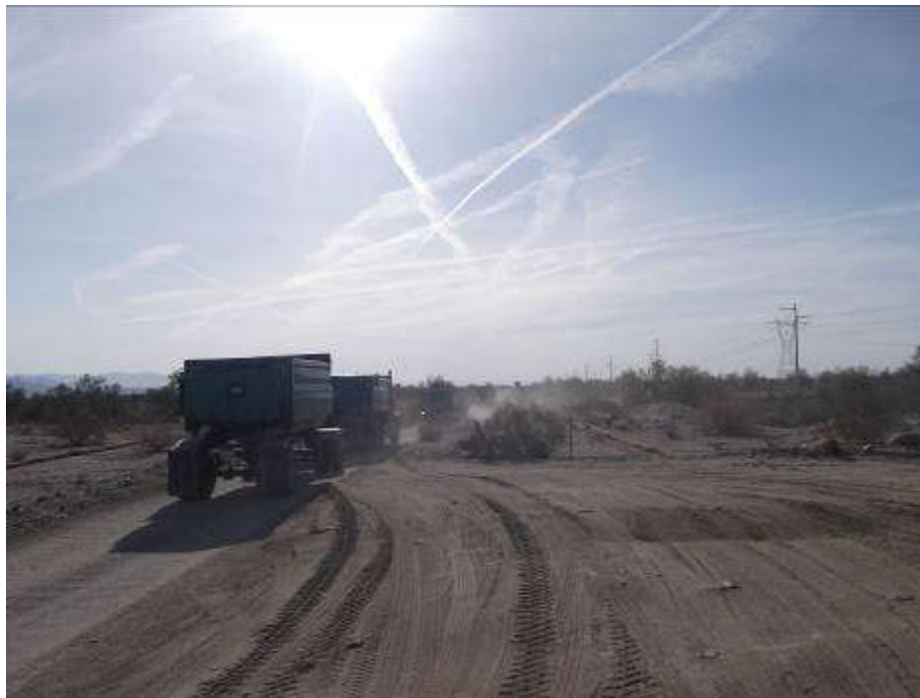
- Project Memorandum #5 was issued on April 18 due to multiple observations by CPUC EMs and SCE General Monitors of excessive fugitive dust along the right-of-way access road between Corn Springs Road and the new Red Bluff Substation eastern access road (see Figure 10).

Figure 10. Excessive dust observed on multiple occasions along the access road near Red Bluff Substation. Project Memorandum #5 was issued as a result.
