PROJECT MEMORANDUM SCE DPV2 TRANSMISSION PROJECT

To: Billie Blanchard, Project Manager, CPUC
From: Vida Strong, Aspen Project Manager
Date: May 21, 2012
Subject: Weekly Report 41, April 23 to April 29, 2012

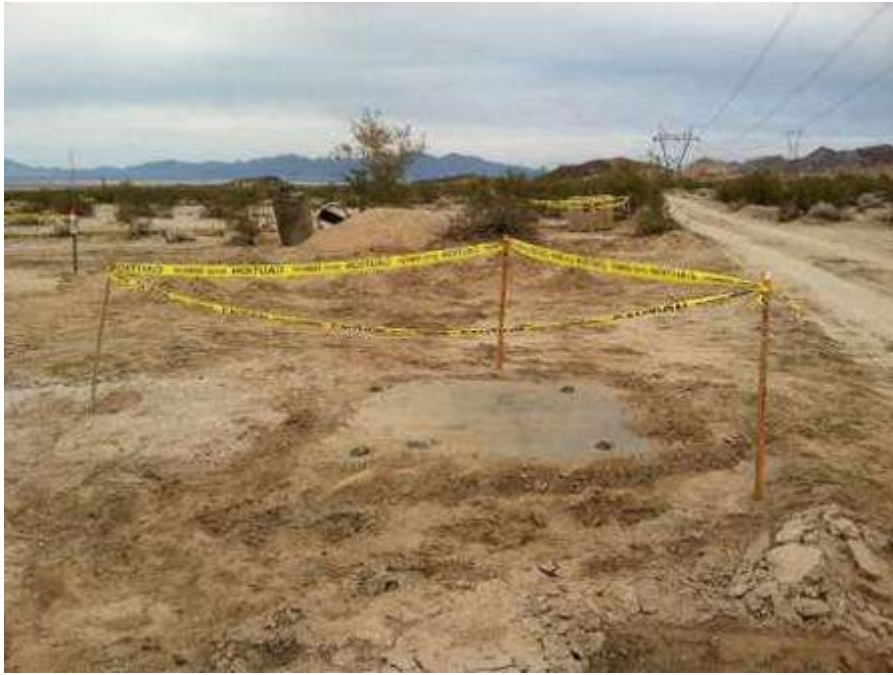
- Tower foundation drilling activities occurred at 2416, 2426, 2505, 2506, 2507, 2508, 2512, 2513, 2516, 2520, 2522, 2523, 2524, 2526, 2527, and 2532 (see Figure 1).

Figure 1. Covering of an open excavation at Tower 2523 was noted to be in compliance.

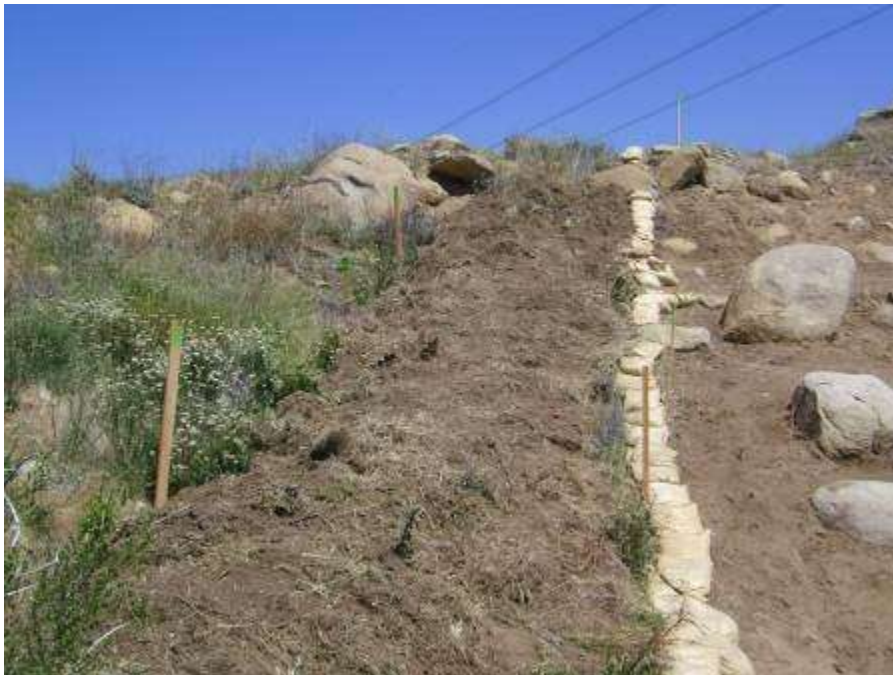
- BMPs were installed at Towers 1004, 1005, 1007, 1009, 1018, 1021, 1024, 1025, and 1095.
- BMP maintenance occurred at Towers 1006, 1015, 1016, and 1023.
- Vegetation clearing occurred at Towers 1004, 1005, 1007, 1009, and 1071.
- Topsoil salvage occurred at Tower 1071 (see Figure 2).
- Spur road and crane pad grading occurred at Towers 1017 and 1095. The access road to Tower 1017 was also graded for maintenance.
- Tower foundation drilling occurred at Towers 1015, 1021, and 1022.
- Tower foundation concrete pouring activities occurred at Towers 1022 and 1024.
- Tower assembly and steel deliveries occurred at Towers 1052, 1053, 1054, 1055 and 1057.
- Steel plates were placed over a fiber optic line on the access road near Tower 1013.

Figure 2. Topsoil salvage at Tower 1071.

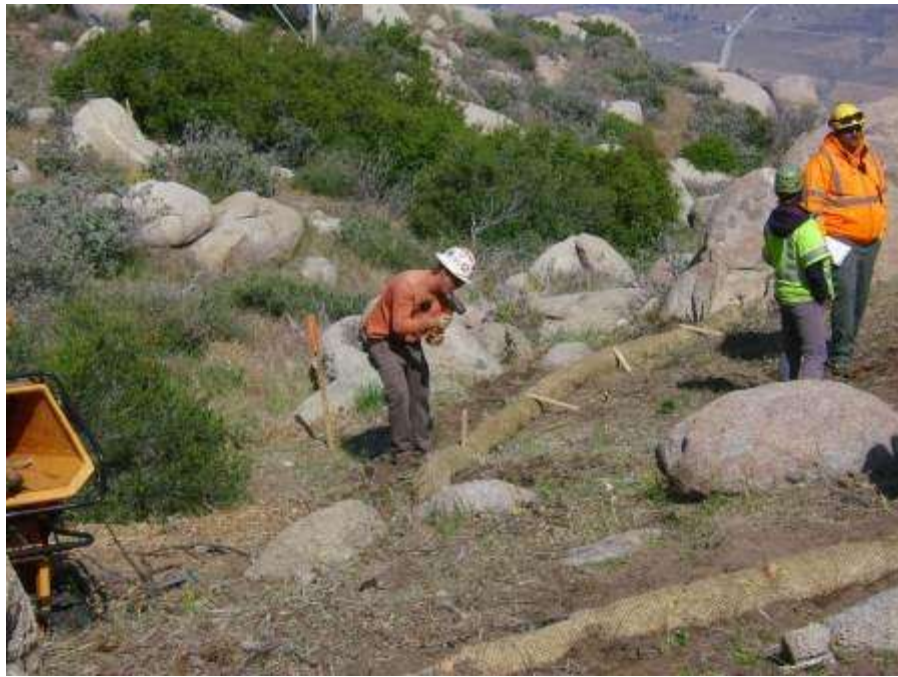
- Vegetation clearing and BMP installation occurred at Towers 1044, 1047, and 1048 (see Figure 3).

Figure 3. BMP installation at Tower 1047.

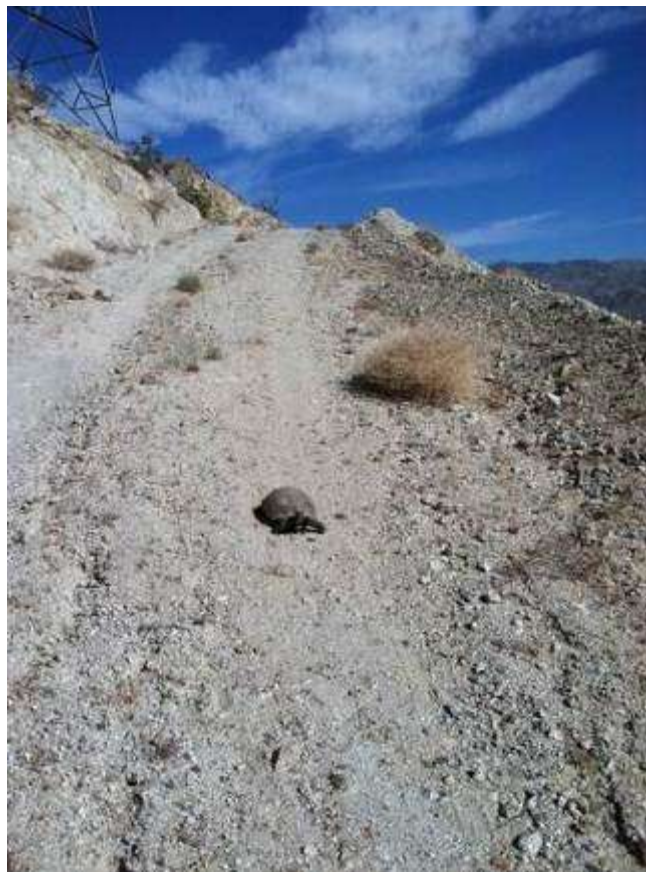
- On April 24, the CPUC EM's observed a desert tortoise walking down the access road from Tower 2416 while they were conducting the field verification. No construction activities were occurring in the vicinity (see Figure 4).

Figure 4. Desert tortoise observed near Tower 2416.

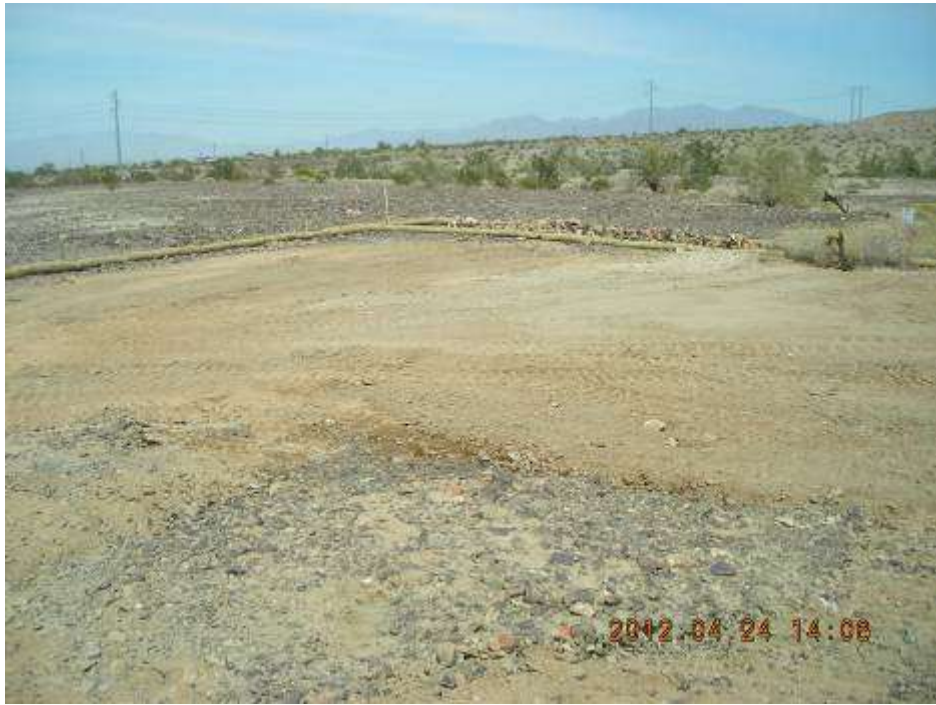
- On April 24, spoils from the foundation excavation were spread on the desert pavement within the temporary disturbance area at Tower 2524. According to the Desert Pavement Plan, spoils shall be spread within the permanent disturbance area (i.e. 20 feet around the tower legs). The desert pavement was fairly undisturbed. A site meeting was conducted after the incident and it was determined that more direction would be given to the crew, and that maps and written guidance would be given to the operators for reference and discussed at the morning tailboard (see Figure 5).

Figure 5. Spoils from foundation excavation placed on desert pavement at Tower 2524 (Photo Courtesy of Mark Augustyn).

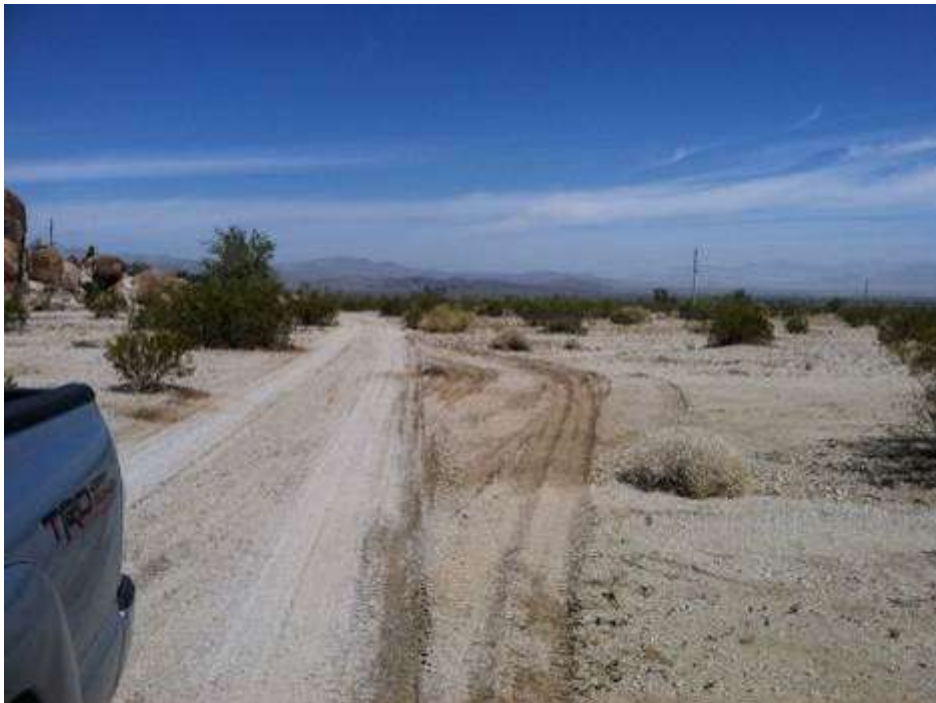
- On April 24, the CPUC EM notified the SCE Biological Field Lead of two locations along the north-south access road off Rice Road where vehicles had driven out of the approved road width. The Field Lead indicated that Environmentally Sensitive Areas (ESA) signs would be installed at those locations to prevent further incidents (see Figure 6).

Figure 6. Area of off access road travel along the north-south access road from Rice Road to the transmission right-of-way.

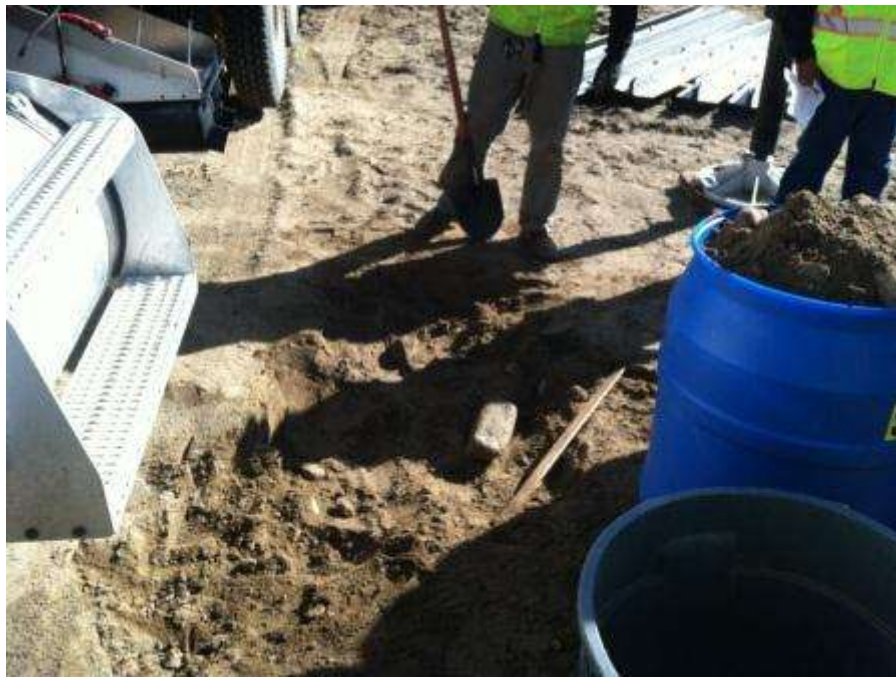
- On April 26, a diesel fuel spill occurred at Tower 1055. The fuel spill resulted from diesel fuel being siphoned out of the gas tank by thieves that left the hose in the tank allowing approximately 10 gallons of fuel to spill on the ground. The crews immediately began the process of soil containment upon arriving to the site (see Figure 7). Two other small areas were also found along the access road to Tower 1055. All contractors were coordinating correct cleanup methods and following all state and local regulations. All materials were removed from the site to be properly disposed.

Figure 7. Diesel spill clean-up from resultant fuel spill as fuel was siphoned by thieves out of the crane parked onsite overnight (Photo Courtesy of Dean Ritter).

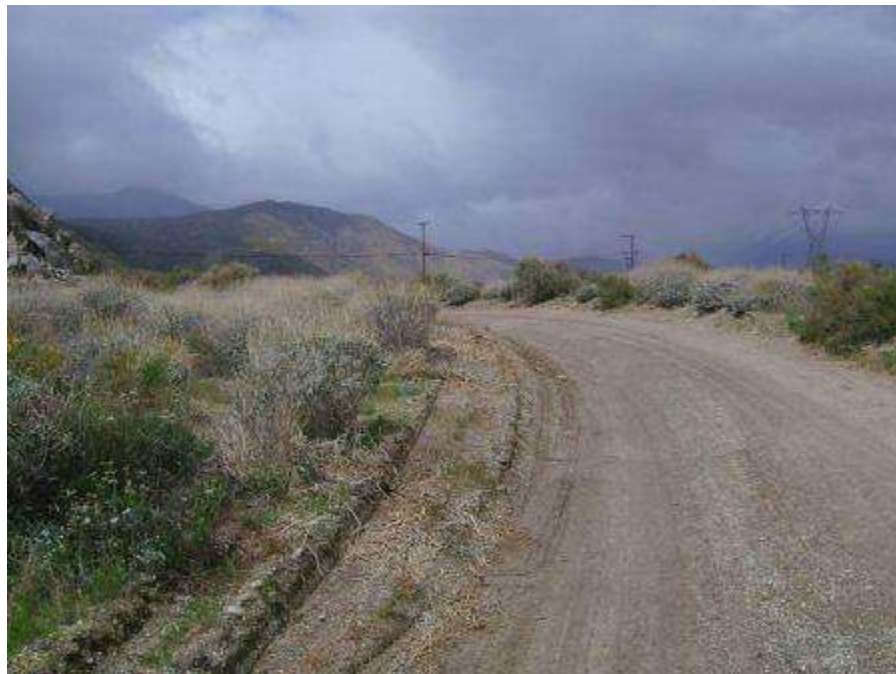
- On April 26, CPUC EM's discovered an area along the access road to Tower 1055 where construction equipment went off of the existing road and crushed native vegetation (see Figure 8). The CPUC EM contacted the Devers to Valley Environmental Coordinator (EC) and informed her of the incident.

Figure 8. Area on the access road to Tower 1055 where equipment went outside of the access road and crushed vegetation

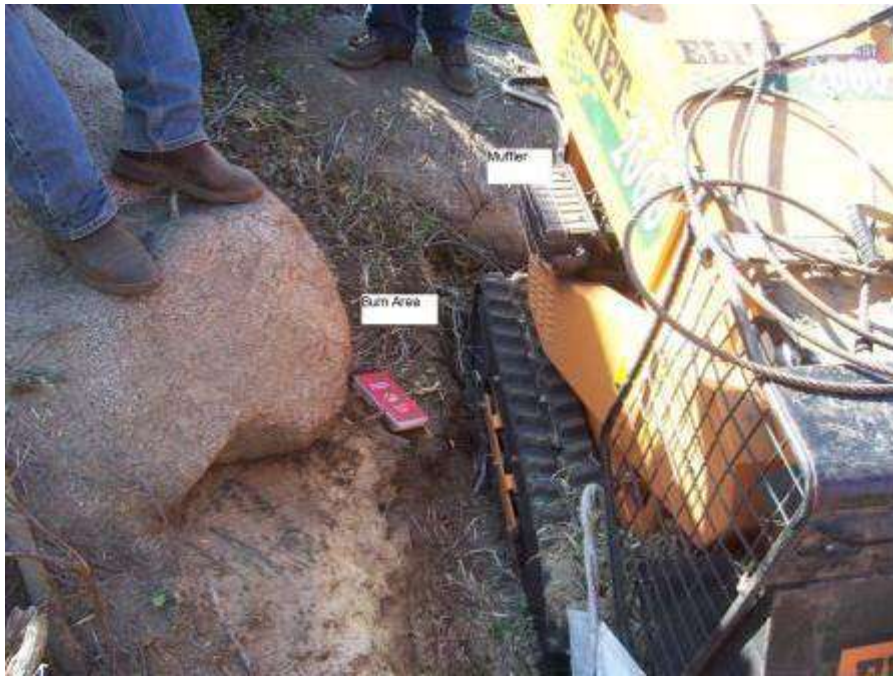
- On April 28, a vegetation clearing crew was chipping vegetation at Tower 1044 when a small spot fire occurred. Vegetation chips from the chipper landed on the exhaust then fell to the ground, igniting a 6- by 18-inch area (see Figure 9). The crew onsite extinguished the fire with a 5 lb. fire extinguisher staged near the chipper. The contractor's Fire Watch put 25 gallons of water on the fire as well. It was determined that the crew working at Tower 1044 had all fire plan and fire mitigation in place. USFS was contacted and a formal report was submitted. . Corrective actions to prevent this incident in the future were to presoak the area during operation and placing the exhaust side of equipment away from where vegetation can build up from the chipper.

Figure 9. Area where small, spot fire was caused by chipped vegetation landing on the chipper exhaust at Tower 1044 (Photo from PAR incident Report).
