PROJECT MEMORANDUM SCE DPV2 TRANSMISSION PROJECT

To: Billie Blanchard, Project Manager, CPUC
From: Vida Strong, Aspen Project Manager
Date: June 13, 2012
Subject: Weekly Report 44, May 14 to May 20, 2012

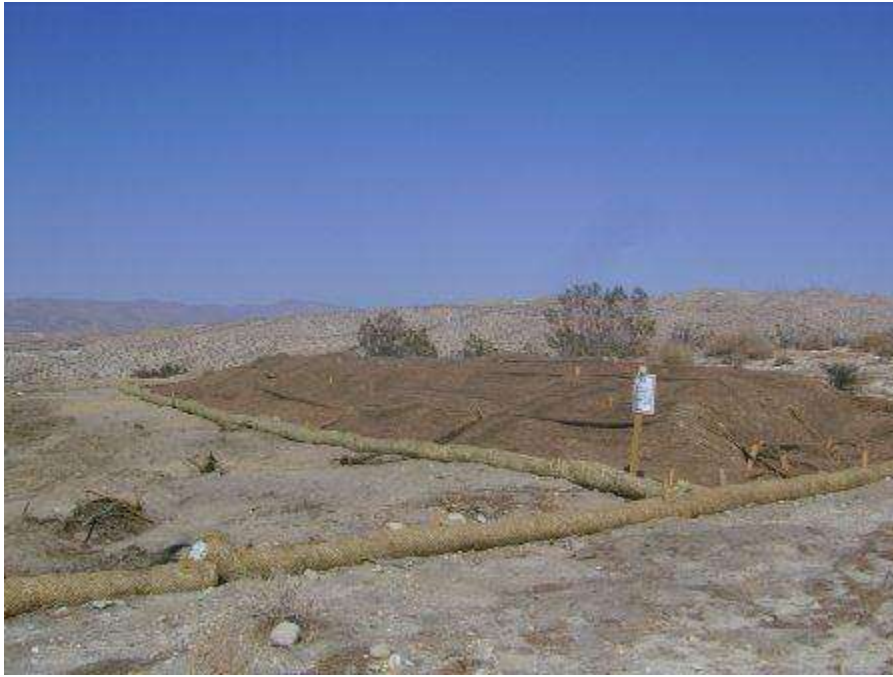
Figure 1. Soil salvage for sensitive plant species at Tower 2107.

- Desert pavement salvage occurred at Towers 2317, 2318, 2319, 2326X, and 2426.
 - Soil salvage for special status plants and/or vegetation communities occurred at Towers 2101, 2102, 2103, 2104, 2105, 2107, and 2112 (see figure 1).

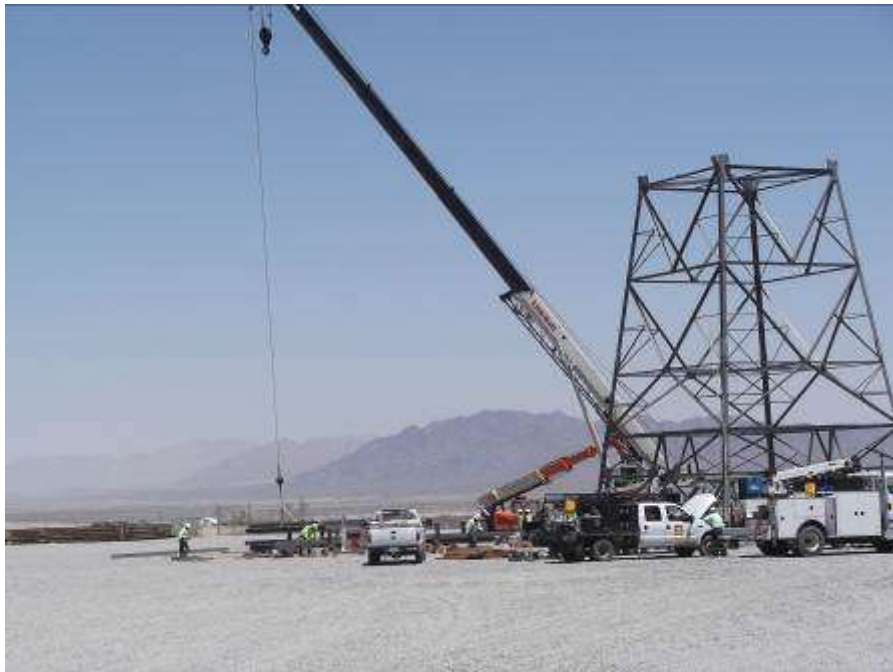
Figure 2. Assembly crew onsite at Tower RB1-3W.

- Tower foundation drilling activities occurred at Towers 2009, 2015, 2016, 2017, 2331, 2333, 2334, 2335, 2403, 2405, 2408, 2409, 2410, 2411, 2514, 2517, 2518, 2524, and 2526.
- Tower foundation concrete pouring activities occurred at Towers 2007, 2009, 2015, 2016, 2331, 2333, 2406, 2408, 2409, 2410, 2411, 2511, 2514, 2517, 2518, and 2521.
- Tower assembly and/or steel deliveries occurred at Towers 2002, 2004, RB1-3W and RB2-5E (see Figure 2).

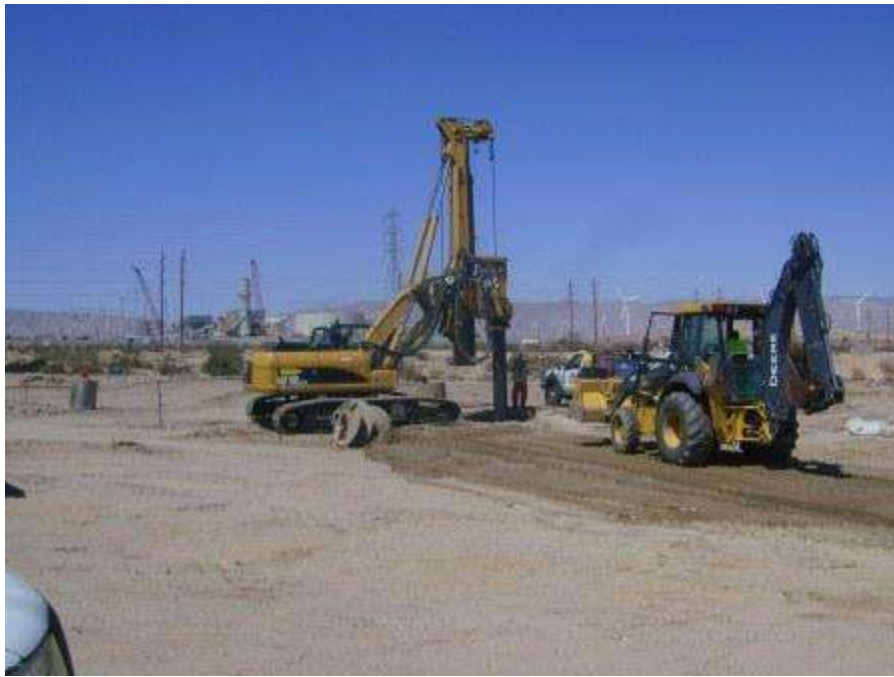
Figure 3. Foundation excavation drilling at Tower 1002.

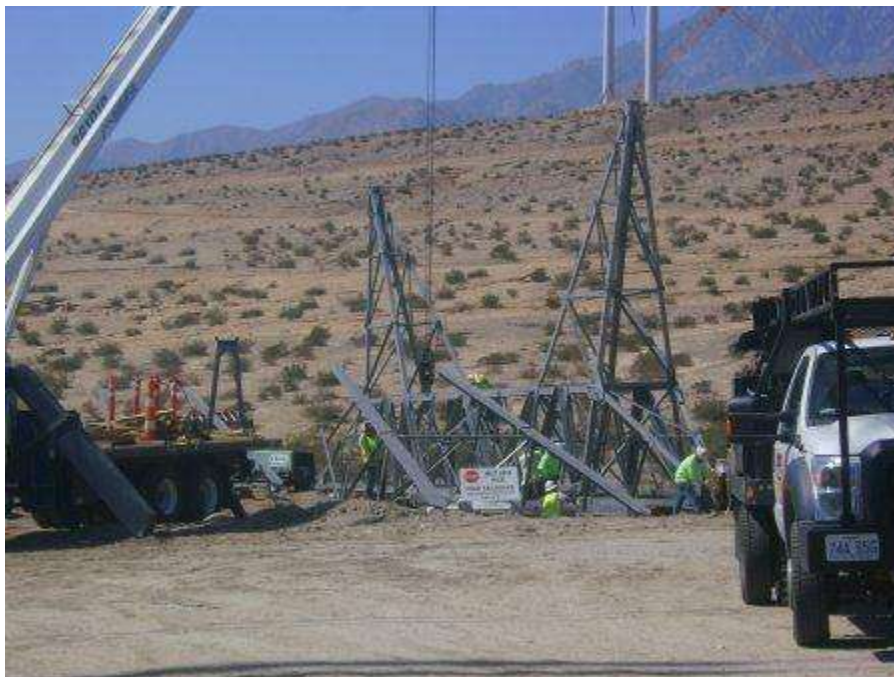
Figure 4. Tower assembly at Tower 1010.

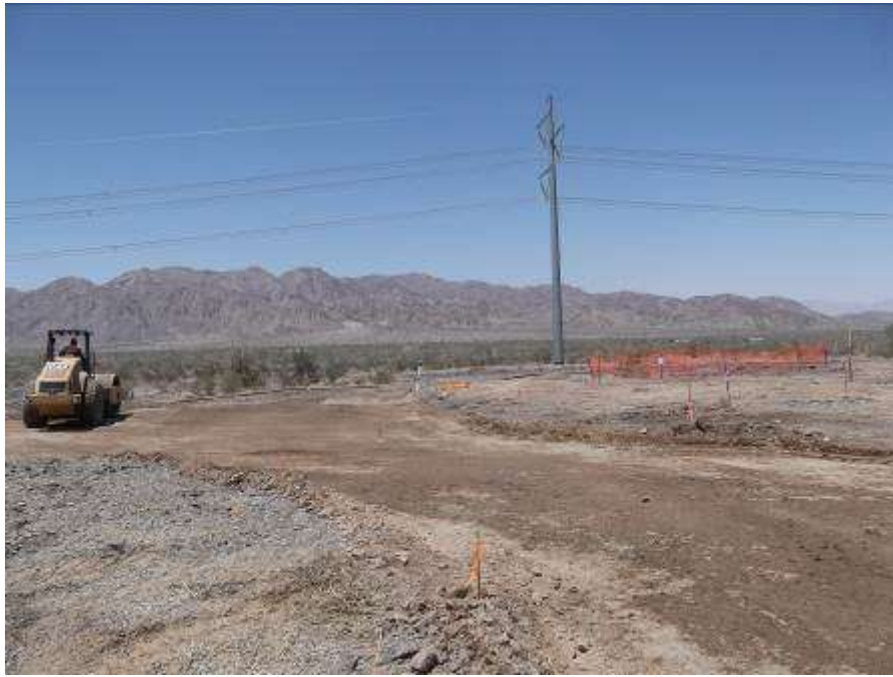
- On May 16, the CPUC EM noted that the Environmentally Sensitive Area (ESA) associated with Tower 2454 was being adequately avoided and monitored throughout grading activities occurring onsite (see Figure 5).

Figure 5. Grading activities occurring while avoiding ESA (right of photo) at Tower 2454.

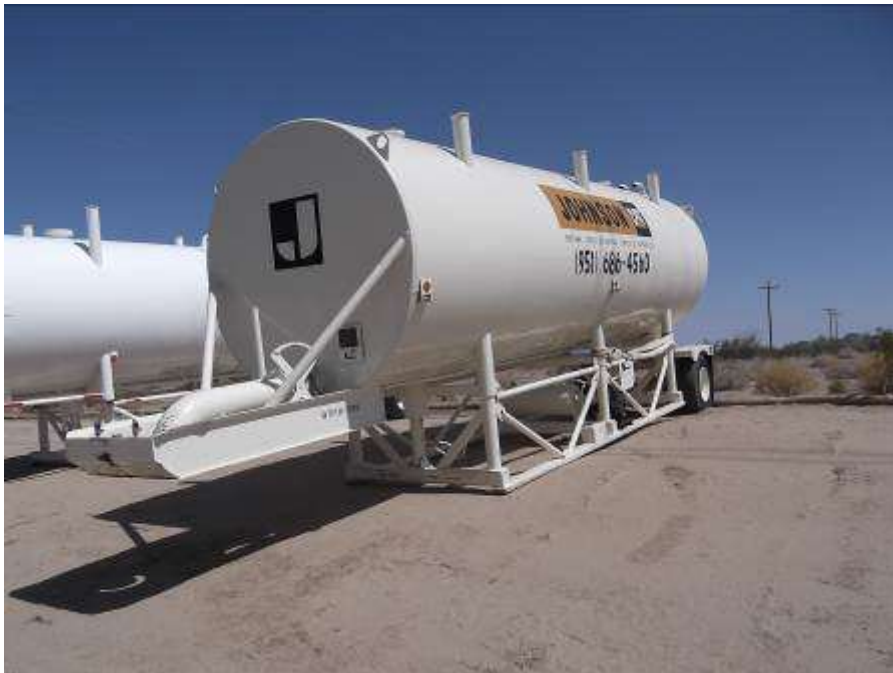
- On May 16, the CPUC EM observed two water stand tanks that had been staged within the disturbance limits at Tower 2443ALT without adequate secondary containment (see Figure 6). Upon checking the equipment, the CPUC EM confirmed that at least one of the pumps associated with the tanks contained fuel. The CPUC EM notified the SCE General Monitor and adequate containment was added the same day.

Figure 6. Water stand tanks staged at Tower 2443ALT with no secondary containment.

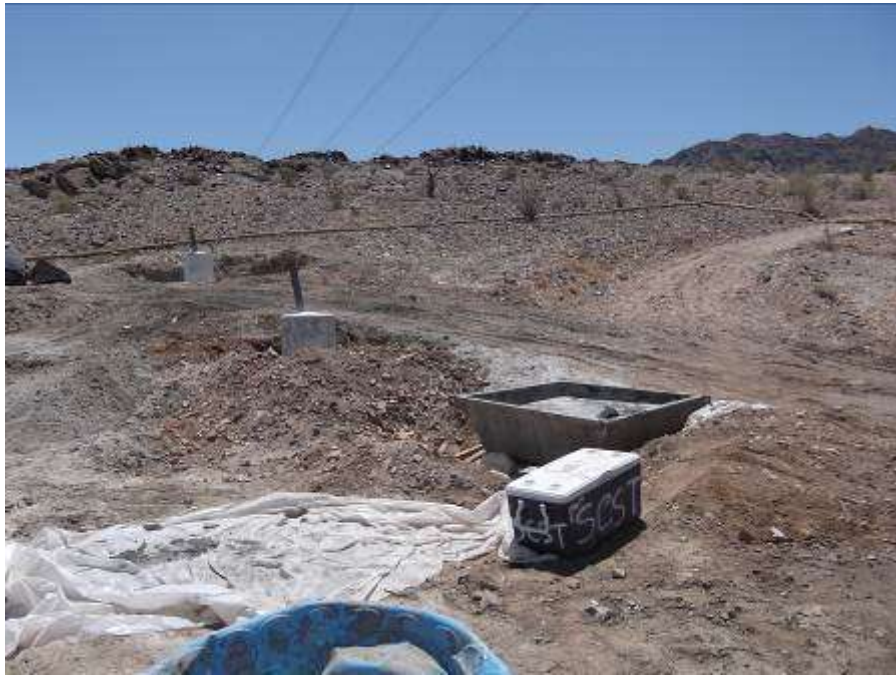
- On May 17, the CPUC EM observed an uncovered concrete washout tub at Tower 2518 (see Figure 7). The CPUC EM reported the finding to the SCE Biological Field Lead who stated that the tub would be covered immediately.

Figure 7. Concrete washout tub left uncovered at Tower 2518.

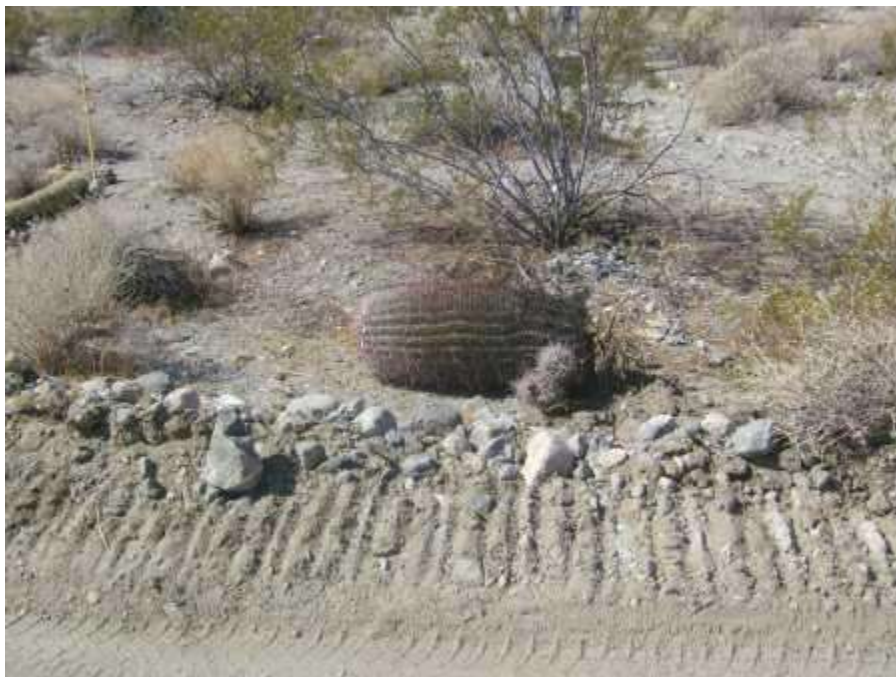
- On May 18, The CPUC EM found a California barrel cactus, flagged for avoidance, lying on the ground at the south edge of the access road near Tower 2333 (see Figure 8). The CPUC EM informed the onsite Monitor and the SCE Environmental Coordinator of the potential project impact to a sensitive species. The Project's Restoration Botanist was dispatched to further investigate the issue. The Botanist concluded that it appeared the incident was not project related. The cactus was replanted and watered by the Botanist.

Figure 8. California barrel cactus found at Tower 2333.

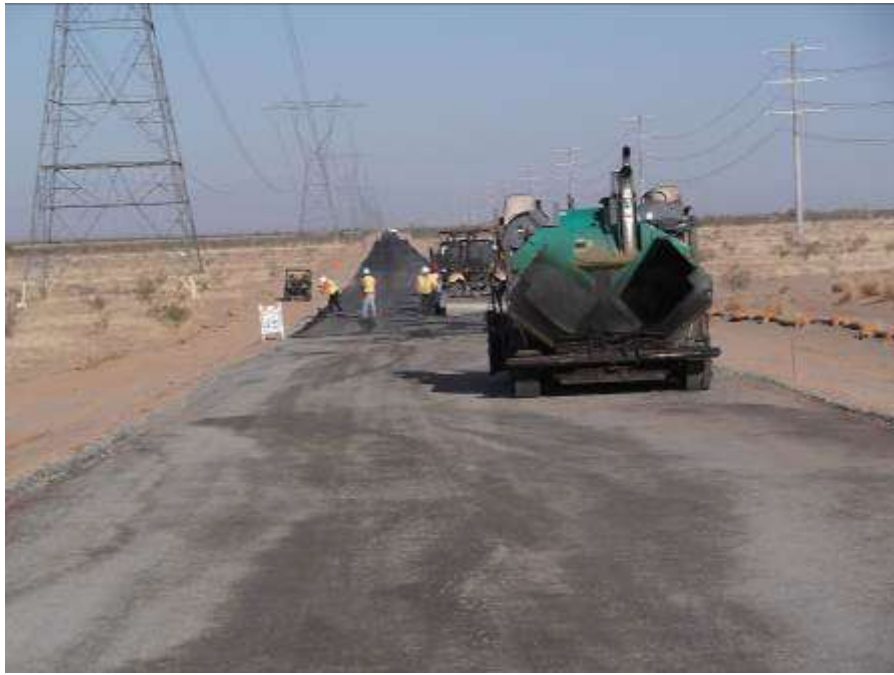
Figure 9. Road paving activities along the primary CRS access road.

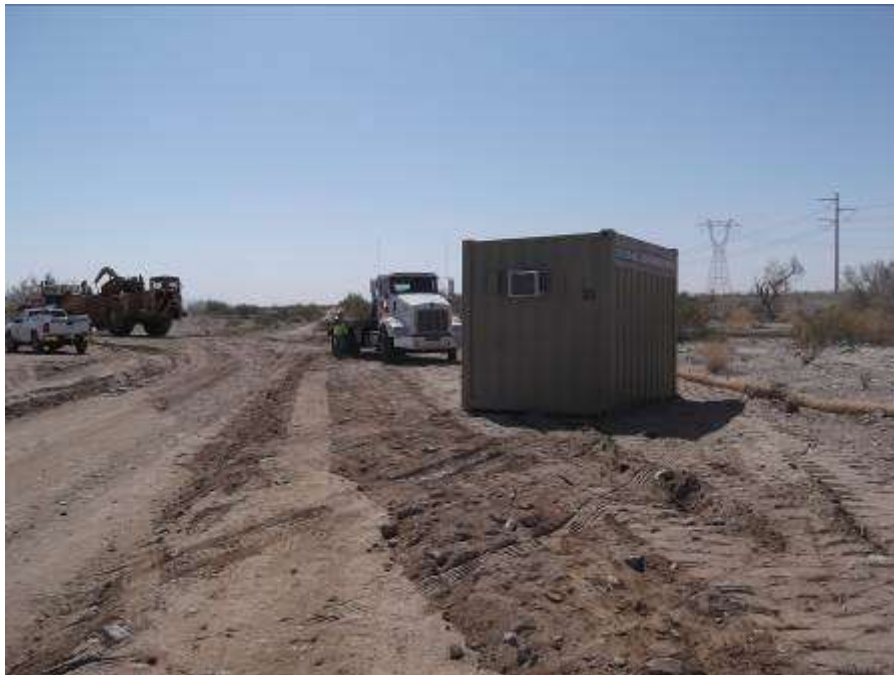
Figure 10. Temporary guard structure installed at intersection of Corn Springs Road and ROW access road.
