PROJECT MEMORANDUM SCE DPV2 TRANSMISSION PROJECT

To: Billie Blanchard, Project Manager, CPUC
From: Vida Strong, Aspen Project Manager
Date: July 31, 2012
Subject: Weekly Report 49, June 18 to June 24, 2012

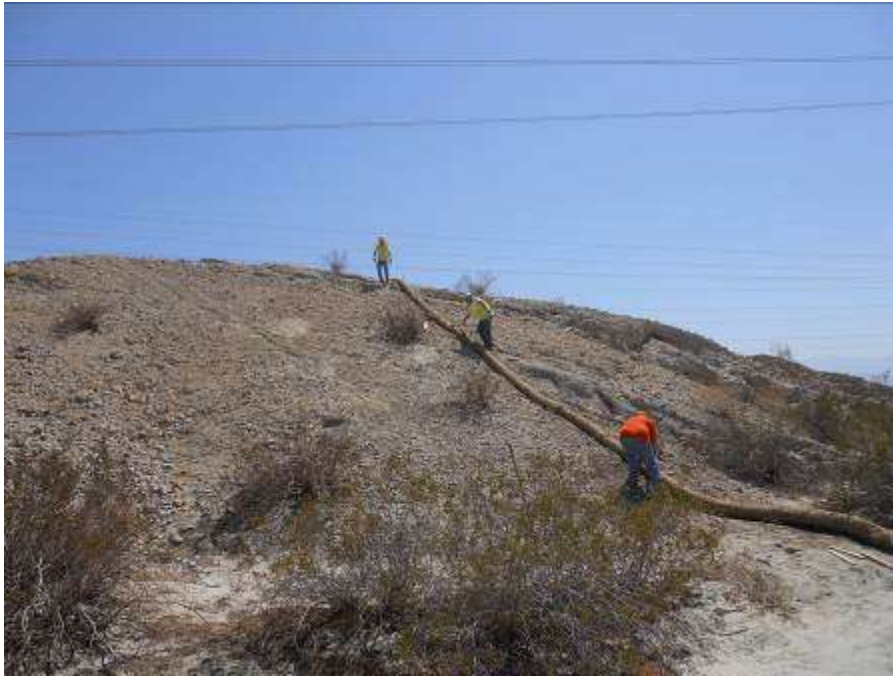
Figure 1. Installation of BMPs at Tower 2232.

- Shaker plates and rock base were installed at the intersection of Corn Springs and Chuckwalla Roads.
2. Red Bluff Substation to Devers Substation
 - BMPs were installed at Towers 2116, 2218, 2219, 2220, 2226, 2227, 2228, 2229, 2230, 2230X, 2231, 2232, 2235, 2236, 2238, 2239, 2241, 2242, 2243, 2263, 2265, 2266, and 2300 (see Figure 1). BMPs were also installed at Helicopter Landing Zones (HLZs) H4 and H5.

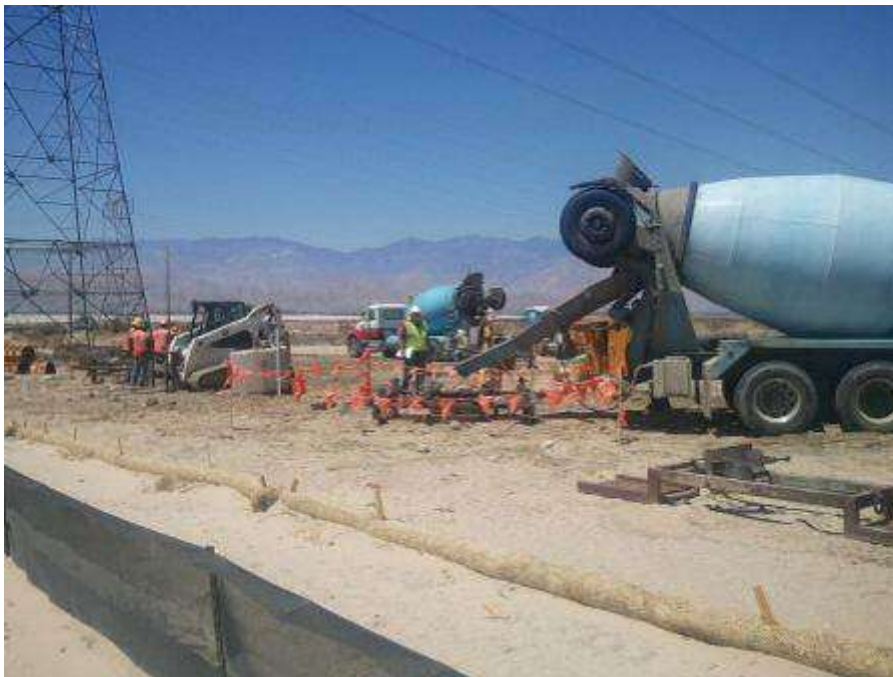
Figure 2. Concrete pouring for foundations at Tower 2127.

- Tower foundation concrete pouring activities occurred at Towers 2116, 2117, 2118, 2119, 2120, 2123, 2125, 2126, 2127, 2128, 2129, 2130, 2131, 2132, 2317, 2318, 2319, 2322, 2323, 2326ALT, and 2326X (see Figure 2).

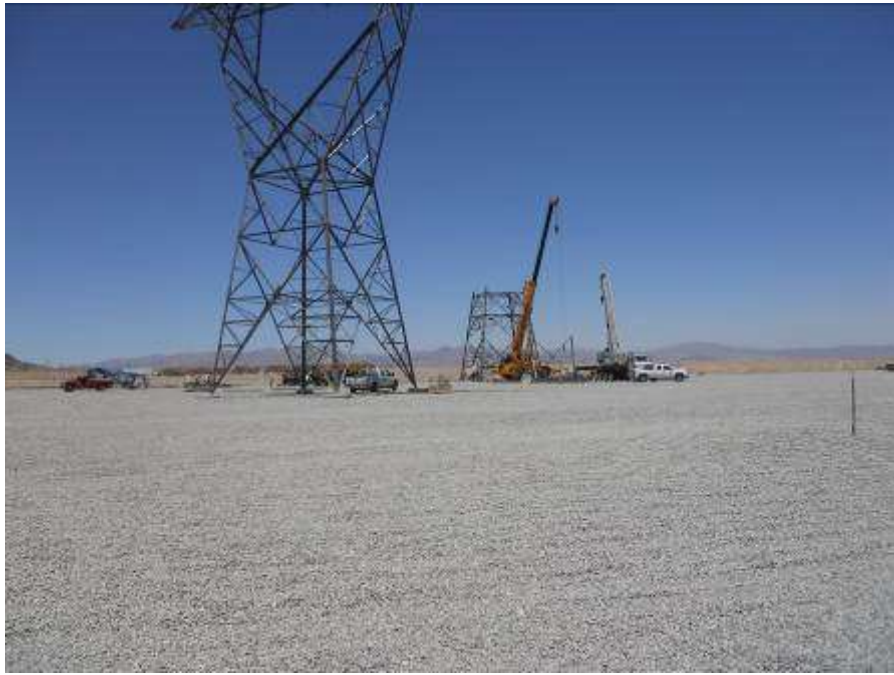
Figure 3. Assembly activities occurring at Tower RB1-4W.

- Tower assembly and/or steel deliveries occurred at Towers 2018, 2019, 2020, 2100, 2101, 2102, 2104, 2319, 2322, 2524, 2527, 2531, 2532, RB1-1W, RB1-4W, RB2-1W, RB1-2E, RB1-5E, and RB2-5E (see Figure 3).

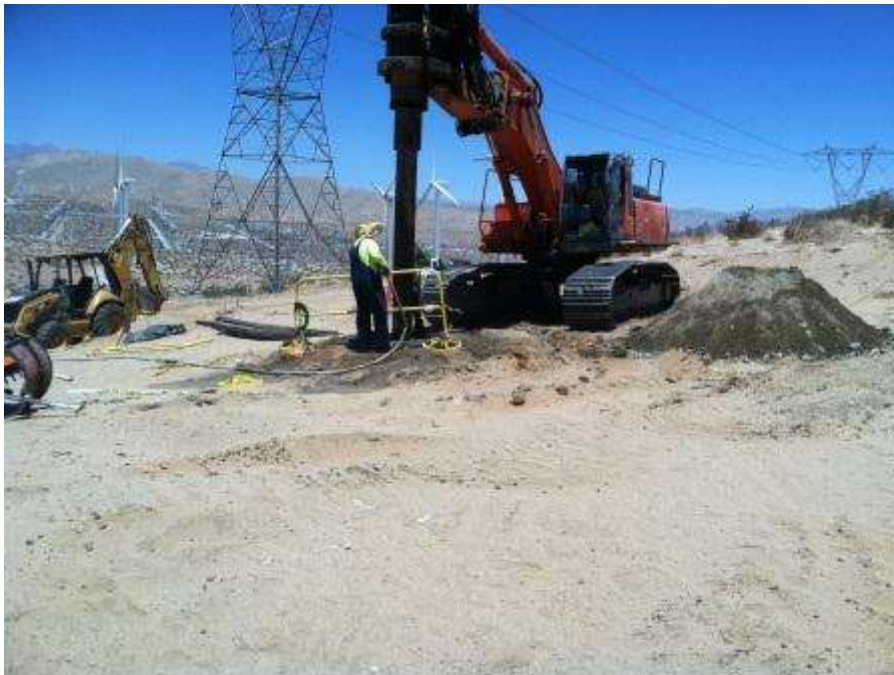
Figure 4. Foundation excavation at Tower 1014.

- Installation of BMPs occurred at Towers 1032, 1033, and 1034.
- Installation of Environmentally Sensitive Area (ESA) fencing occurred at Towers 1019, 1080, and 1147.
- Vegetation clearing occurred at Towers 1032, 1033, and 1034.
- Tower foundation drilling occurred at Towers 1014, 1023, 1029, 1030, 1031, 1071, 1073, and 1076 (see Figure 4).
- Tower foundation concrete pouring activities occurred at Towers 1014, 1023, 1029, 1030, 1031, and 1076.
- Tower assembly and steel deliveries occurred at Tower 1006, 1009, and 1011.
- Potholing on the access road occurred near Tower 1147.

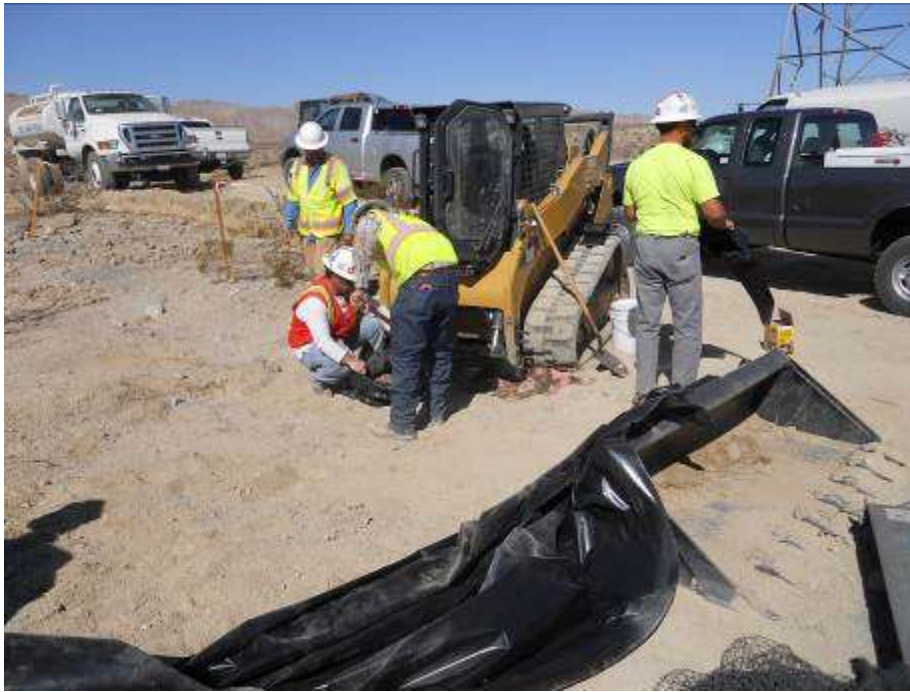
- On June 19, the construction crew identified a trail of fluid from a skid-steer loader that was being moved at Tower 2266. Work was immediately stopped in the area. It was determined that the leak was caused by a damaged hydraulic hose resulting in a spill of hydraulic fluid approximately 10 inches wide and 30 feet long. An additional spill of approximately three feet by six feet in size was observed under the loader. It was estimated that the combined spills totaled roughly five gallons. The CPUC EM arrived onsite as the contaminated soil was being removed from the affected areas and disposed of according to the appropriate mitigation measures and SWPPP guidelines (see Figure 5). During a site visit the following day, the CPUC EM observed that the spill had been completely cleaned and the damaged skid-steer had been repaired. The construction foreman notified the CPUC EM that the skid-steer was going to be removed from the site that day to be power washed.

Figure 5. Crew working to remove contaminated soil due to hydraulic fluid spill at Tower 2266.

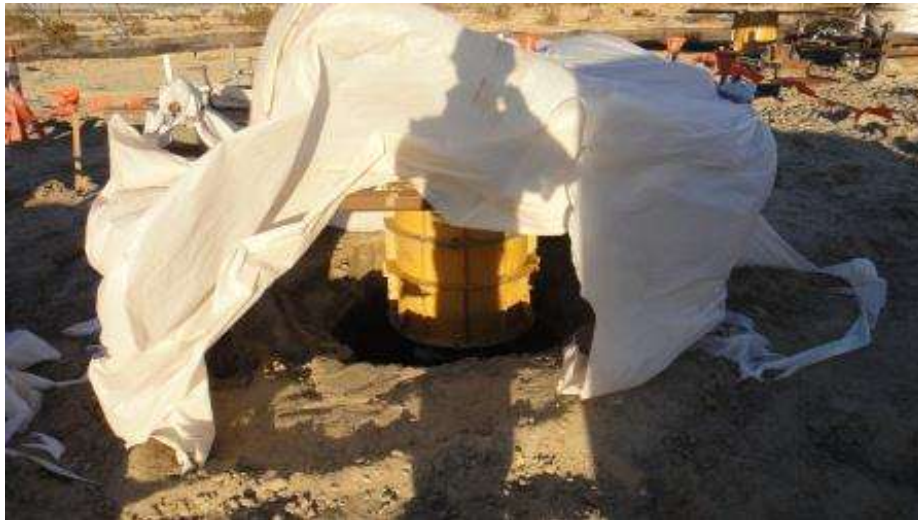
- On June 19, foundation excavation holes at Tower 2125 were observed to be inadequately covered for preventing harm to wildlife by the Coachella Valley Fringe-toed Qualified Biologist (see Figure 6). Due to high winds, the plastic sheeting used was not adequate and was blown away from the holes, leaving space for wildlife. The pouring crew arrived on site, removed the inadequate covering, and finished preparing for the concrete pour. The onsite foreman was informed of the non-compliance. The contractor's response indicated a new method will be implemented in the field. Tower 2125 is in Coachella Valley fringe-toed lizard habitat. No biological constraints were found by the onsite monitor; however, there was no way for the Biological Monitor to see if wildlife fell into the drilled holes.

Figure 6. Inadequate covering of open hole excavation at Tower 2125.

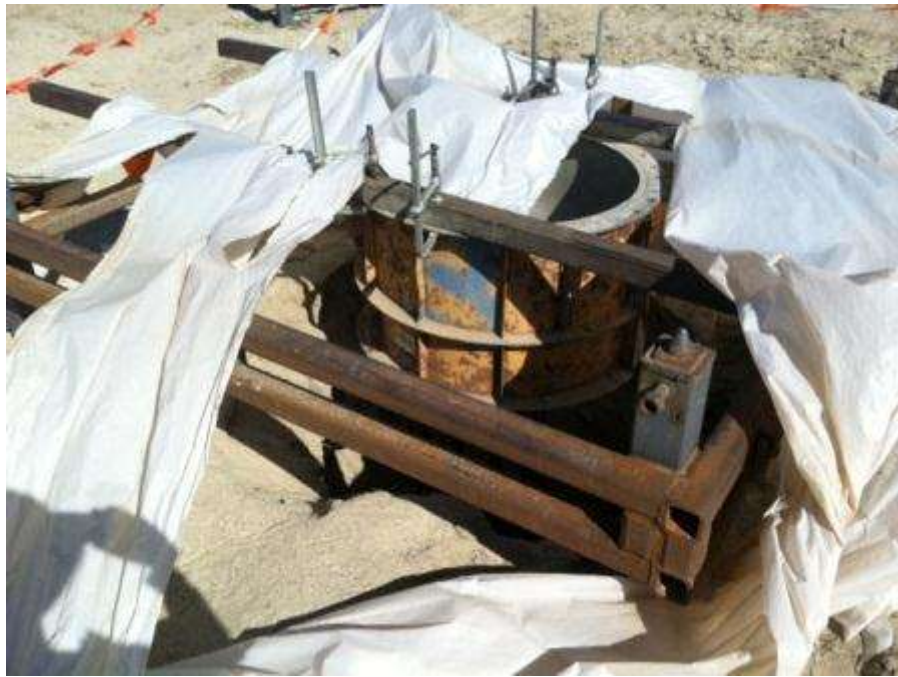
- On June 19, the CPUC EM discovered a foundation excavation hole at Tower 2126 to be inadequately covered for preventing harm to wildlife or the general public (see Figure 7). High winds had blown the plastic sheeting away from the holes, leaving space for wildlife. The CPUC EM contacted the SCE EC. Later that day the pouring crew arrived on site, removed the inadequate covering, and finished preparing for pouring. The onsite biological monitor informed the foreman of the non-compliance. The contractor's response indicated a new method will be implemented in the field. Tower 2126 is in Coachella Valley fringe-toed lizard habitat. No bio constraints were found, how-

ever, there was no way for the biological monitor to see if wildlife fell into the drilled holes. Project Memorandum #9 was issued for this incident on June 19.

Figure 7. Inadequate covering of open hole excavation at Tower 2126.

PM #9	06/19/12	Tower 2126	Inadequate covering of foundation excavations at Tower 2126. Violation of BO-13.
CPUC Non-Compliance Reports (NCR)			
NCR #1	01/13/12	Project-wide	Unapproved removal of stick nests from DPV1 Transmission Line towers.
NCR #2	05/18/12	Tower 2333	Failure to protect wildlife during construction which resulted in the death of a kit fox.
NCR #3	06/04/12	Near Tower 2310	Road base was installed at two locations along the access road to protect the utility crossings near Tower 2310. This work was completed prior to the pre-construction verification and release of this road from the CPUC.
NCR #4	07/02/12	Near 2303X	Road base installed along a portion on a road not approved for the Project.
NCR #5	07/02/12	Near 2204 and 2205	Project equipment drove outside the approved road width along the access road near Towers 2204 and 2205. These towers are located within the Coachella Valley Preserve.

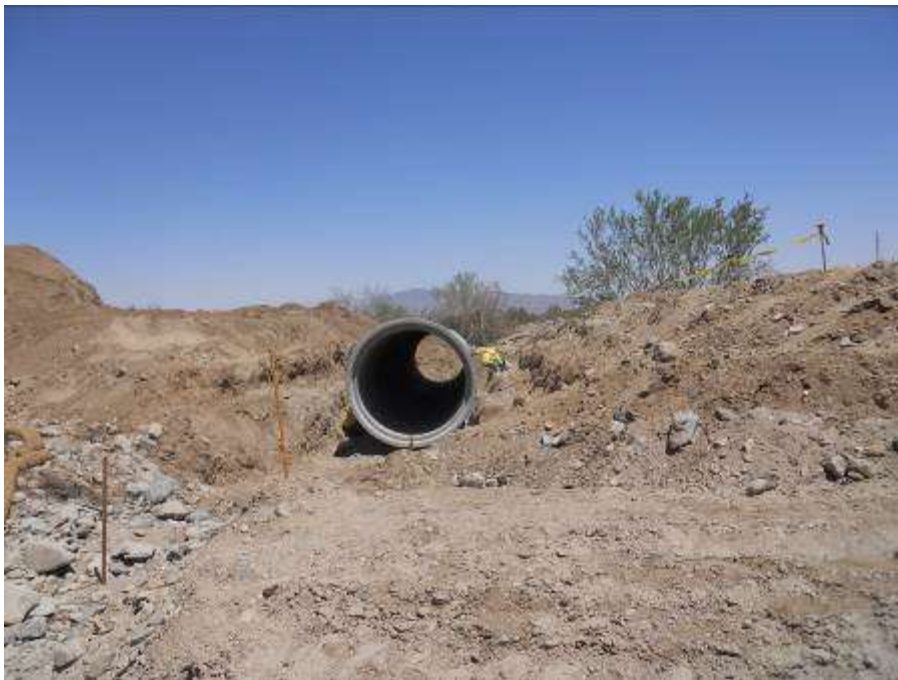
4. Red Bluff Substation (BLM Lands) – Activities that were conducted at the Red Bluff site included ongoing grading of cut and fill areas, installation of drainage structures, and rock crushing of native fill. Well development, involving pumping of the well, continued throughout the subject period. Activities that were conducted along the primary access road between Corn Springs Road and the substation eastern access road included grading and culvert and drainage improvements (see Figure 8). BMP installation and maintenance continued, as required.

Figure 8. Installation of a culvert at a drainage crossing along Red Bluff access road.

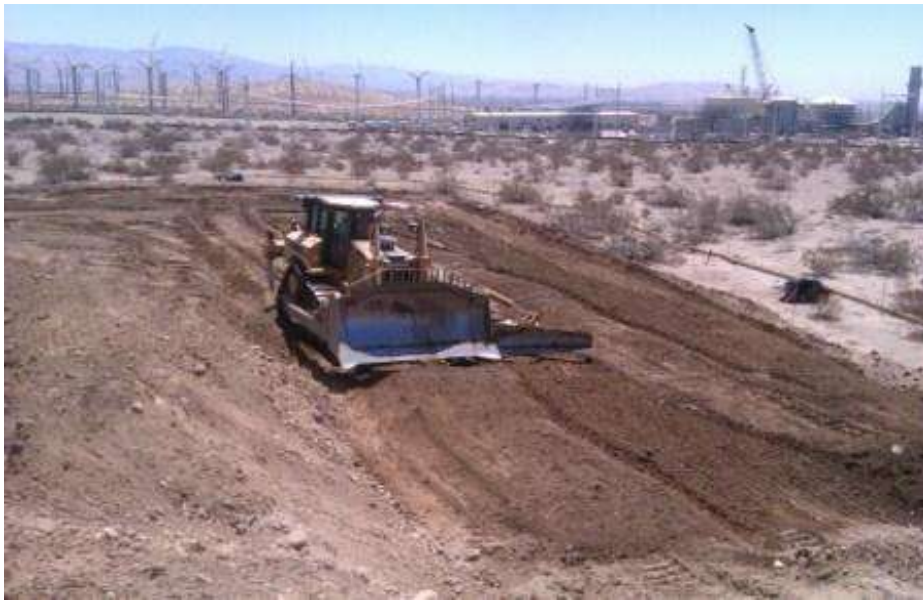
5. Devers Substation – Activities included site clearing and grading within the Devers Expansion Area. (see Figure 9). Grading activities included creating a ramp from the substation gate into the expansion area to allow access for water trucks and fill trucks. Gravel was delivered for the ramp to prevent track out into the substation. Staking activities included staking the new roads and helicopter pad area within the existing substation boundaries.

Figure 9. Grading activities within the Expansion Area of the Devers Substation.

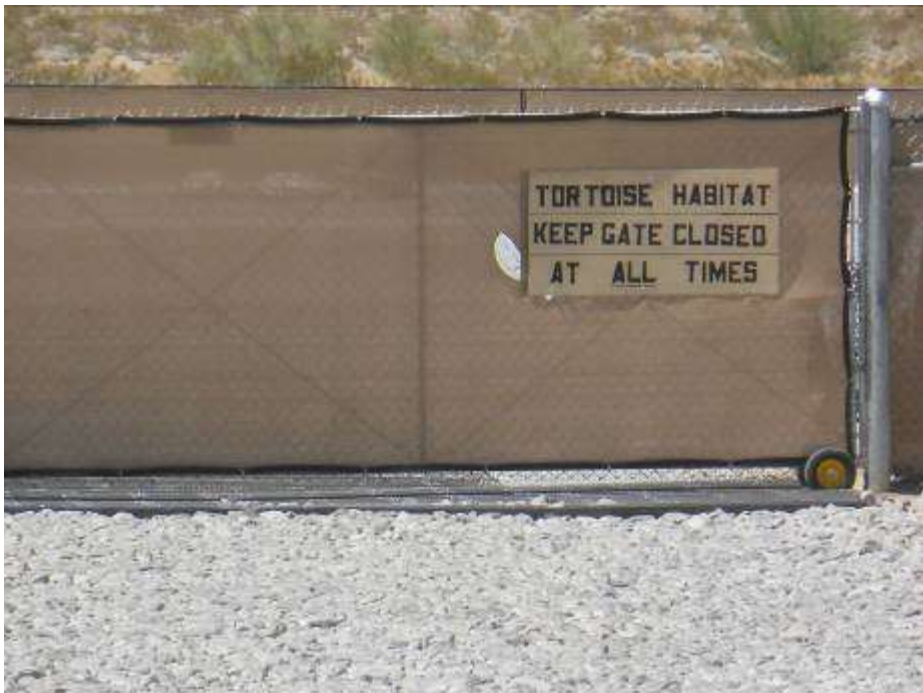
- SCE Biological Monitors conducted biological sweeps at all construction yards throughout the subject period.
- On June 19, the CPUC EM observed that the entrance gate to the Summit Construction Yard was closed and signs indicating that the gate must remain closed were installed (see Figure 10).

Figure 10. Sign installed on entrance gate to Summit Construction Yard.
