## PROJECT MEMORANDUM SCE DPV2 TRANSMISSION PROJECT

**To:** Billie Blanchard, Project Manager, CPUC  
**From:** Vida Strong, Aspen Project Manager  
**Date:** September 6, 2012  
**Subject:** Weekly Report 57, August 13 to August 19, 2012

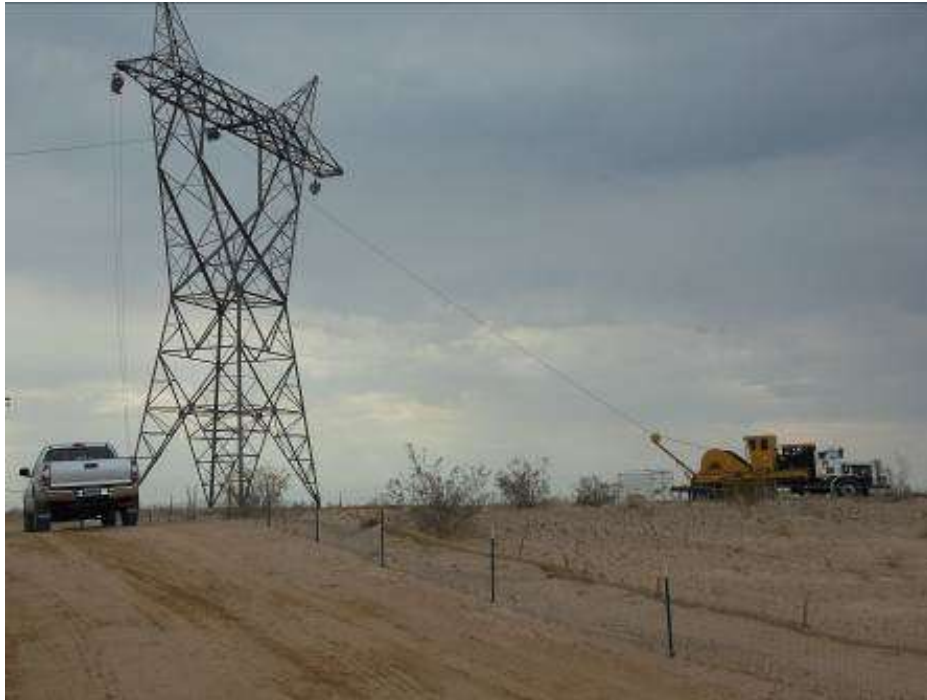
**Figure 1.** Wire stringing activities occurring at the CRS loop-in tower sites.

- Tower assembly and/or steel deliveries occurred at Tower 2534, 2535, 2538, 2629, and 2633.
  - Wire stringing activities occurred at Towers 2652, 2653, and CR1-1E (see Figure 1).

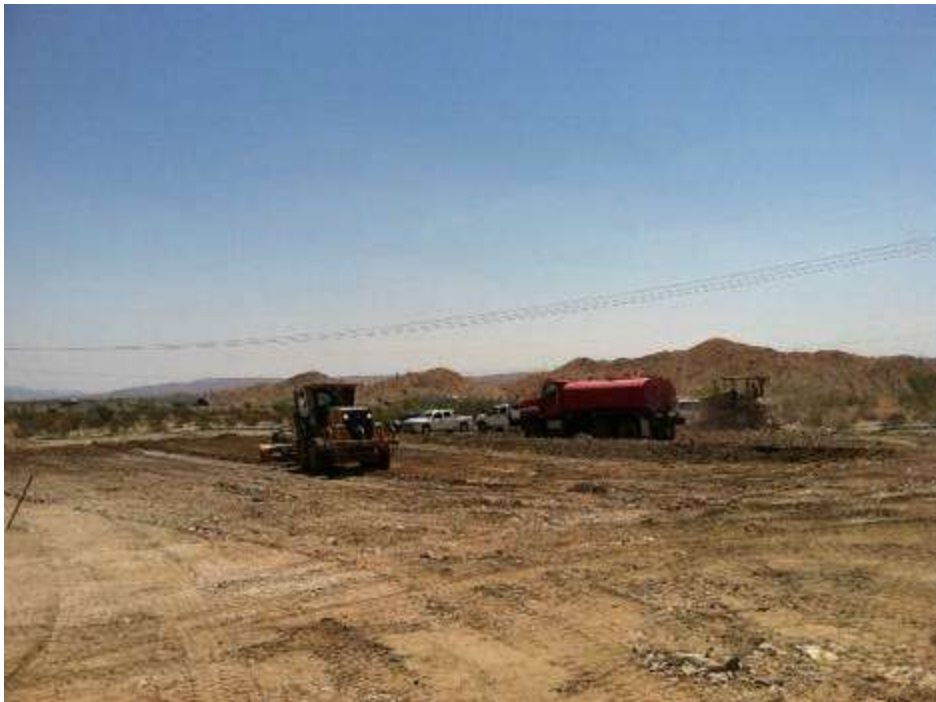
**Figure 2.** Grading at HLZ H1E.

- Vegetation clearing occurred at Towers 2414 and 2415, at Helicopter Landing Zones (HLZ) H1E and H4.
- Spur road and crane pad grading occurred at Towers 2235, 2242, 2244, 2265, 2269, 2414, 2415, 2416, 2507, and HLZ H1E (see Figure 2).

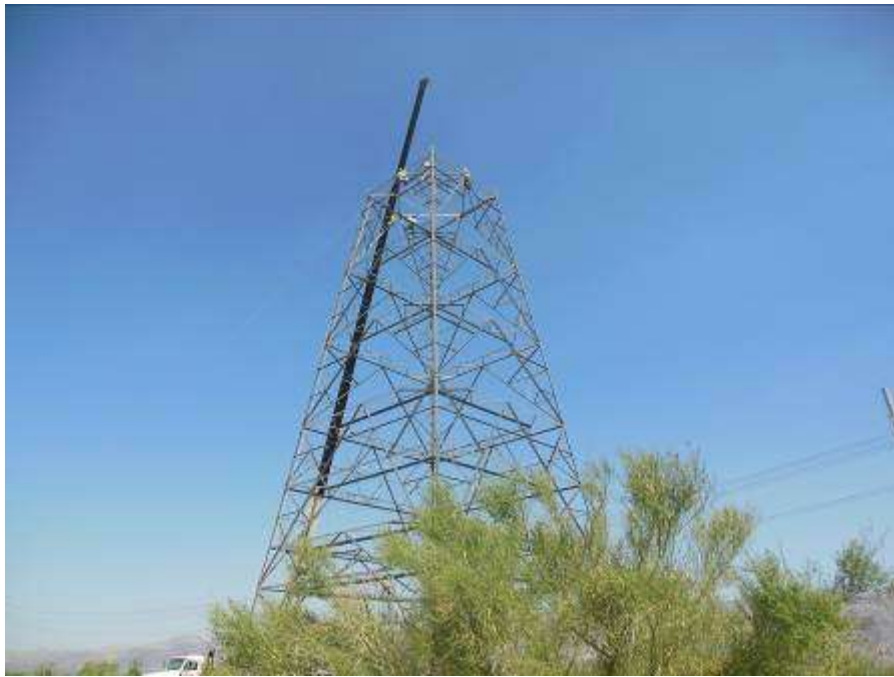
**Figure 3.** Assembly/erection activities occurring at Tower 2435.

- Tower assembly and/or steel deliveries occurred at Towers 2112, 2113, 2116, 2117, 2137, 2201, 2202, 2203, 2205, 2206, 2207, 2208, 2209, 2210, 2242, 2231, 2235, 2236, 2239, 2242, 2243, 2247, 2248, 2249, 2304, 2305, 2306, 2313, 2328, 2329, 2330, 2331, 2333, 2334, 2335, 2336, 2337, 2338, 2427, 2428, 2429, 2432, 2433, 2435, 2436, 2437, 2438, 2439, 2441, 2442, 2445, 2448, 2453, RB2-1W, RB2-3E, RB2-4E, and RB2-5E (see Figure 3).

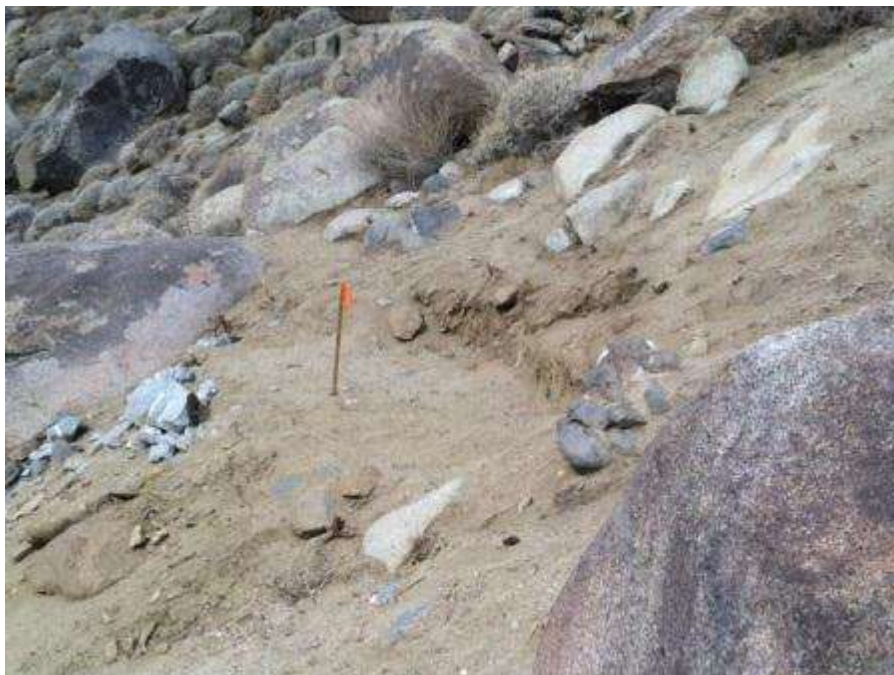
**Figure 4.** Rock clearing and micropile foundation preparation at Tower 1033.

- Rock clearing and micropile foundation preparation occurred at Tower 1037.

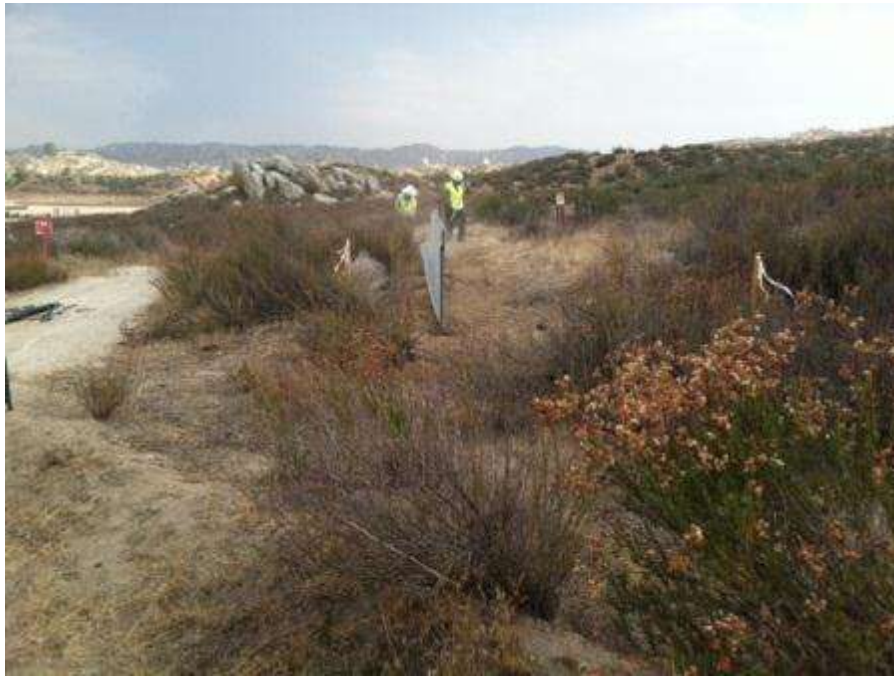
**Figure 5.** Installation of Stephen's kangaroo rat exclusionary fencing at Tower 1133.

- A Stephen's kangaroo rat Qualified Biologist was present during the installation of exclusionary fencing at Tower 1100 and 1133.
- Three incidents associated with project activities outside of approved project disturbance limits were reported during the subject period.

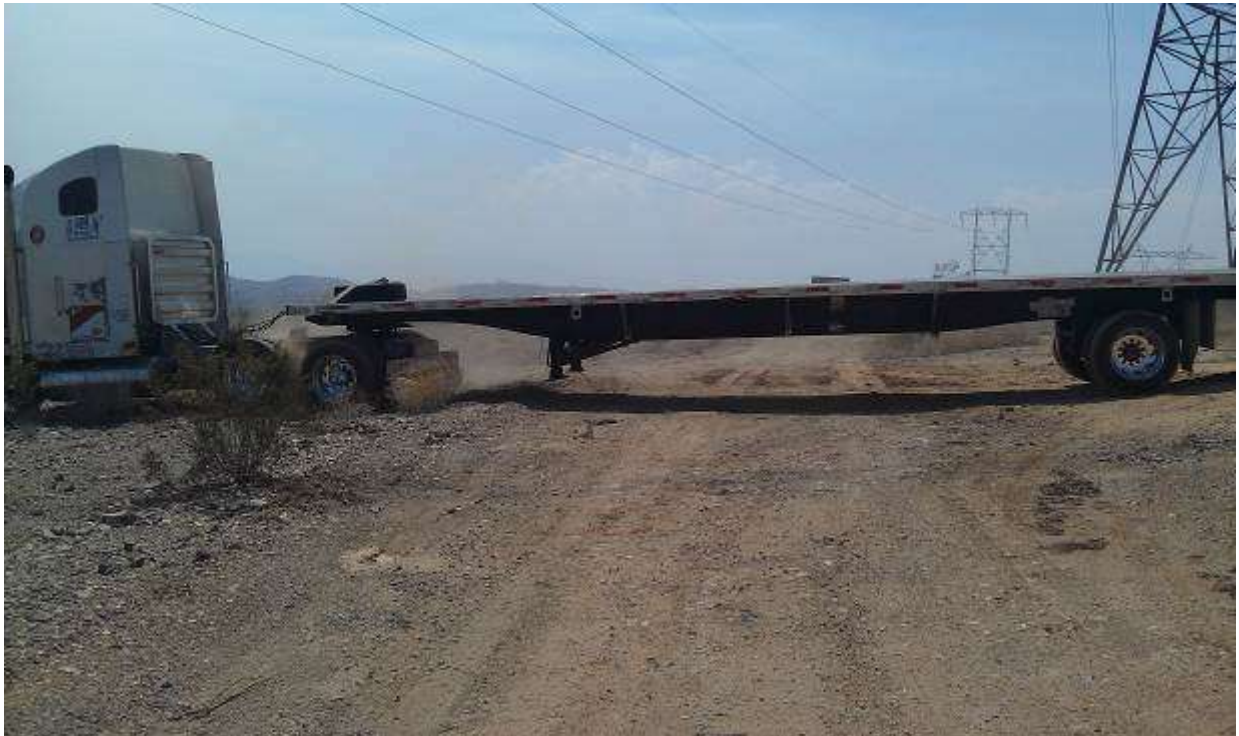
- On August 14, a Biological Monitor observed a semi-truck pull off the access road into desert tortoise habitat near Tower 2326. The driver informed the Biological Monitor that he was attempting to turn around and got stuck (see Figure 6). The monitor explained to the driver that he was not allowed to pull off the approved access road and this incident would result in a non-compliance. The driver stated that he was unaware that he could not drive off the access road and did not have the DPV2 WEAP sticker on his hard hat. Stakes with red flagging were installed in this area to avoid any future incidents. The CPUC EM sent an email to SCE on August 20 asking if the driver had a spotter to assist him and if the driver had been re-trained, which was a corrective action condition stated in NCR #8. To date, SCE has not provided a response.

**Figure 6.** Semi-truck drove off the approved access road in desert tortoise habitat while attempting to turn around near Tower 2326.

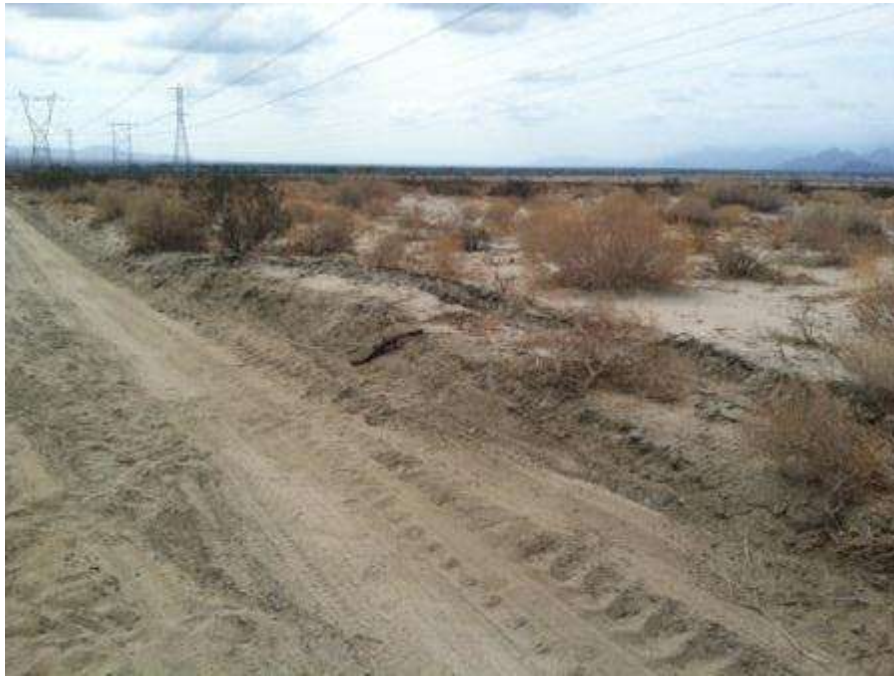
- On August 16, a Biological Monitor observed a crane drive outside of the access road boundaries while exiting Tower 2205 within the Coachella Valley Preserve in Coachella Valley fringe-toed lizard critical habitat (see Figure 7). The crane had driven four feet over the berm and travelled approximately 20 feet while being off of the ROW. The Biological Monitor honked at the crane driver prior to the crane going over the berm, but the driver did not stop. The Biological Monitor notified the SCE Field Contact Representative (FCR) and the FCR discussed the incident with the driver. The CPUC EM sent an email to SCE on August 18 and again on August 20 inquiring if the driver had a spotter to assist him and if the driver had been re-trained, which was a corrective action condition stated in NCR #8. To date, SCE has not provided a response.

**Figure 7.** Impacts where a crane drove outside of the access road boundaries at Tower 2205.

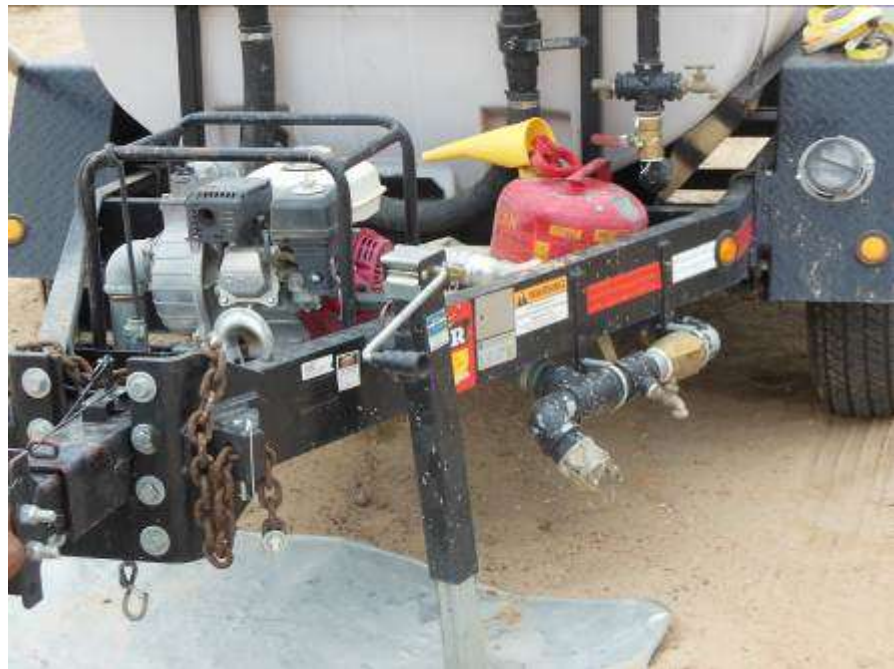
- There was one reported incident associated with working without a Biological Monitor present during the subject period.
- There were four reported incidents associated with improper implementation of SWPPP conditions, including inadequate BMP maintenance/repairs, improper BMP installation, and secondary containment during the subject period. Additionally, the CPUC EM observed an uncontained gasoline can at Tower 2637 on August 16 (see Figure 8).

**Figure 8.** Gasoline can with no secondary containment at Tower 2637.

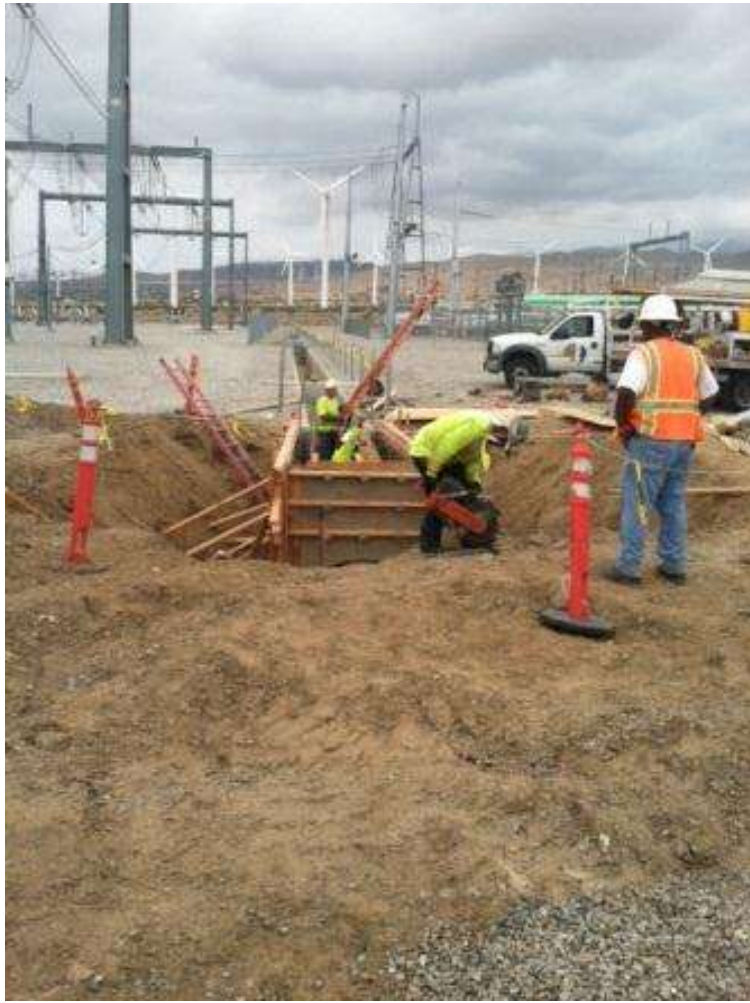
5. Devers Substation (Private Lands) – Activities that were conducted for the Devers Substation expansion and upgrades included grading and soil import to the expansion area. Within the northern portion of the existing substation trenching to remove and replace the old waterline continued (see Figure 9).

**Figure 9.** Trenching for a new waterline in the northern portion of the Devers Substation.

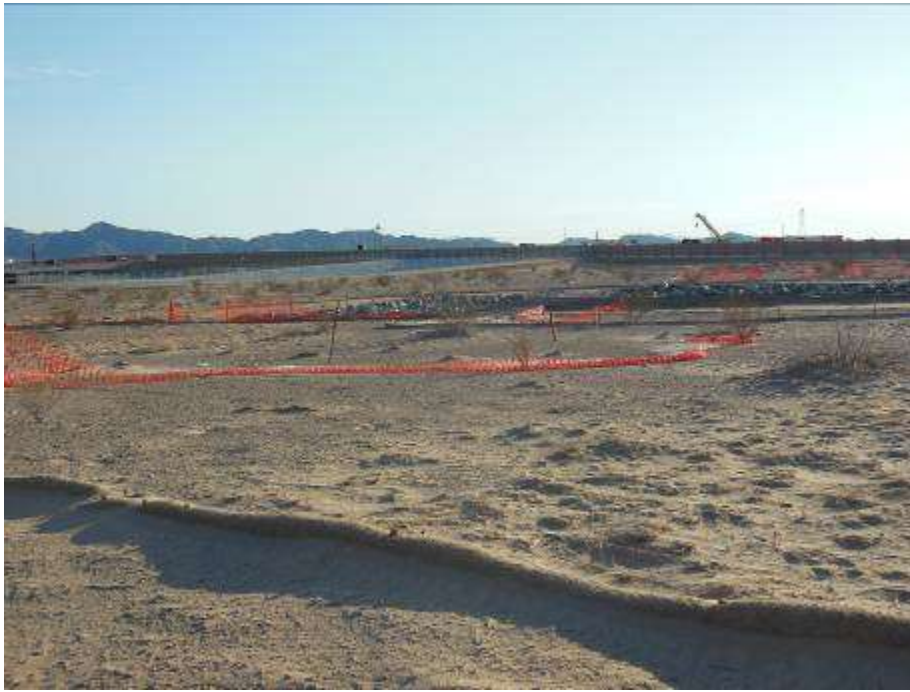
**Figure 10.** Damaged ESA fencing along the CRS access road.

- SCE General, Biological, and Archeological Monitors were onsite, as appropriate, throughout all construction activities associated with CRS, the Red Bluff Substation, Devers Substation, Valley Substation, and the Series Capacitor sites.
- There was one reported incident associated with excessive vehicle/equipment speeds along the CRS access road during the subject period.
- There was one reported incident associated with improper secondary containment at Devers Substation during the subject period.
- On August 19, the CPUC EM observed several Environmentally Sensitive Area (ESA) locations along the CRS access road where exclusionary fencing was damaged (see Figure 10). The CPUC EM notified the SCE EC and was assured that a crew would be scheduled to conduct the necessary repairs.
