## PROJECT MEMORANDUM SCE DPV2 TRANSMISSION PROJECT

**To:** Billie Blanchard, Project Manager, CPUC  
**From:** Vida Strong, Aspen Project Manager  
**Date:** December 18, 2012  
**Subject:** Weekly Report 71, November 19 to November 25, 2012

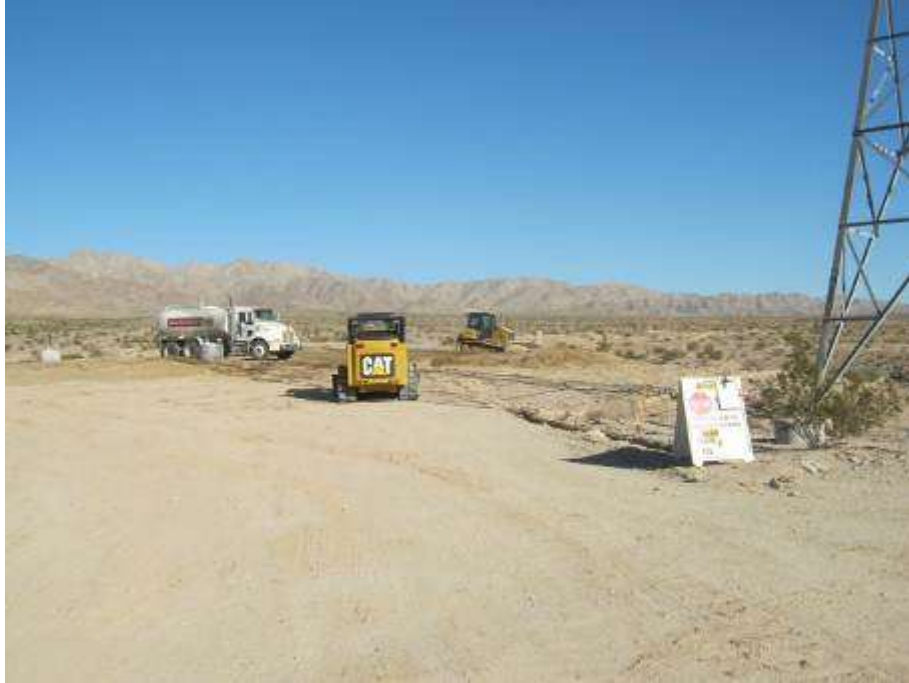
Figure 1. Grading at Tower 2258.

- Grading activities occurred at Towers 2255, 2258, and 2260, at Fiber Optic Reel Sites 49, 51, 61, and 63, at Splice Sites 46 and 50, and at Wire Site 55/Pull Site 56/Splice Site 43 (see Figure 1).

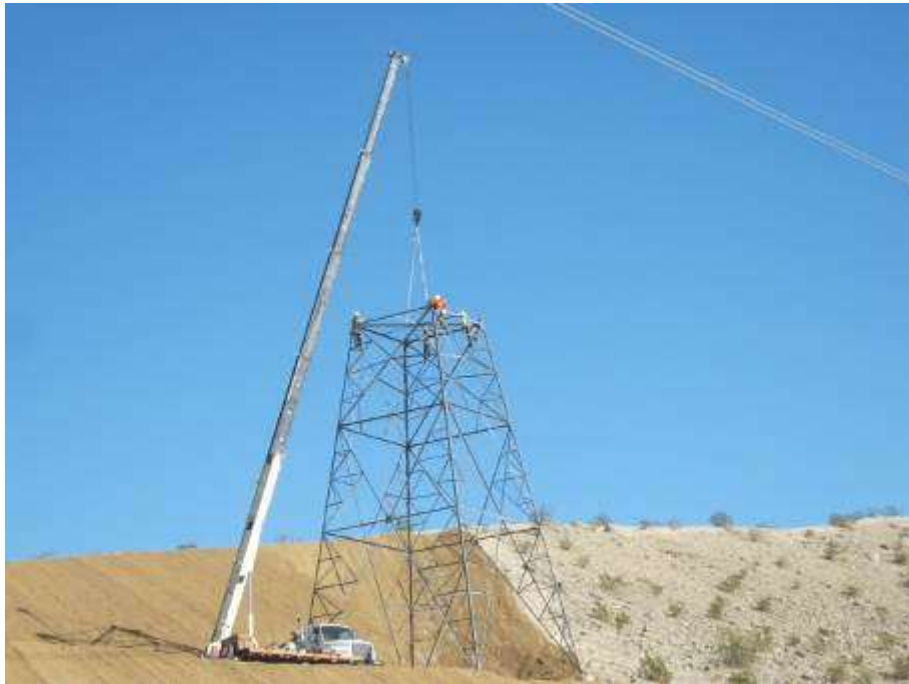
Figure 2. Assembly at Tower 2244.

- Foundation repairs were conducted at Tower 2413.
- Tower assembly and/or steel deliveries occurred at Towers 2000B, 2006, 2013, 2015, 2109, 2121, 2244, 2246, 2254, 2255, 2260, 2265, 2443, 2454, 2501, 2505, 2508, and 2517, and within Helicopter Landing Zone (HLZ) H1E (see Figure 2).

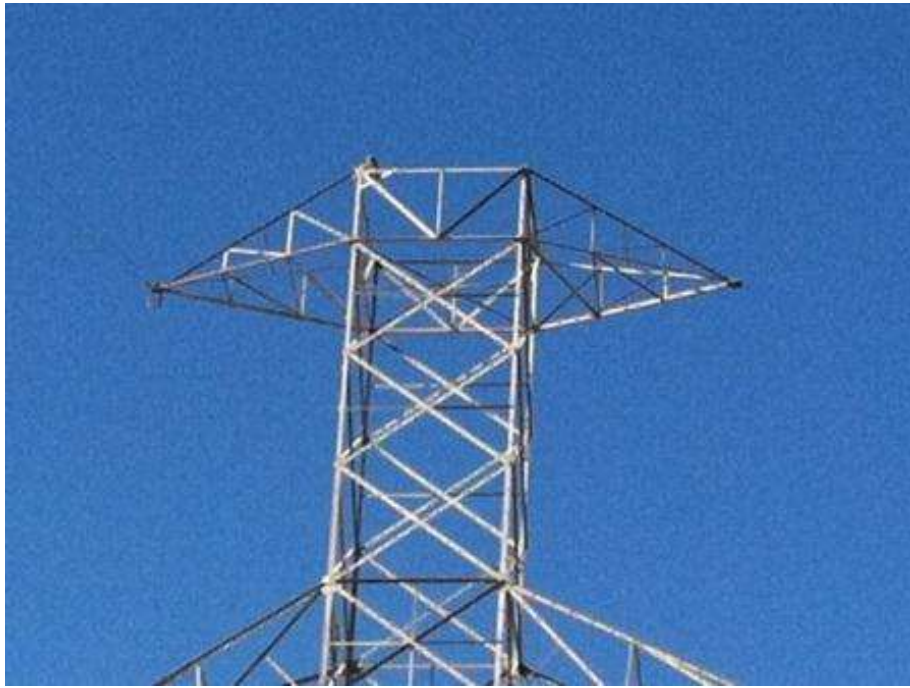
Figure 3. Installation of FAA Lighting on Tower 2000X.

- Wire stringing activities were conducted between Towers 2519 and 2532, at all Red Bluff loop-in towers, and associated wire stringing locations.
- FAA lighting installation occurred at Tower 2000X (see Figure 3).

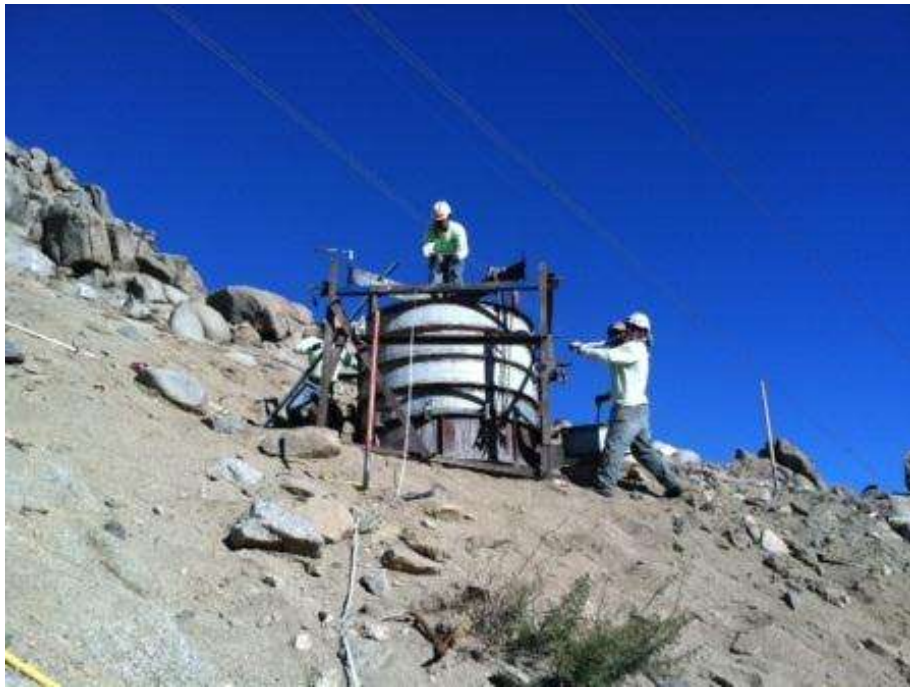
Figure 4. Micropile foundation pile cap preparation at Tower 1033.

- Micropile foundation activities occurred at Towers 1032, 1033, 1034, 1035, 1036, 1070, 1072, and 1107 (see Figure 4).
- Tower foundation drilling activities occurred at Towers 1079, 1143, and 1144.

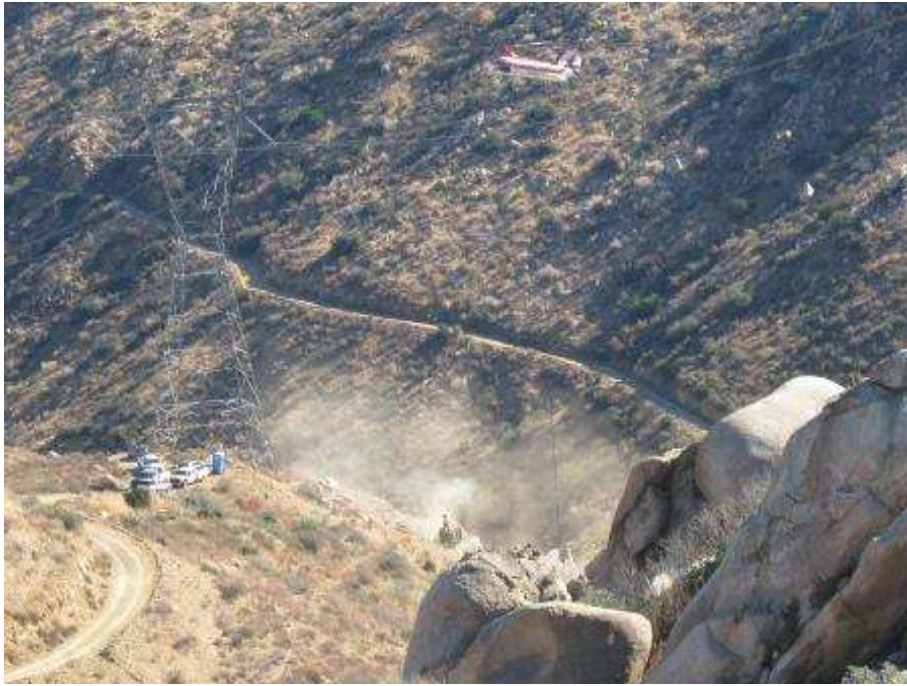
- On November 20, the CPUC EM observed inadequate dust control at Tower 1070 during helicopter operations (see Figure 5). The SCE General Monitor was notified of the observation and suggested he would visit the site later in the day to observe fugitive dust control.

Figure 5. Inadequate dust control during helicopter operations at Tower 1070.

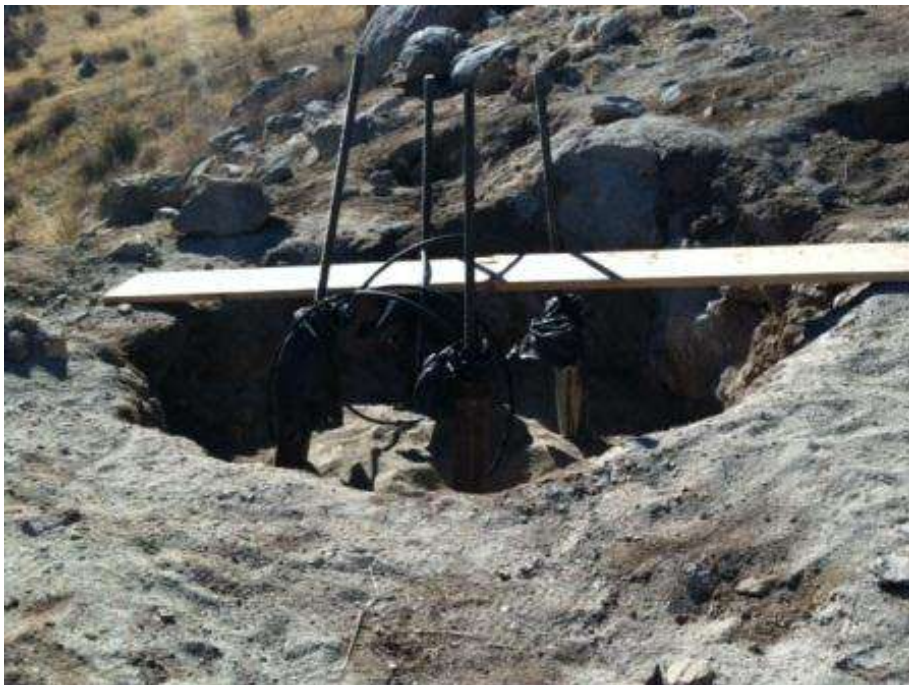
- On November 19, the CPUC EM observed a steep-walled excavation at Tower 1067 with its wildlife ramp lying across the top of the hole thus becoming ineffective as a way for wildlife to escape entrapment (see Figure 6). The SCE Environmental Coordinator (EC) was immediately notified. Before the end of the day, a Biological Monitor checked the hole for wildlife and properly installed the ramp. No wildlife was trapped.

Figure 6. Ineffective wildlife ramp at Tower 1067.

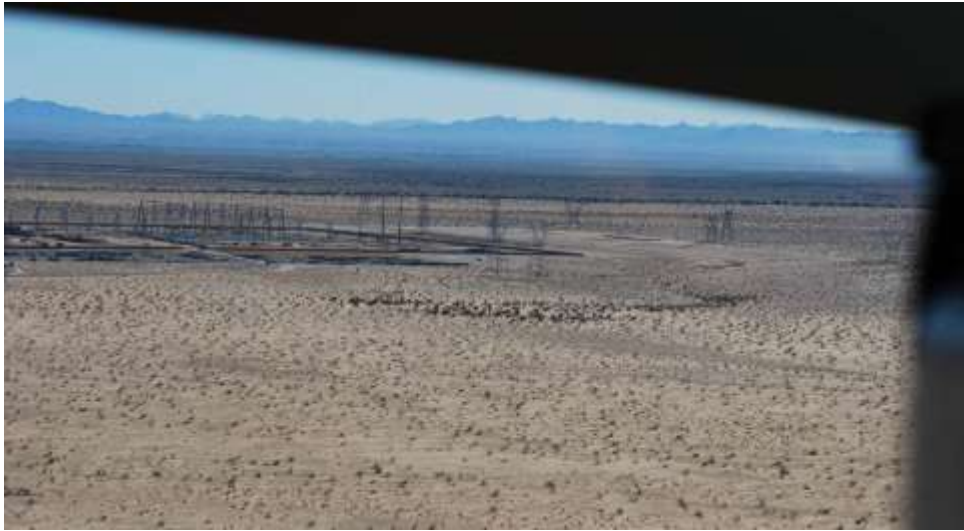
1. Colorado River Substation (CRS) (BLM Lands) – Activities that occurred at CRS during the subject period included foundation excavation, construction of the MEER building and transformer pads, installation of conductor cable and other conduit, trenching for grounding and backfilling of trenches, and maintenance of drainage structures. Maintenance repairs along the CRS access road and side slopes are ongoing (see Figure 7).

Figure 7. Overview photo of CRS taken from the helicopter (photo provided by Kenny Construction).

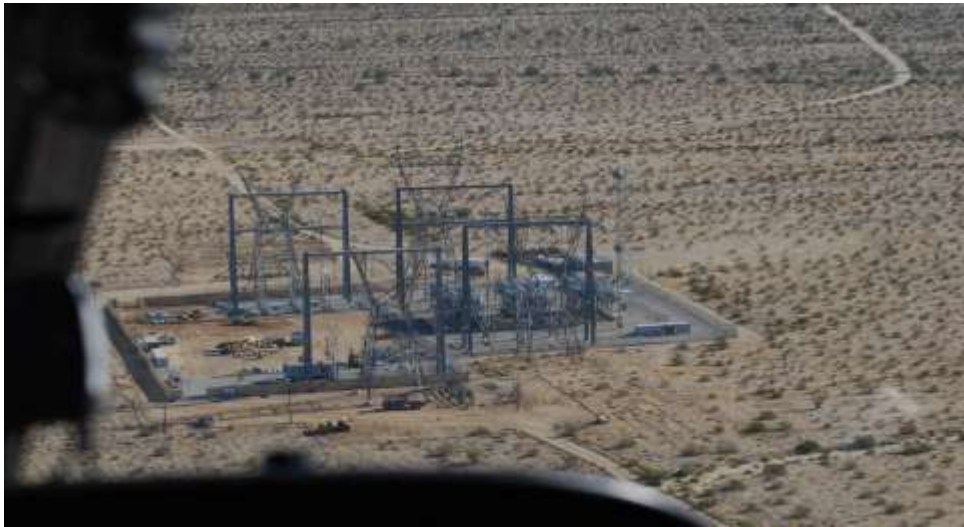
6. Series Capacitor (BLM Lands) – Activities that were conducted during the subject period included construction associated with the capacitor and equipment deliveries (see Figure 8).

Figure 8. Overview photo of the Series Capacitor taken from the helicopter (photo provided by Kenny Construction).

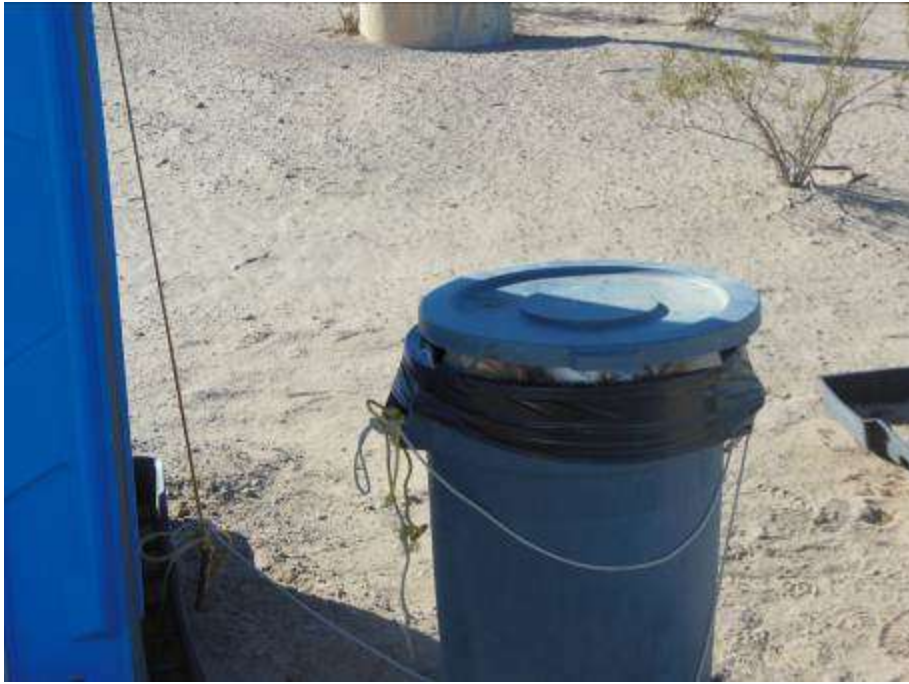
- SCE General, Biological, and Archeological Monitors were onsite, as appropriate, throughout all construction activities associated with the above listed sites.
- On November 21, the CPUC EM observed a small trash can at the entrance to CRS from Wiley's Well Road that was overfilled and contained improperly (see Figure 9). The CPUC EM informed the SCE FCR and the contractor was immediately notified.

Figure 9. Improperly contained trash at entrance to CRS access road.
