**PROJECT MEMORANDUM
SCE EL CASCO SYSTEM PROJECT**

To: Lynne Mosley, CPUC
From: Vida Strong, Aspen Project Manager
Date: October 14, 2009
Subject: Report #9: October 4, 2009 – October 10, 2009

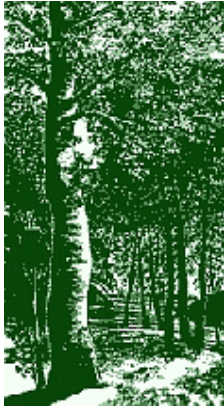
Figure 8: Equipment and vehicles were checked regularly for fluid leaks. This paddle-wheel excavator at the El Casco Substation staging area has been fitted with a drip pan until it is repaired.

- Biological, cultural resource, and other mitigation monitoring was conducted by NRC, LSA, and RMT consultant field monitors at both the El Casco Substation and the FOC work areas. In addition, SCE provided air quality monitoring. Monitors representing pertinent environmental issues were present with each construction crew at all times during construction.
- Equipment was continually checked for air pollution control compliance, and for leakages (see Figure 8).

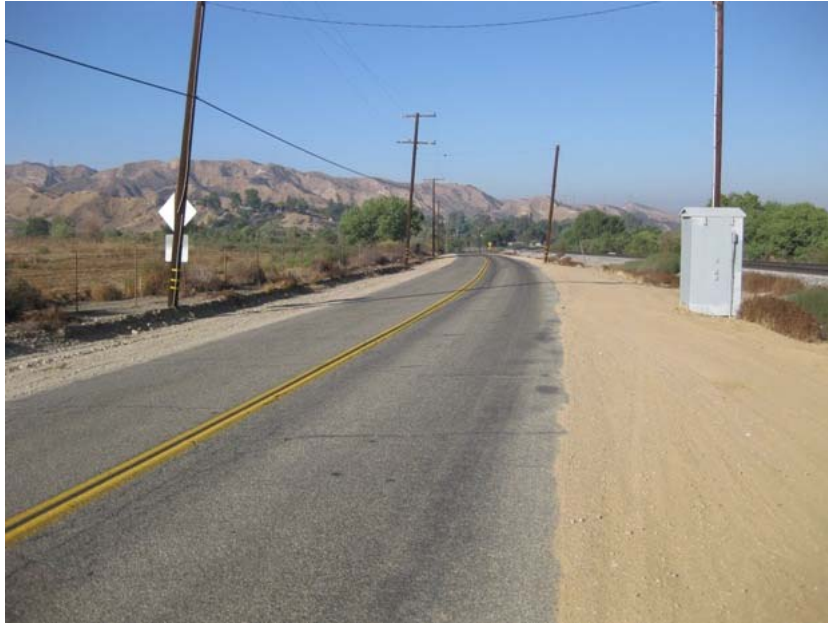
Figure 1: The water source for the primary elevated water tower will be a well-head at Fisherman's Retreat (in the background). The four-inch pipeline will lay on the dirt fringe of San Timoteo Canyon Road (left side) and run a distance of 2500 feet to the entrance gate area for the El Casco Substation. There is a small amount of riparian vegetation close to the well-head that will be avoided. The photograph faces westward.

On May 8, 2009, SCE submitted the Notice to Proceed (NTP) request for the construction of the El Casco Substation and associated HDD bore work and conduit installation under San Timoteo Creek, and construction of three adjacent towers. NTP #5 for the El Casco Substation NTP request was granted by CPUC on August 31, 2009. On October 1, SCE submitted a Variance Request to allow the installation of two water tanks and above ground water piping to facilitate watering activities at the El Casco Substation site. This request was approved by CPUC on October 9, 2009. Two conditions were added to the Water Towers and Pipelines request concerning protection of nearby riparian vegetation (see Figures 1 and 2).

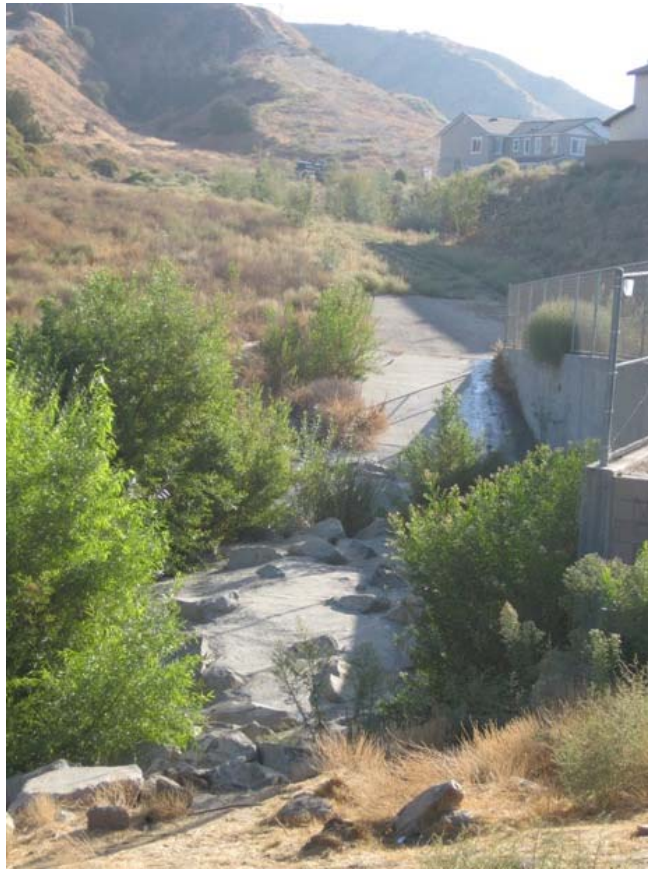
Figure 2: The water source for the auxiliary elevated water tower will be a hydrant at the end of a cul-de-sac in Fairway Estates housing development (in the background). The four-inch above-ground pipeline will cross a small creek and riparian area on the concrete skirting in the foreground. The pipe will connect to the water tower that will be situated at the edge of San Timoteo Canyon Road.

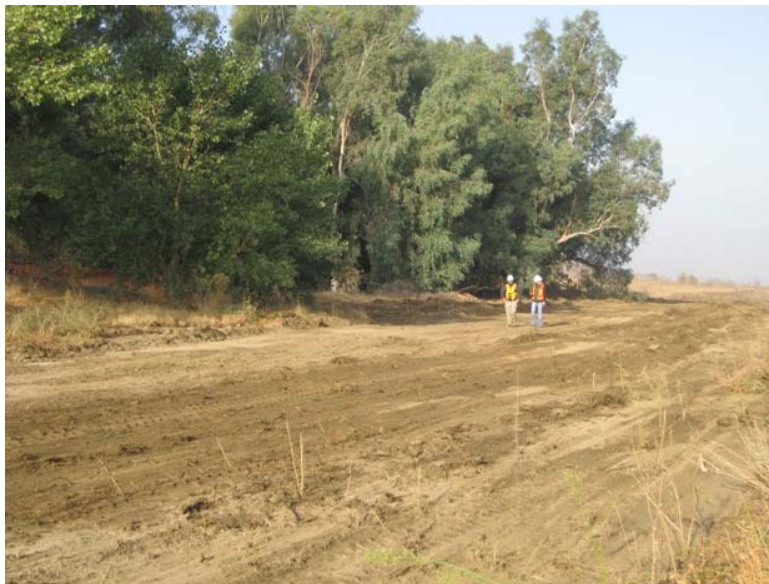
Figure 3: The grading of the new access road to El Casco Substation began during the subject week. California walnut and cottonwood trees at the edge of the grove in the background were avoided. The grading activity was accompanied by biological and cultural resource monitors at all times. The photograph faces westward.

During the subject week, grading of the new access road began (see Figure 3). The equipment and material yard and vehicle parking area next to the Substation site is currently functional (see Figure 4).

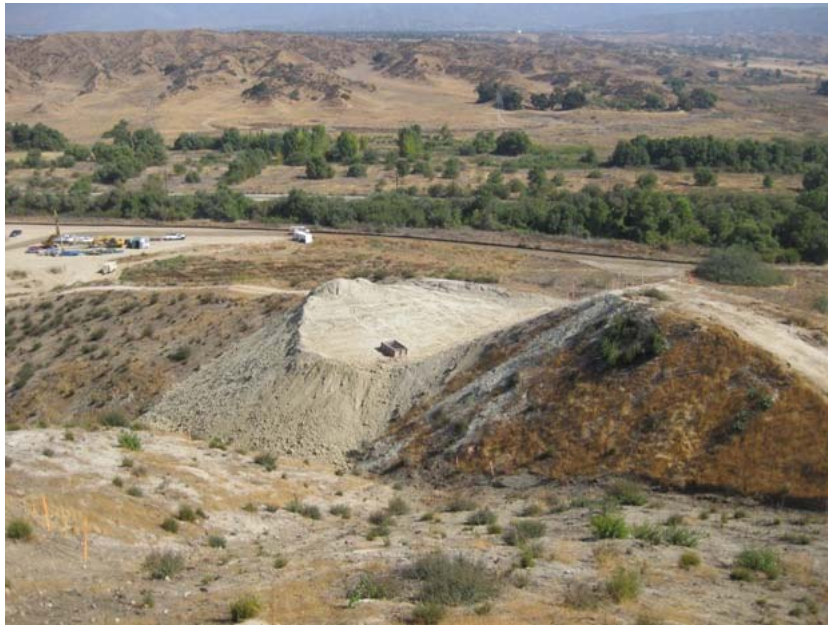
Figure 4: Terracing of the hillside began on Wednesday of the prior week. Fourteen terraces will be constructed in stair step fashion on two prominent ridges of the hillside. There will be four terraces on the ridge in view, and ten on another ridge to the left of the photograph. The staging area is in the distance on the left. The photograph faces northward.

Terracing of the hillside began on Wednesday of the prior week. Fourteen terraces will be constructed in stair step fashion on two prominent ridges of the hillside. There will be four terraces on one ridge, and ten on another (see Figure 4). The face of each terrace will be fitted with a tie-back wailer structure that will provide an anchor for an approximately 120 foot long cable placed in an oblique bore dug into the hill (see Figure 5). Each bore will have a concrete caisson at the bottom for the lower cable anchor. The cable will then be tightened to create tension between the upper wailer and the lower caisson. Geologists have determined there is a layer of clay within the hill that has approximately the same slope as the hillside. Building of the substation will require the removal of the toe of the slope. This removal may increase the likelihood of slippage of the material above the clay layer. The intended function of the tension cable anchor system is to put pressure on the clay layer and thereby prevent land slippage (see Figure 6).

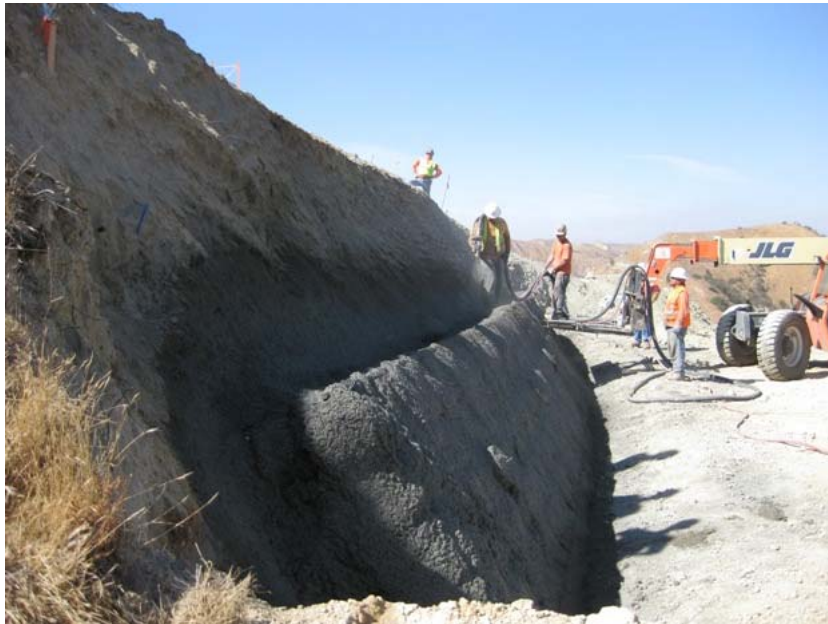
Figure 5: The face of each terrace will be fitted with a tie-back structure that will provide an anchor for an approximately 120 foot long cable placed in an oblique bore dug into the hill.

During the subject week, the uppermost terrace on each ridge was fitted with tie-backs that were shotcreted in place.

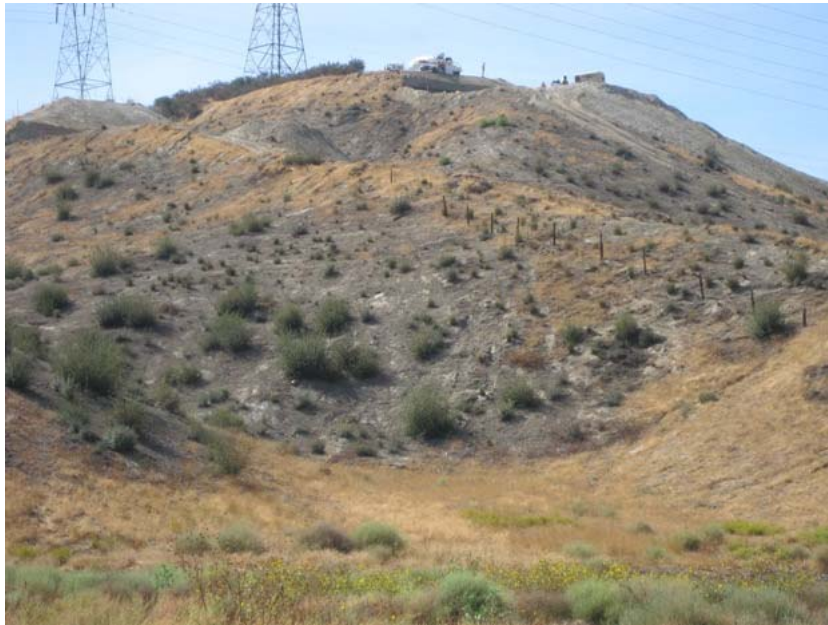
Figure 6: Geologists have determined there is a layer of clay within the hill that has approximately the same slope as the hillside. Building of the substation will require the removal of the toe of the slope. This removal may increase the likelihood of slippage of the material above the clay layer. The intended function of the tension cable anchor system is to put pressure on the clay layer and thereby prevent land slippage. The photograph faces southeastward.

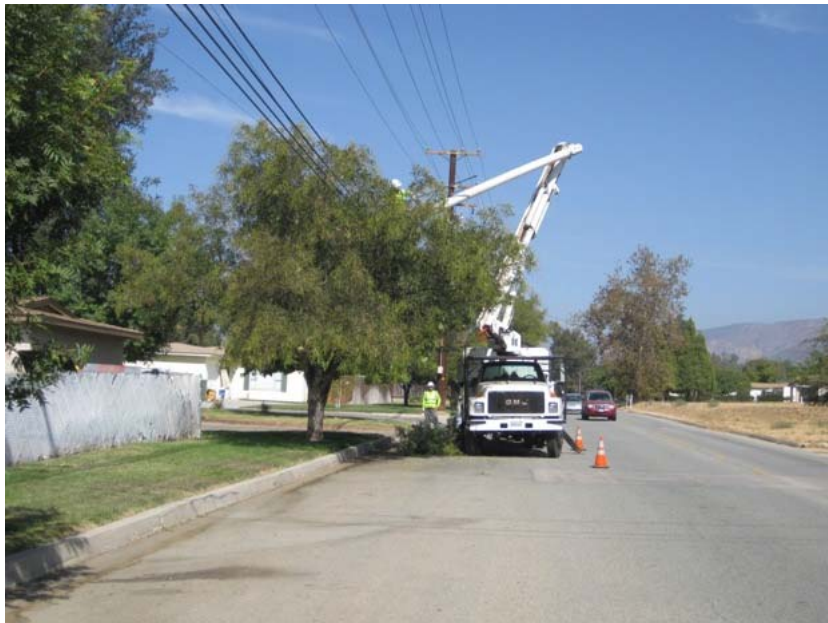
Figure 7: During the subject week, tree-trimming for FOC installation occurred on Bryant Street in Yucaipa. A biological monitor (to the left of the truck) accompanied the crew at all times. The photograph faces southward.

The tree-trimming crew completed the Mentone Substation to Zanja Substation route during the subject week, and proceeded southward through Yucaipa on Juniper, Bryant, Date, Douglas, Avenue E, Wildwood streets to Avenue H (see Figure 7). On Monday of the following week, they will pass the Yucaipa Substation and proceed westward towards Live Oak Canyon Road in Redlands.

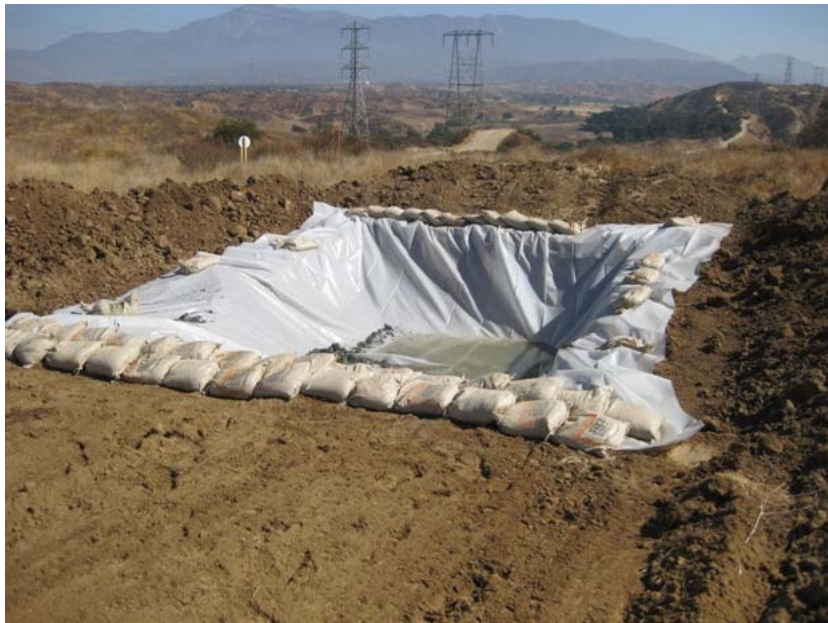
Figure 9: A concrete wash basin was built on the top of the hill at El Casco Substation site in order that concrete trucks supplying the terrace work can be cleaned before the residue concrete dries inside the trucks. The photograph faces eastward.

- A concrete truck wash-out basin was established on the top of the hill where terracing occurred (see Figure 9). This basin is located on top of the hill because the remoteness of the concrete placement activity would cause the residual concrete in the empty trucks to dry before they were able to reach the equipment yard below.

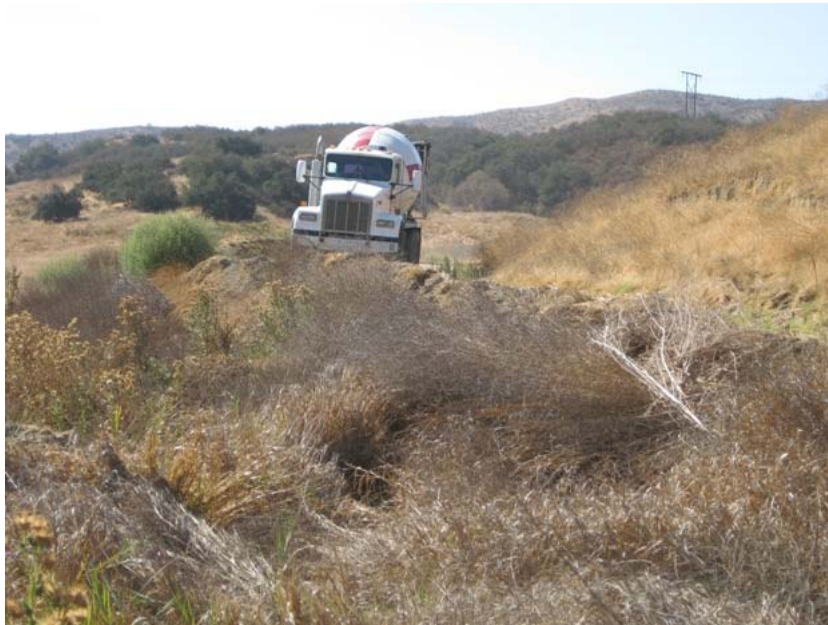
Figure 10: Access roads south of the El Casco Substation site are being used to reach the top of the hill within the Substation site with vehicles, equipment, concrete trucks, and water trucks. These are pre-existing roads. There will be no disturbance of natural habitat off the roads. The roads are being watered regularly for dust control. The photograph faces eastward.

- The contractor at El Casco Substation is using access roads south of the Substation site to reach the top of the hill within the Substation site with vehicles, equipment, concrete trucks, and water trucks (see Figure 10). These are pre-existing roads. There will be no disturbance of natural habitat off the roads.
