**PROJECT MEMORANDUM
SCE EL CASCO SYSTEM PROJECT**

To: Lynne Mosley, CPUC
From: Vida Strong, Aspen Project Manager
Date: November 10, 2009
Subject: Report #13: November 1, 2009 – November 7, 2009

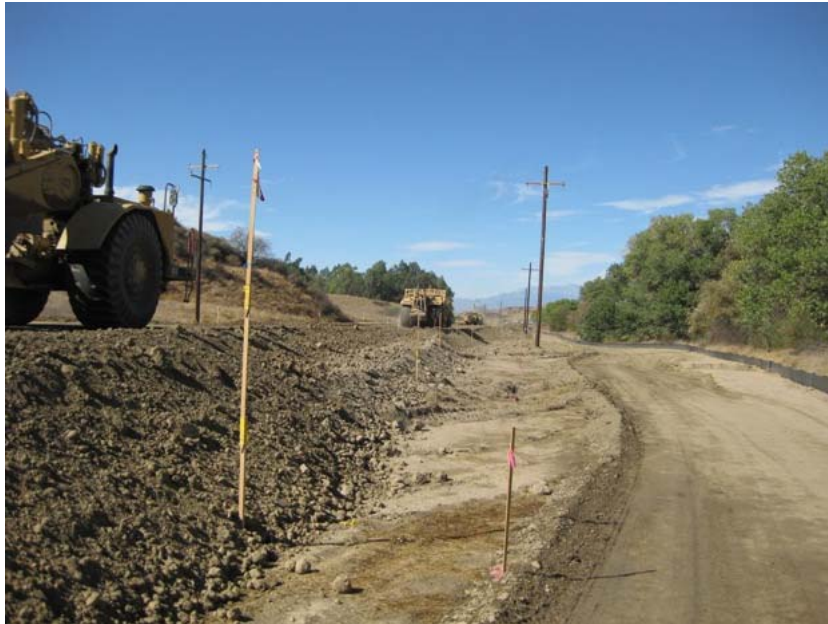
Figure 1: During the subject week, grading of the new access road continued. The new access is being raised several feet above the original ground level, and the level of the pre-existing access road on the right. The photograph faces westward.

During the subject week, grading of the new access road continued. Five cottonwood trees and one eucalyptus tree were removed during the subject week to allow for the construction of a drain on the south side of the road. The new access road is being raised several feet above the original ground level (see Figure 1). The material for the heightened road is being hauled in from the over-excavation area of the substation site (see Figure 2). This area is being over-excavated to allow the placement of a more firm base for the substation.

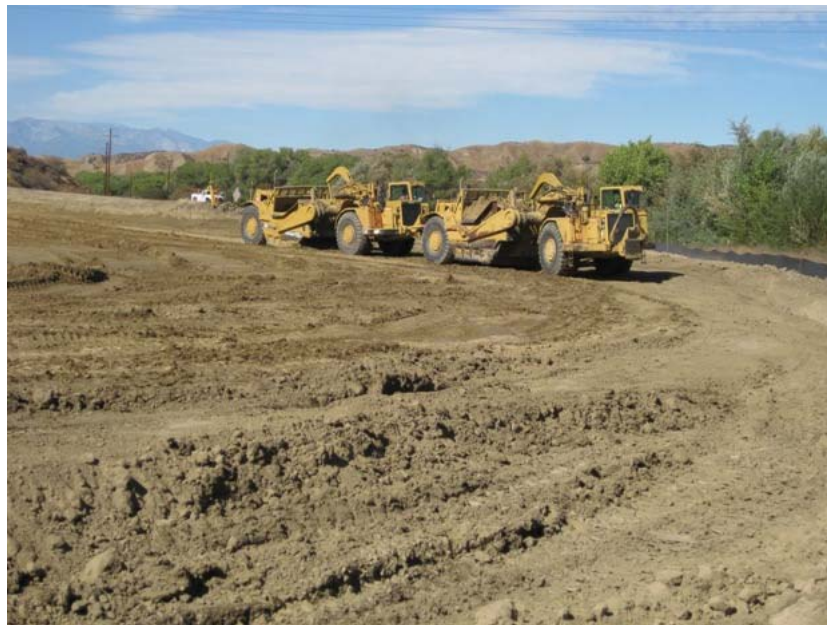
Figure 2: The material for the heightened road is being hauled in from the over-excavation area of the substation site. This area is being over-excavated to allow the placement of a more firm base for the substation. The photograph faces northwestward.

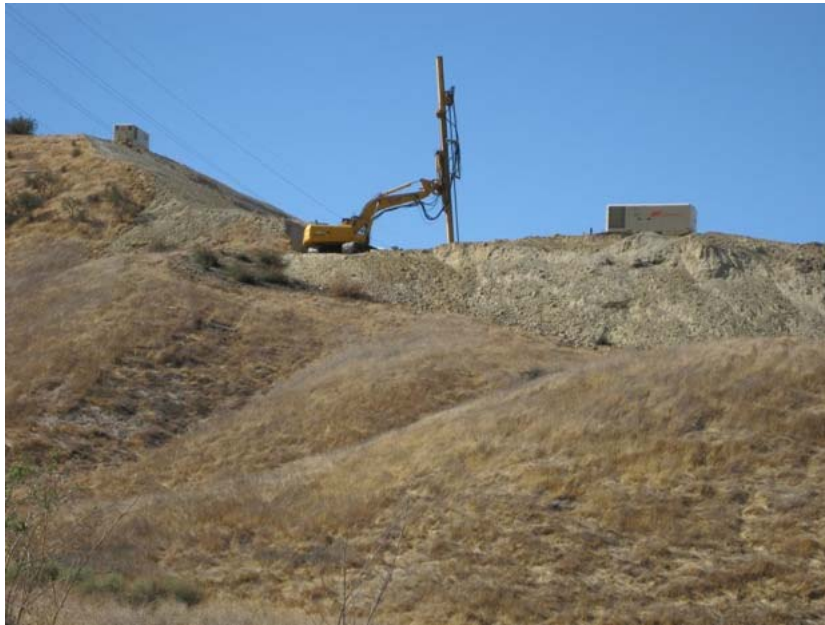
Figure 3: During the subject week, the second terrace on each of the two ridges was excavated. Construction of the tie-in wailers and boring of the anchor holes at the second terraces began. An anchor hole is being bored at terrace N. The tie-ins at Terrace M, above it, have been backfilled. The second, higher ridge is out of sight. Its terraces begin with A at the top. Terrace B is under construction presently. The photograph faces southeastward.

Terracing of the hillside continued during the subject week. Geologists have determined there is a layer of clay within the hill that has approximately the same slope as the hillside. Building of the substation will require the removal of the toe of the slope. This removal may increase the likelihood of slippage of the material above the clay layer. A tension cable anchor system is being constructed on and into the hillside

to put pressure on the clay layer and thereby prevent land slippage. Fourteen terraces will be constructed in stair step fashion on two prominent ridges of the hillside. There will be four terraces on the shorter ridge, and ten on another higher ridge. The face of each terrace will be fitted with a tie-back wailer structure that will provide anchors for several approximately 120-foot-long cables per wailer placed in oblique bores dug into the hill. Each bore will have a concrete caisson at the bottom for the lower cable anchor. Each cable will then be tightened to create tension between the upper wailer tie-back and the lower caisson. The terrace will then be backfilled, and the operation moved to the next lower terrace. It is estimated that approximately two hundred anchors will be constructed.

During the subject week, the second terrace on each of the two ridges was excavated. Construction of the tie-in wailers and boring of the anchor holes at the second terraces began (see Figure 3).

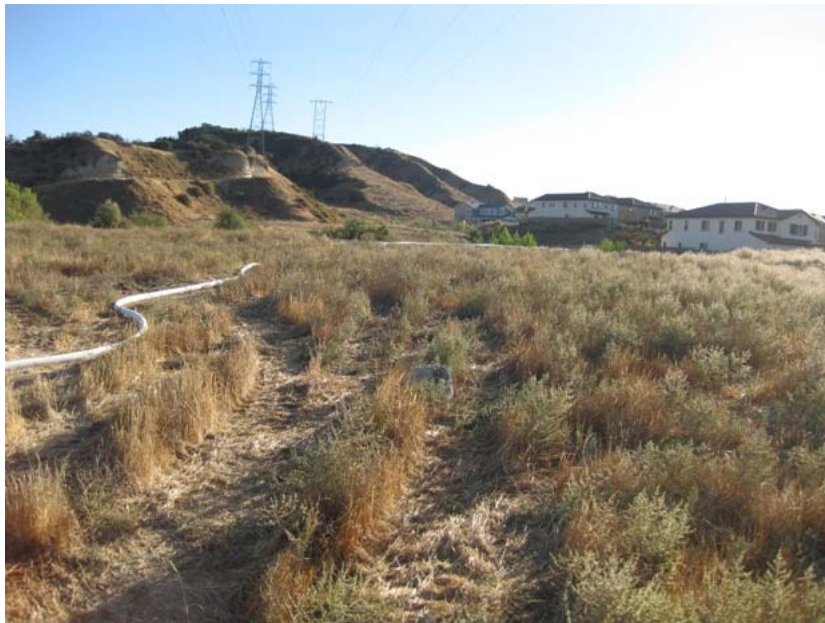
Figure 4: The water for the second water pipeline/tower system for the El Casco Substation construction is piped from a hydrant in an adjacent housing development in the distance. The water tower is behind the photograph, which faces northeastward.

- The second water pipeline/tower system for the El Casco Substation construction water needs was constructed and in operation by the subject week. The tower area is adjacent to San Timoteo Canyon Road. The water is piped from a hydrant in an adjacent housing development (see Figure 4). The area around the tower has been fenced off including a gate (see Figure 5). A shaker plate and a gravel loop driveway for the water truck have been built to reduce soilage on the public road. Silt fencing also is in place to prevent runoff.

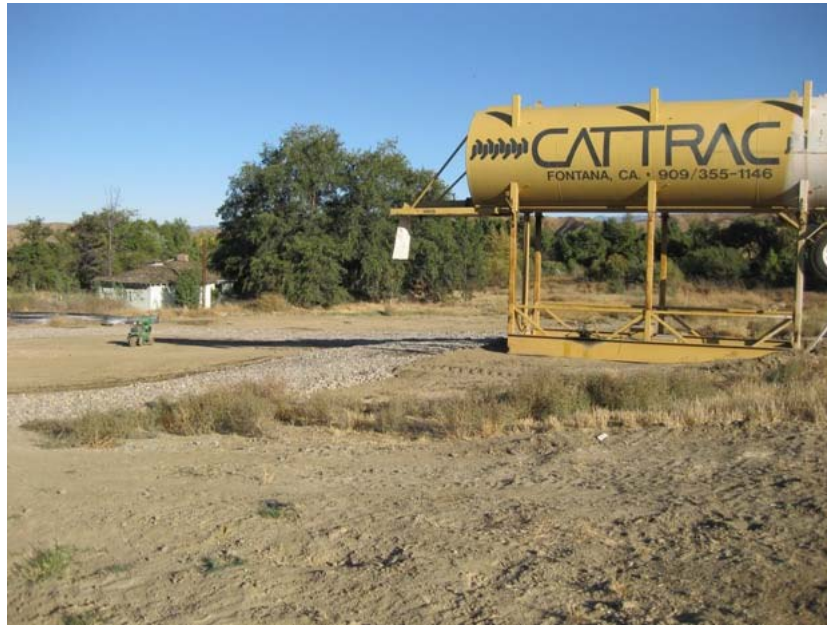
Figure 5: The second water tower is adjacent to San Timoteo Road (to the left of the photograph). The tower area has been fitted with a shaker plate, a gravel loop road for water loading, a perimeter fence and gate, and a silt fence for run off prevention. The photograph faces westward.
