**PROJECT MEMORANDUM  
SCE EL CASCO SYSTEM PROJECT**

**To:** Lynne Mosley, CPUC  
**From:** Vida Strong, Aspen Project Manager  
**Date:** December 9, 2009  
**Subject:** Report #16: November 22, 2009 – December 5, 2009

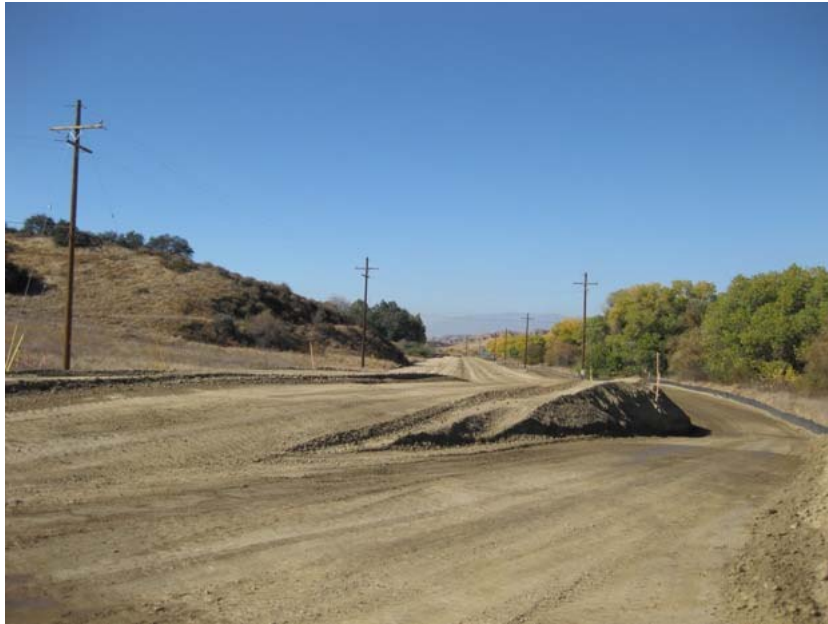
**Figure 1:** The utility line installation for the construction site field office trailers at the El Casco Substation site was completed by SCE FOC crews during the second week of the subject period. The new access road is on the left; the pre-existing road is on the right. The photograph faces westward.

Rough grading of the new access road has been completed. The new access road has been raised several feet above the original ground level. The material for the heightened road was hauled in from the over-excavation areas of the substation site. The notch in the center of the road will be filled with gravel, and may or may not be paved. The utility line installation for the construction site field office trailers was completed by SCE FOC crews during the second week of the subject period (see Figure 1).

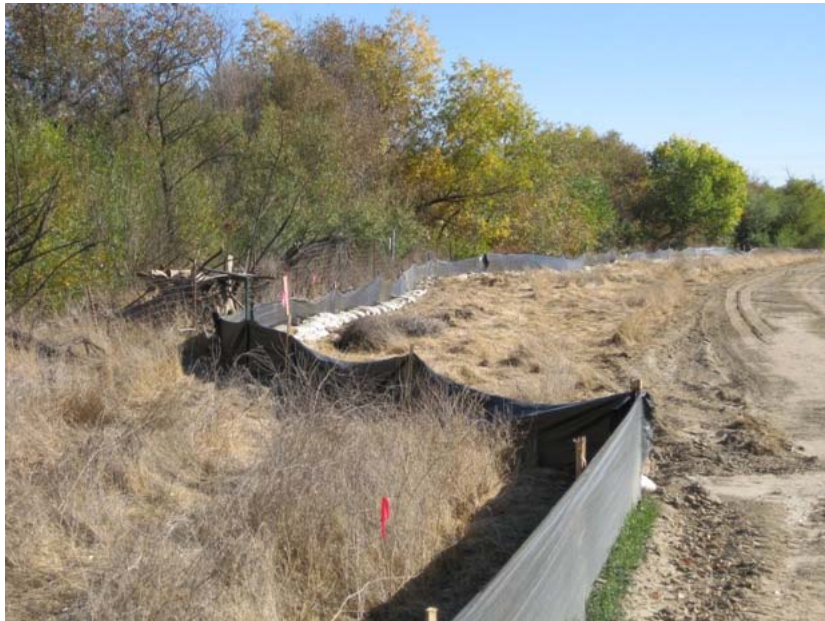
**Figure 2:** During the subject period, the silt fence previously located at the northern edge of the pre-existing access road was moved closer to the San Timoteo Creek bank adjacent to the substation site. Note the sand bags at the base of the fencing for additional water runoff containment. The photograph faces eastward.

During the subject period the CPUC EM discovered that the silt fence previously located at the northern edge of the pre-existing access road was moved closer to the San Timoteo Creek bank adjacent to the substation site. SCE provided that this was in order to allow space for over-excavation as shown in the Plans (see Figure 2). SCE also provided that the Project permits allow for the movement; however, copies of the permits, namely the CDFG Streambed Alteration Agreement and the USACE 404 permit, have not yet been provided to the CPUC for verification.

- During the subject period the CPUC EM discovered that the silt fence previously located at the northern edge of the pre-existing access road was moved closer to the San Timoteo Creek bank adjacent to the substation site. SCE provided that this was in order to allow space for over-excavation as shown in the Plans (see Figure 2). SCE also provided that the Project permits allow for the movement; however, copies of the permits, namely the CDFG Streambed Alteration Agreement and the USACE 404 permit, have not yet been provided to the CPUC for verification.

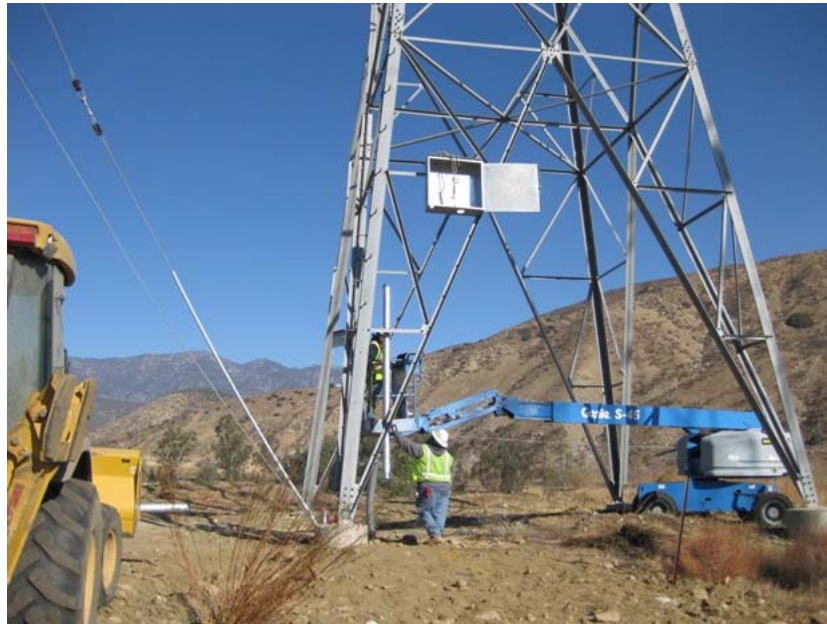
**Figure 3:** Recently installed underground conduit was connected to Tower M12T2 via a steel riser and a 3x3 box at the north end of the Banning to Tower M17T2 FOC segment on Bluff Road. The photograph faces northward.

A PAR underground conduit crew connected the underground conduit to Tower M12T2 via a steel riser at the north end of the Banning to Tower M17T2 FOC segment on Bluff Road in Banning (see Figure 3). They were accompanied by a biological monitor.

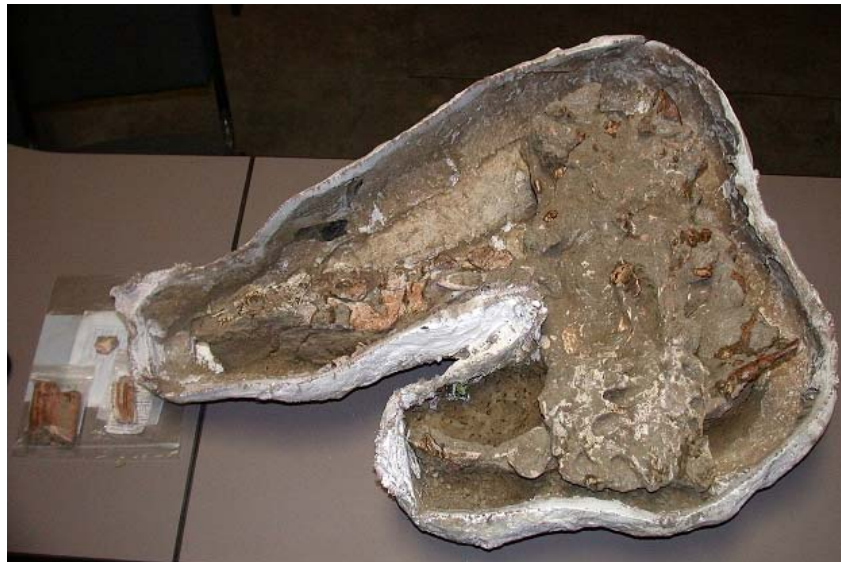
**Figure 4:** The fossilized skull of a pre-historic ground sloth was discovered, processed and recovered from excavation at the El Casco Substation site. Note the plaster casing that was placed around the skull and a protective rock layer prior to movement.

- During the subject period, fossils have continued to be located, recovered, and processed at the El Casco Substation site. The fossils have been found during excavation in one of the over-excavation pits at the toe of the eastern ridge and in some of the hillside terraces. The fossils found so far include, but are not limited to, horse/camel, sloth, birds, rodent teeth, and plant material. The fossils are within the San Timoteo Formation and thought to be between 0.9 and 6.1 million years old. The San Timoteo Formation is known to be particularly rich in significant fossil resources from the medial Pleistocene and the later Pliocene epochs. This formation, found throughout the San Timoteo Badlands, spans three of the four most recent North American Land Mammal "ages." No other terrestrial sequence in North America records relatively continuous deposition over this interval of time. The discovery and recovery of a Harlan's ground sloth skull and associated bones represents the first record of an early Pleistocene (1.3 million years ago) sloth of this species from California (see Figure 4). The sloth skull will be of significant scientific value in the study of both evolutionary and geographic patterns in prehistoric sloths. Up to three paleontological monitors were on site during the reporting period. All excavation activity, especially in the areas containing the San Timoteo Formation, was continually monitored. Also material samples were collected from the terrace excavations and from all areas where fossils have been discovered. These samples were then processed by wet screening to uncover small and difficult to detect fossil material. These activities will continue as long as construction activity uncovers material within the fossiliferous San Timoteo Formation. When fossils were discovered, each area was immediately roped off, with construction activity temporarily diverted to other areas, while the paleontologists packaged and removed the fossils. All parties, including the monitors, SCE staff, and the contractor have worked together to facilitate the recovery of fossils, and to minimize construction delay. CPUC/Aspen personnel have been kept informed of events as they happened. It is expected that fossil discovery and removal will continue for some time at the site. To date, the monitoring of construction activities and treatment of fossil discoveries have followed the El Casco Paleontological Treatment Plan.

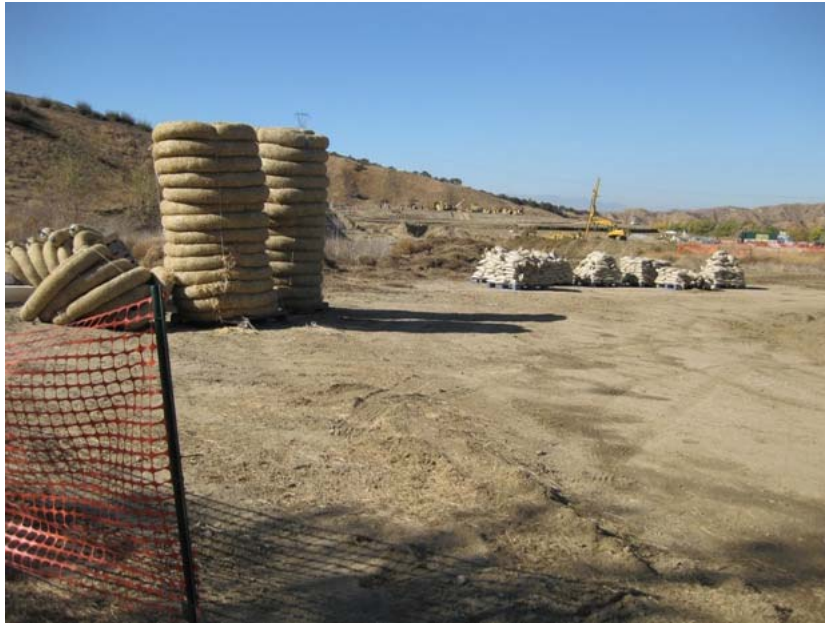
**Figure 5:** Several significant storm events are predicted beginning Monday of the following week. At El Casco Substation site several measures have been implemented or are ready to be implemented including the placement of straw wattling and sand bags. The photograph was taken at the substation site and faces southwestward.

- Several significant storm events are predicted beginning Monday of the following week. At El Casco Substation site the silt fencing along the pre-existing access road has been reinforced with sand bags. Also straw wattling is on site and will be placed on the cleared hillsides SCE has prepared for the potential of erosion and siltation being generated by these storms together with the recent grading activity at the site (see Figure 5). In addition, sand bags have been placed near the top of the terraced area to direct runoff water away from the cleared hillsides.
