**PROJECT MEMORANDUM  
SCE EL CASCO SYSTEM PROJECT**

**To:** Lynne Mosley, CPUC  
**From:** Vida Strong, Aspen Project Manager  
**Date:** April 7, 2010  
**Subject:** Report 23: February 21, 2010 – March 20, 2010

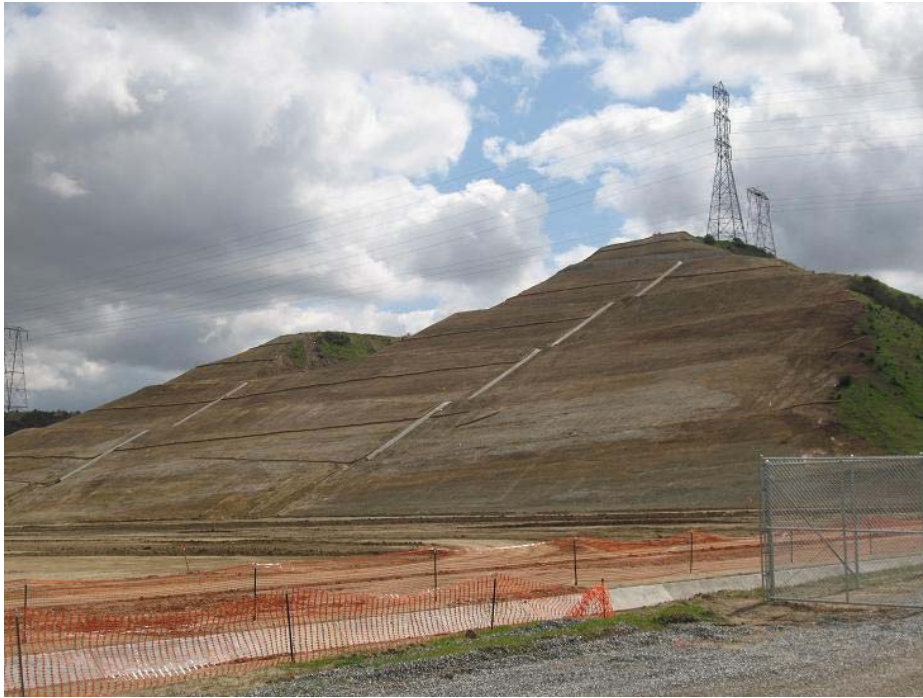
**Figure 1:** View of completed terraced slope at El Casco Substation. Note the newly installed V-ditches. The photograph faces southeast.

The tension cable anchor systems have been completed on the four terraces on the eastern ridge to put pressure on an underlying clay layer and thereby prevent land slippage. The anchor systems on the ten terraces on the western ridge have also been completed. Excavation of the toe of the western slope was completed with scrapers during the subject period. The installation of V-ditches on the terraces was nearly completed (see Figure 1). Application of soil stabilizer to the terraced slopes and various erodible slopes throughout the substation was also applied.

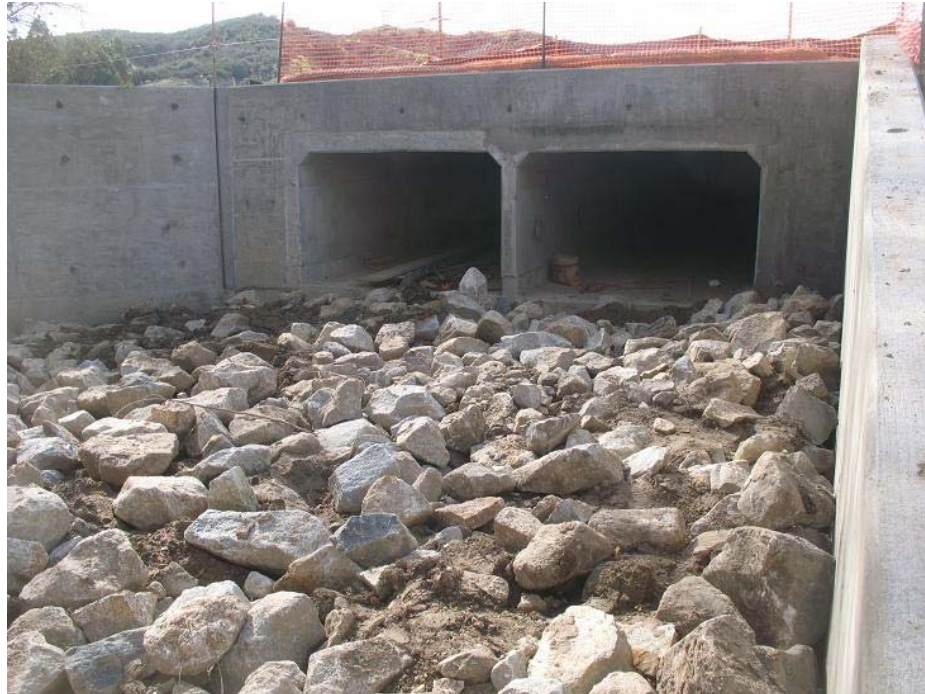
**Figure 2:** View of completed box culvert outlet near El Casco Substation entrance. The photograph faces southward.

Work continued on the box culvert across the access road near the entrance gate. The outlet of the box culvert was completed early in the subject period and the inlet to the box culvert was completed near the end of the subject period (see Figures 2 & 3). The culvert was back filled and was nearly complete by the end of the subject period with the exception of the tie-in with the V-ditch adjacent to the road.

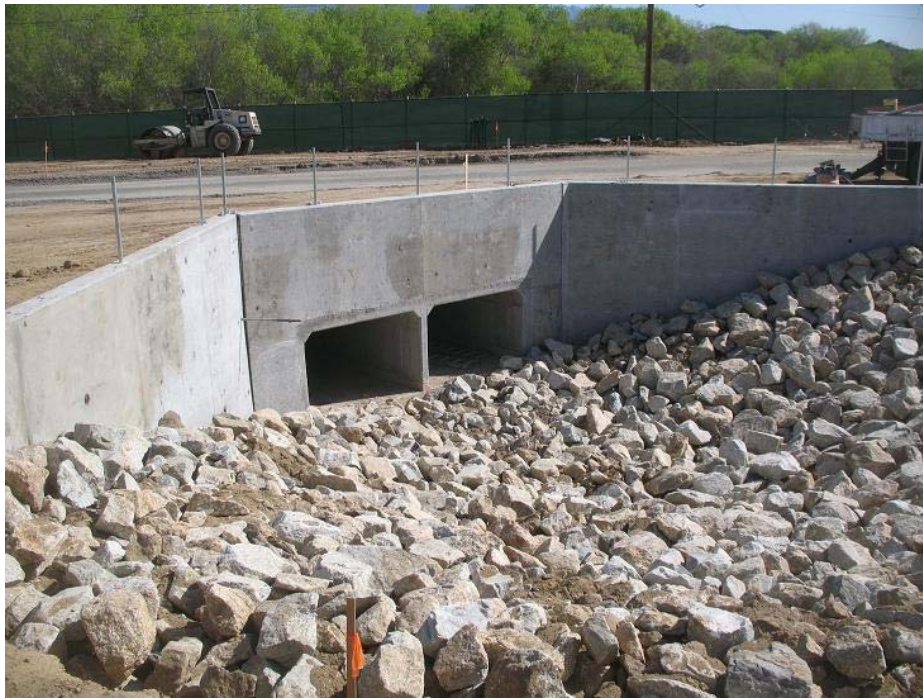
**Figure 3:** View of completed box culvert inlet near El Casco Substation entrance. The photograph faces northward.

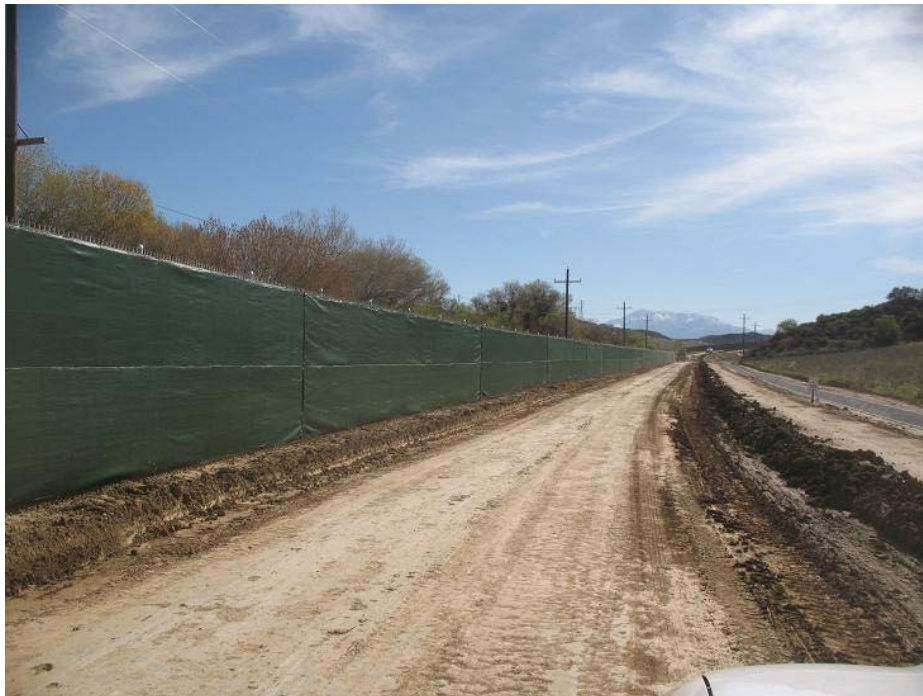
**Figure 4:** View of completed chain link fencing along the access road. The photograph faces eastward towards the substation site.

Installation of the chain link fencing along the access road and substation pad continued during the subject period. Shade cloth and the sound barrier were also being installed (see Figures 4 & 5).

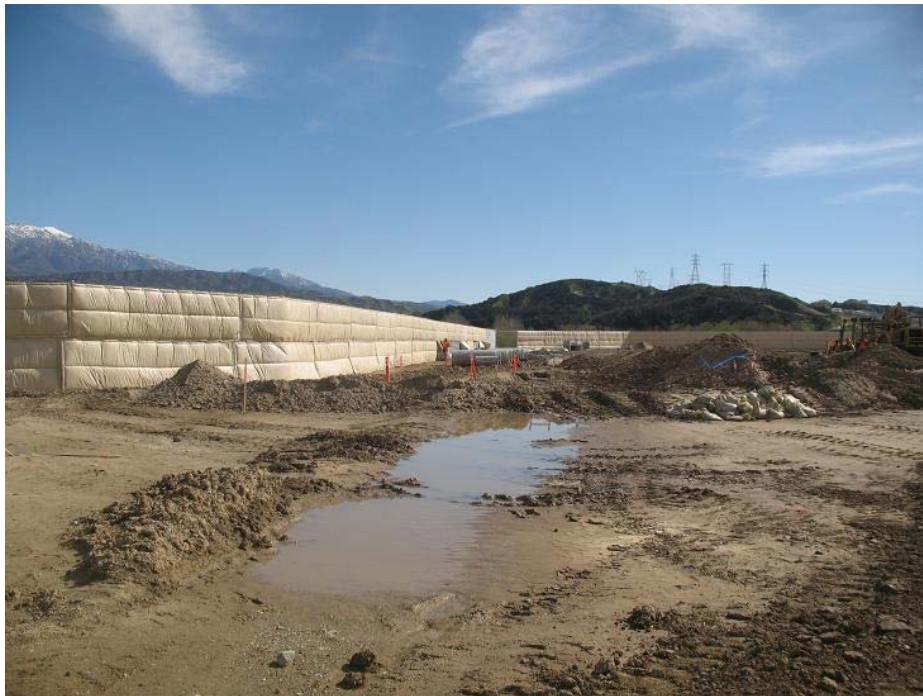
**Figure 5:** View of the nearly completed chain link fencing around the El Casco Substation pad. The photograph faces northeastward.

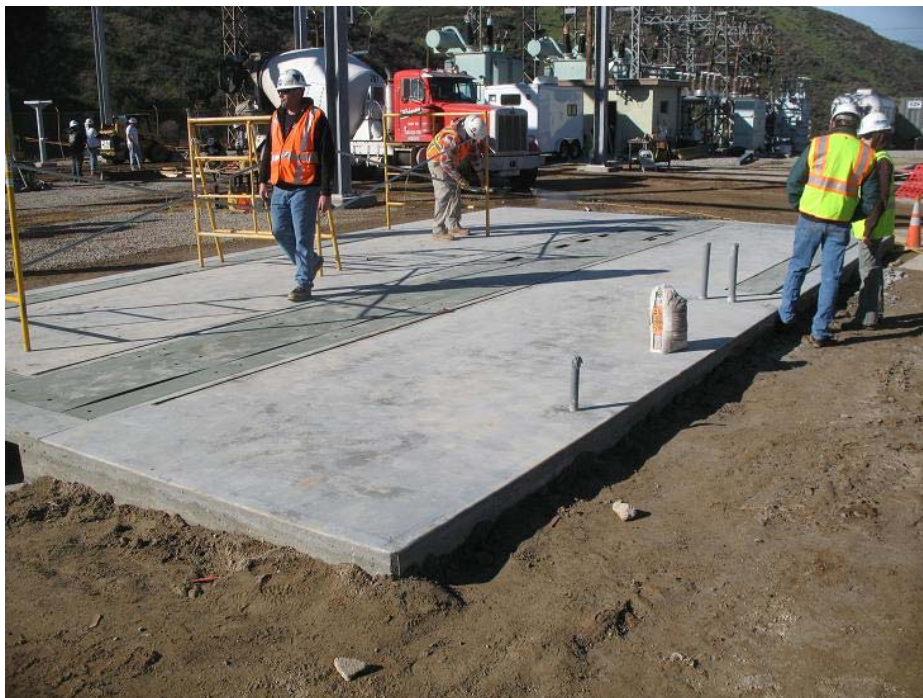
**Figure 6:** View of completed MEER building foundation at the Zanja Substation. The photograph faces southwestward

The foundation for the new MEER building was completed during the subject period (see Figure 6). The new steel rack and MEER building were also completed (see Figure 7). Work is continuing on the installation of the new electrical components.

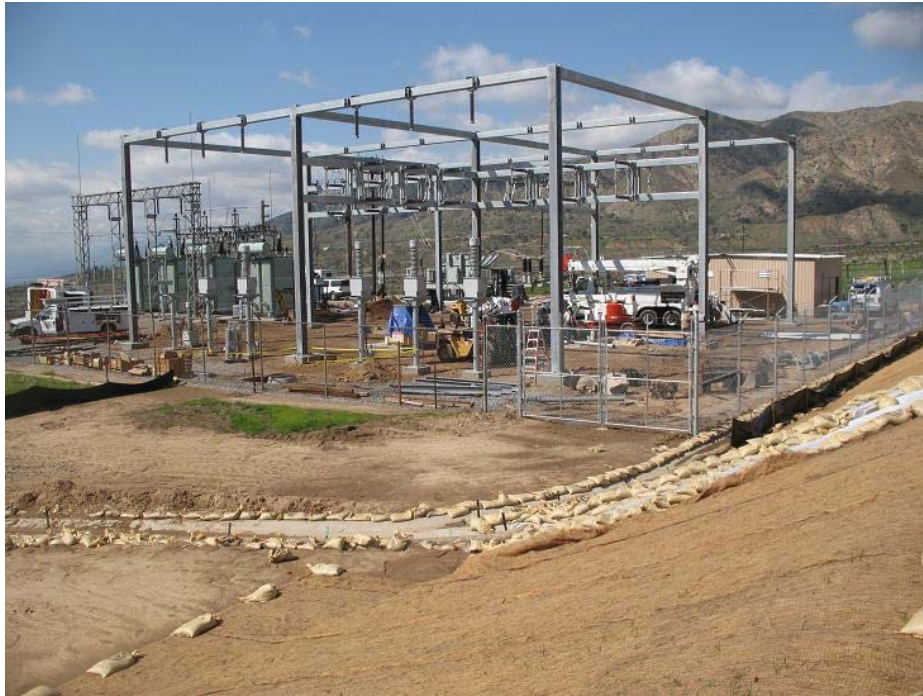
**Figure 7:** View of the completed rack and MEER building at the Zanja Substation. The photograph faces northwestward.
