**PROJECT MEMORANDUM
SCE EL CASCO SYSTEM PROJECT**

To: Lynne Mosley, CPUC
From: Vida Strong, Aspen Project Manager
Date: October 27, 2010
Subject: Report 38: October 10, 2010 – October 24, 2010

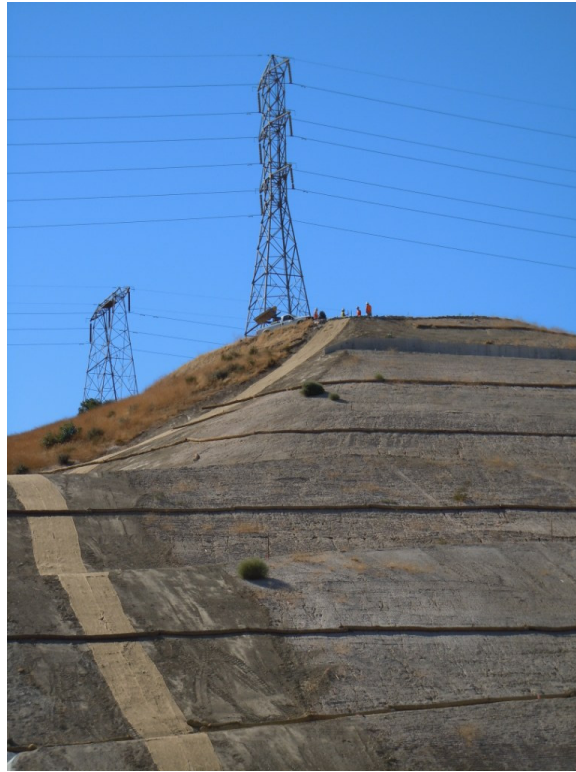
During the subject period, telephone conduit was installed through a trench in the hill on the southern portion of the site (see Figure 1). Additionally, the transfer of 20,000 gallons of oil into two 220 kV transformers was completed and into two 115/12 kV transformers began.

Figure 1: At the El Casco Substation site, crews worked on installing telephone conduit in the southern slope of the site. Netting was put in place to prevent erosion.

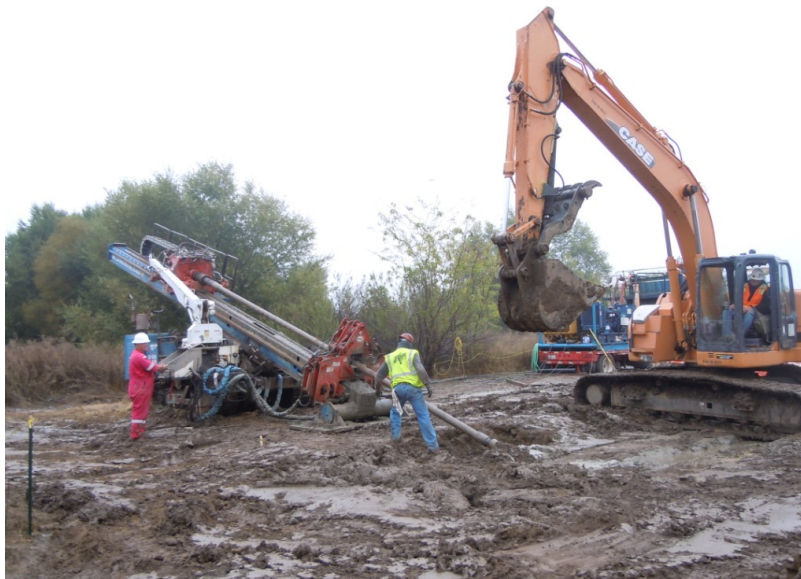
Horizontal directional drilling (HDD) work continued (see Figure 2). Herman-Weissker, the HDD contractor, finished the first of three 36” bore casings.

Figure 2: Along San Timoteo Canyon Road, the drilling rig at the bore entry side.

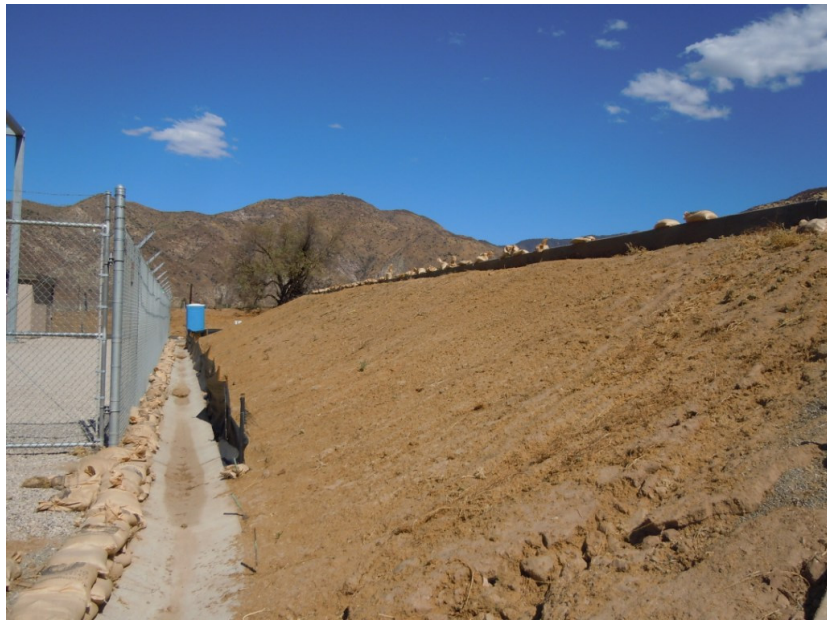
Erosion control hydroseeding with a native plant mix was applied on September 17th. The hydroseeded area will be watered every 3 days. The CPUC EM visited the site on October 13th and saw no germination (see Figure 3).

Figure 3: At the Zanja Substation site no germination was evident at one of the hydroseeded areas. The photo is taken facing north.

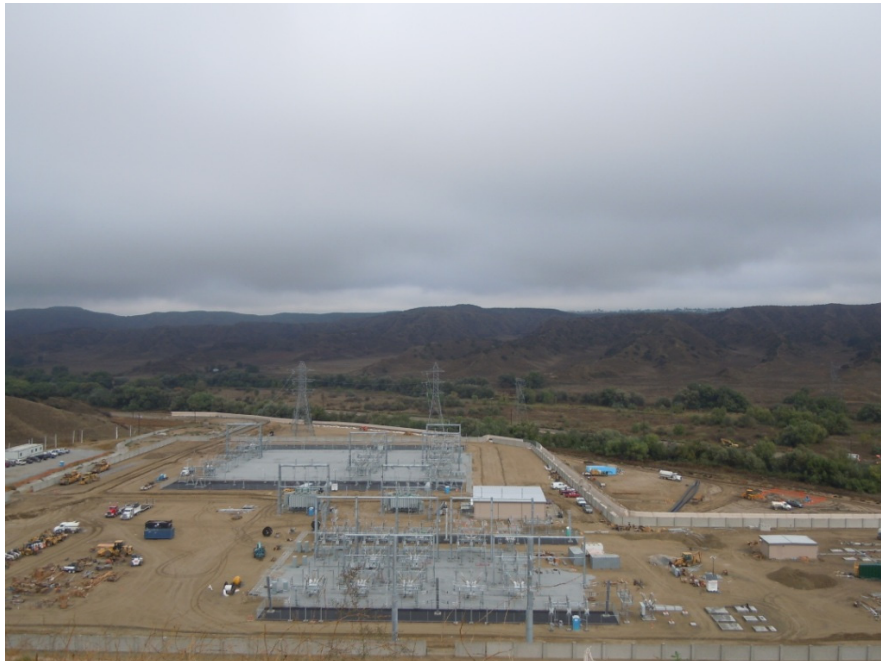
Figure 4: At the El Casco Substation site, a view of the substation from atop the slope at the southern end of the site. The three new 220 kV towers are visible in the background as well as the HDD bore exit side.
