**PROJECT MEMORANDUM
SCE EL CASCO SYSTEM PROJECT**

To: Lynne Mosley, CPUC
From: Vida Strong, Aspen Project Manager
Date: January 28, 2010
Subject: Report 42: December 19, 2010 – January 22, 2011

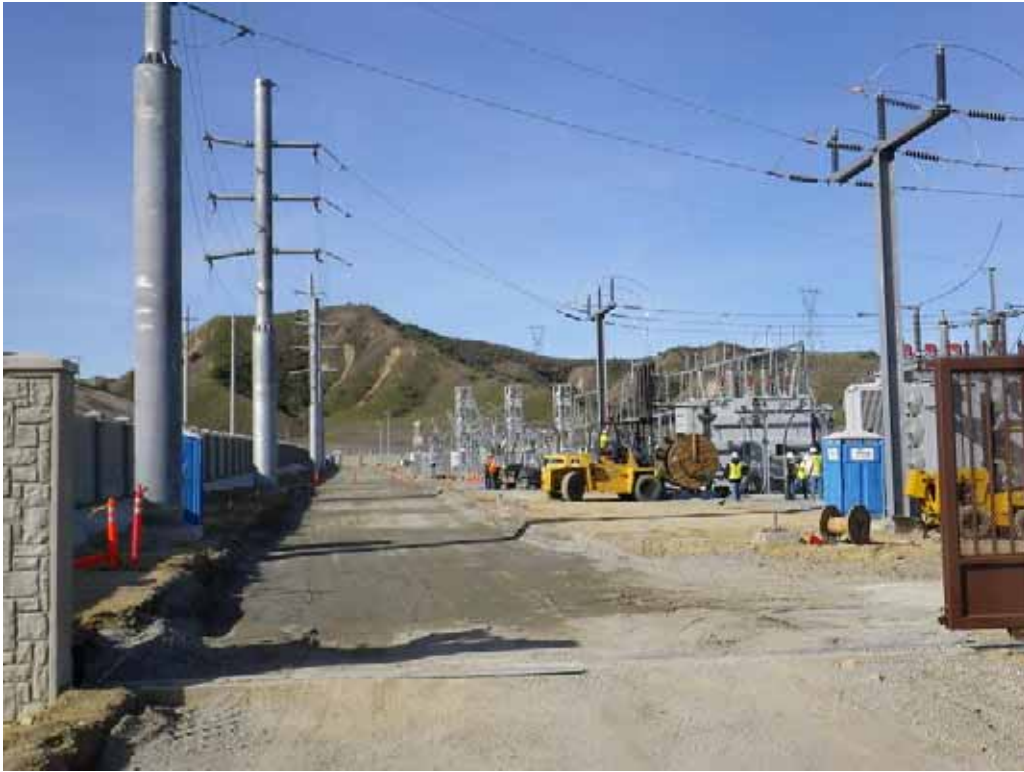
During the subject period, limited work on the substation pad continued. Crews continued the testing of electrical equipment and conducting various activities within the substation limits (see Figure 1). Crews repaired portions of the access road that were damaged during the heavy rain event that occurred during the subject period and crews also paved the main access road to the substation (see Figure 2). Crews have not yet paved the access roads within the substation walls. During paving activities, vehicles used the old access road to enter the substation. The perimeter walls have been completed and access into the substation is limited to three points.

Figure 1: View of activities with the El Casco Substation. The photograph faces west.

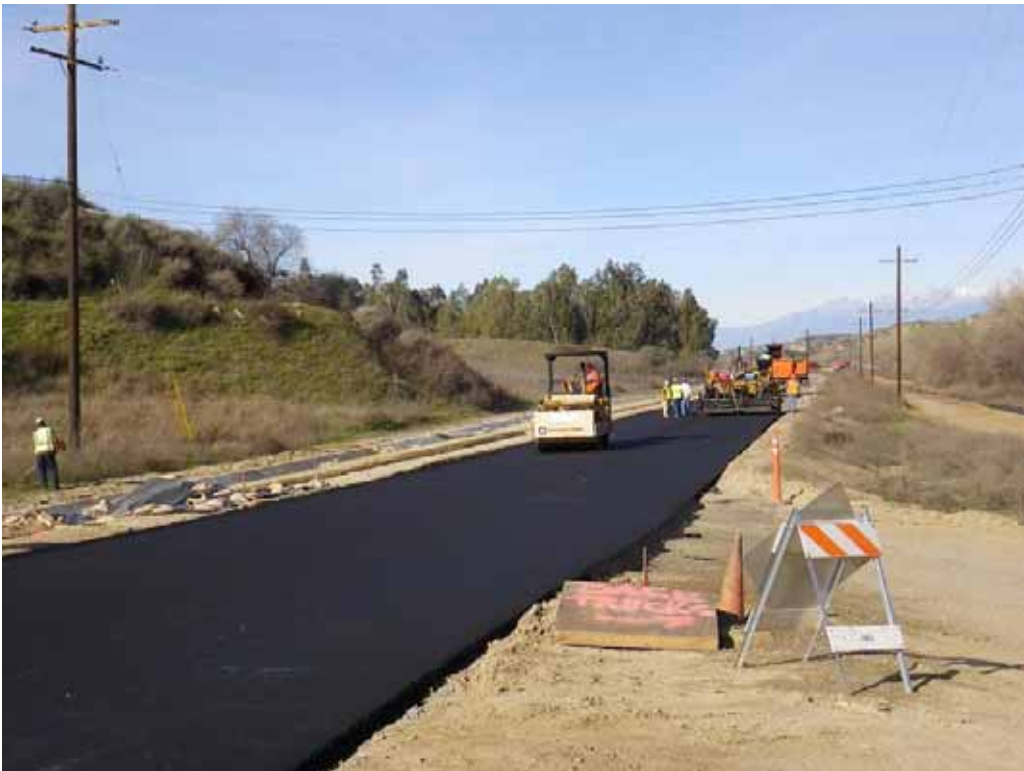
Figure 2: View of paving activities at the El Casco Substation access road. The photograph faces west.

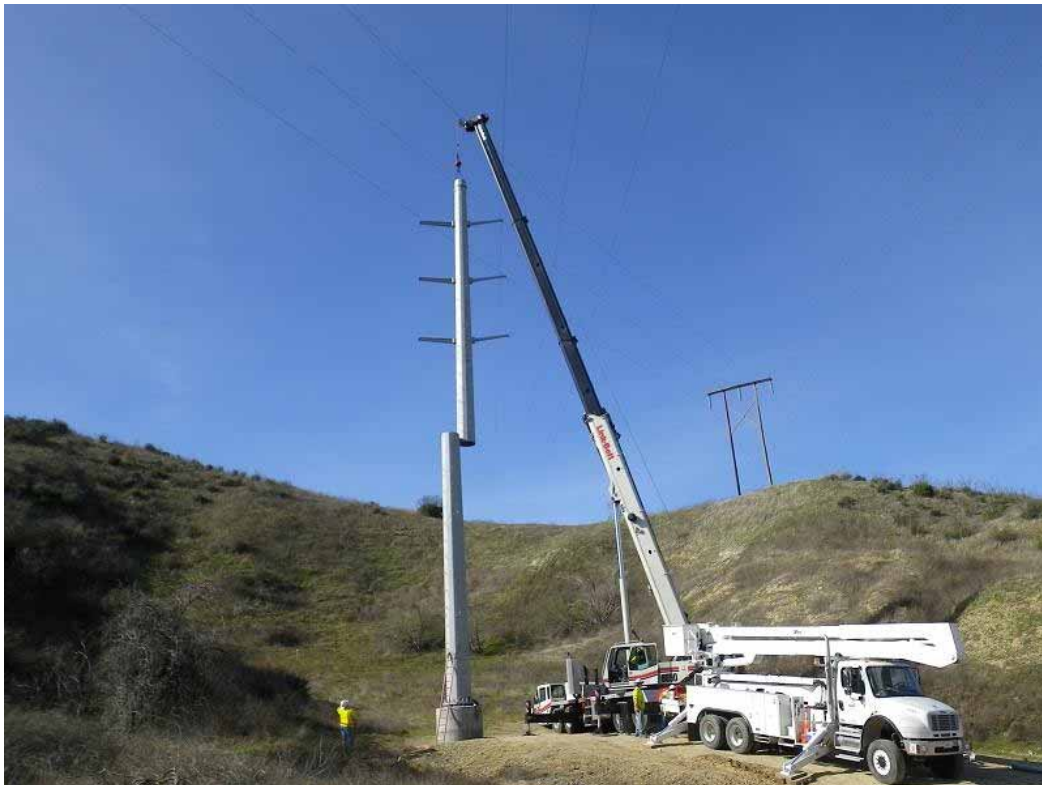
Notice to Proceed #8 for construction of Segments 5 through 8 was issued by CPUC on July 19th. Work on Segment 8 began on October 26th. All pole foundations on Segment 8 have been completed and installation of tubular steel poles is underway (see Figures 3 & 4).

Figure 3: View of tubular steel poles being installed just south of the El Casco Substation. The photograph faces southwest.

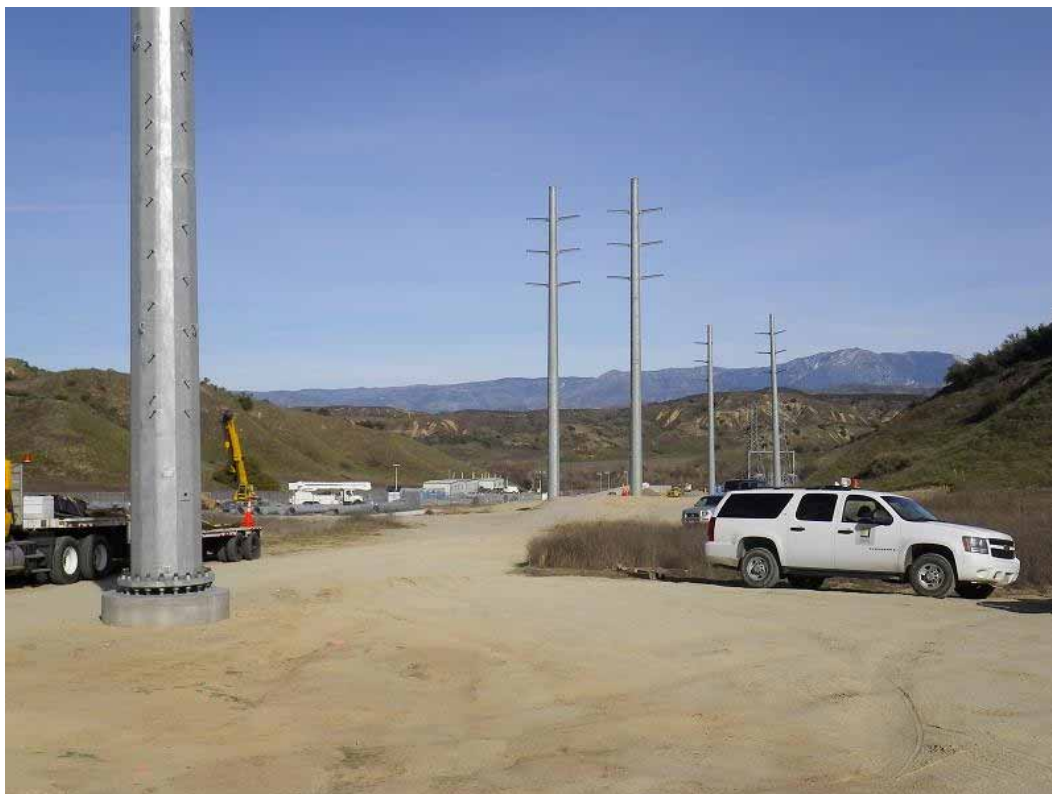
Figure 4: View of recently installed tubular steel poles just south of the El Casco Substation. The photograph faces north.
