**PROJECT MEMORANDUM
SCE EL CASCO SYSTEM PROJECT**

To: Lynne Mosley, CPUC
From: Vida Strong, Aspen Project Manager
Date: March 18, 2011
Subject: Report 45: February 20 – March 12, 2011

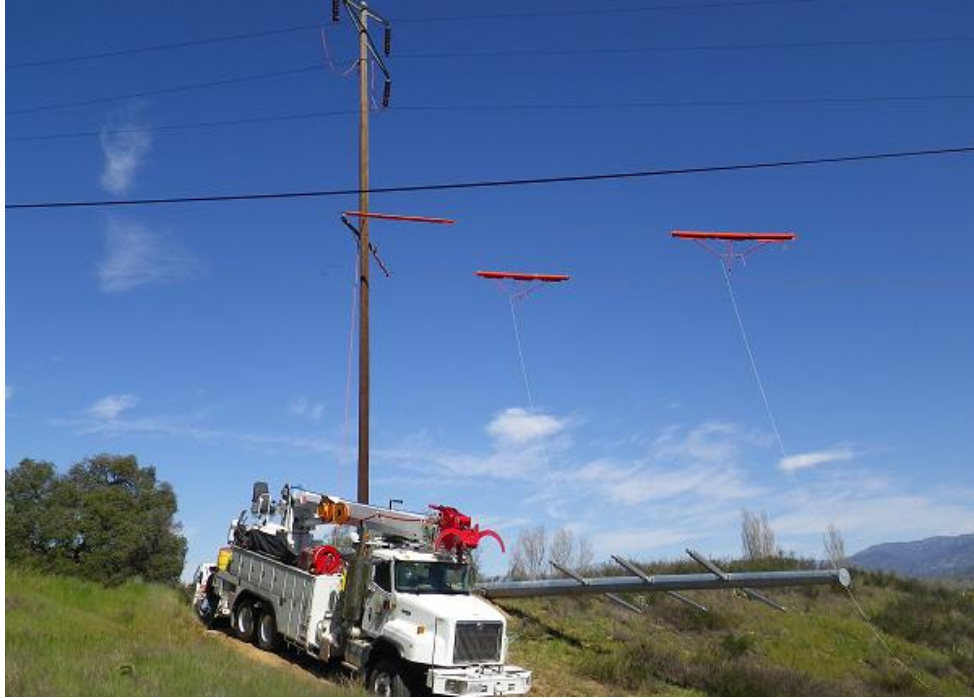
Figure 1: View of crews installing pole 213 on Segment 7. The photograph faces northwest.

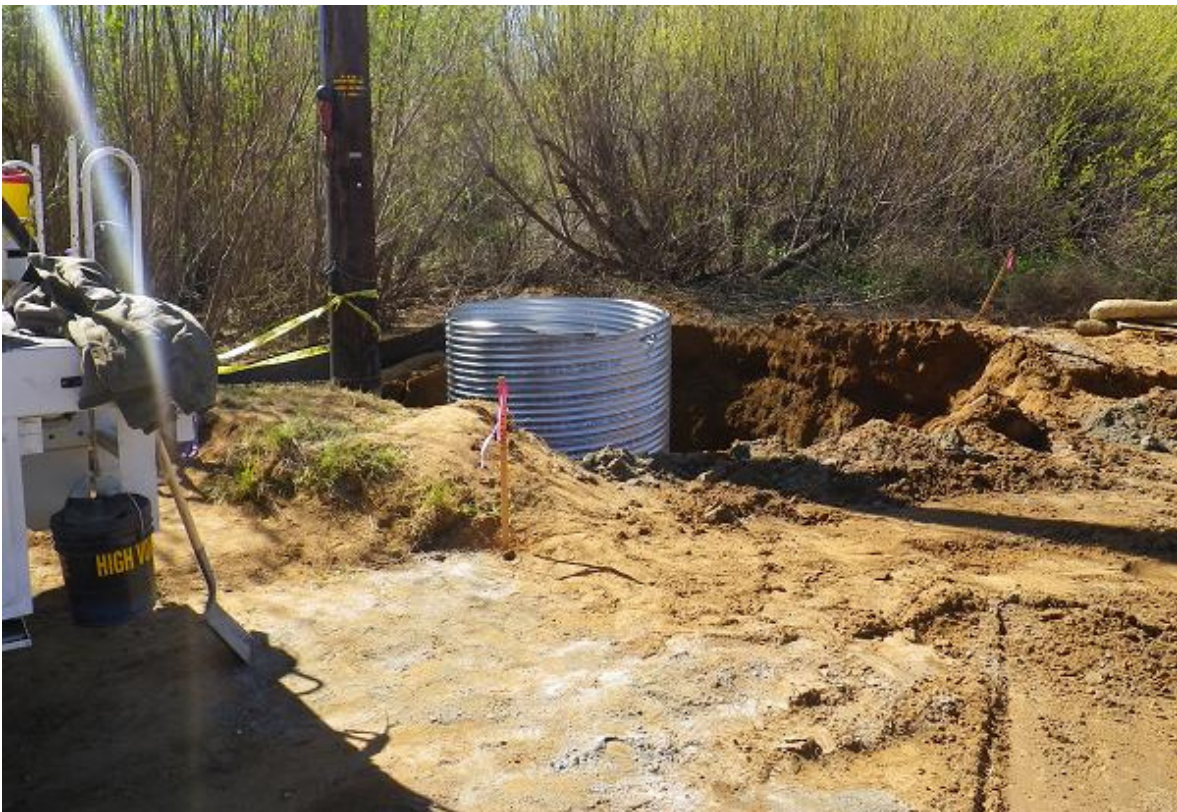
Figure 2: View showing the foundation of pole 207 on Segment 7 after the foundation had been removed and a second installation attempt was made. The photograph faces south.

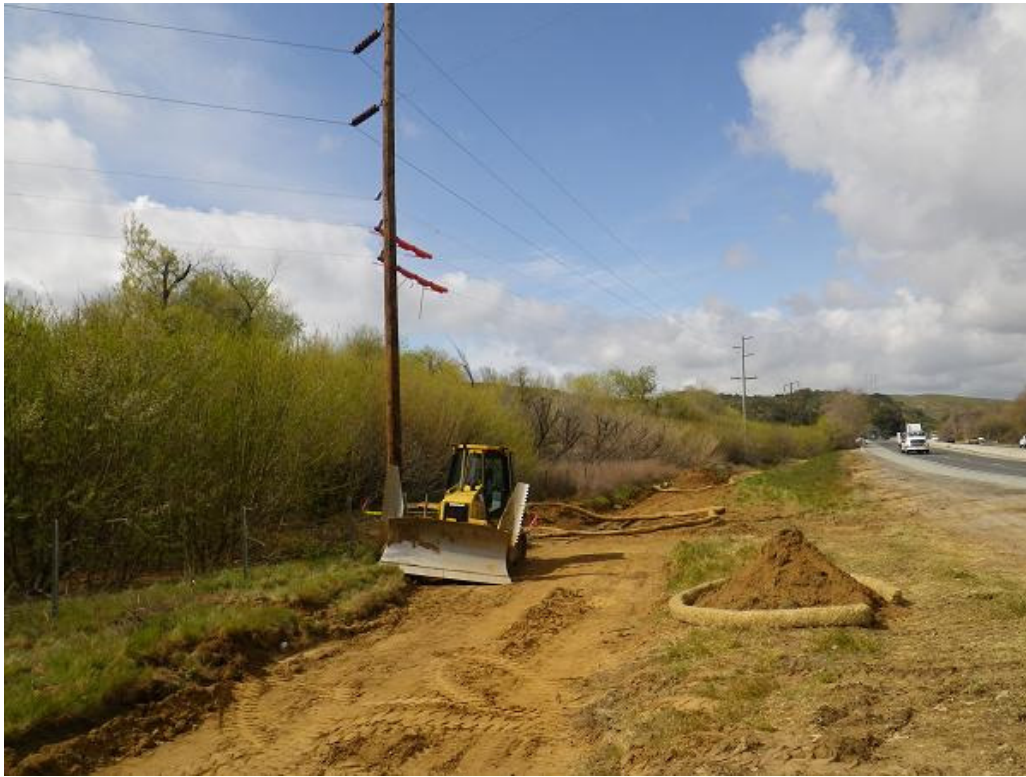
- On March 3rd, the CPUC EM observed riparian vegetation in the vicinity of pole 207 that had been cut prior to the authorization of the work (see Figure 3). The CPUC EM informed SCE and it was determined that survey crews had cut the vegetation; SCE indicated that they would take the proper actions.
- Also on March 3rd, the CPUC EM observed sage scrub within the works limits of pole 205 that appeared to have been cleared after the March 1st deadline indicated in the Western Riverside MSHCP (see Figure 4). SCE was aware of the problem and indicated they would take the proper action to document the problem and prevent it from happening again in the future.

Figure 2: View of work in the vicinity of pole 207, the trimmed riparian vegetation is immediately to the left of the existing pole. The photograph faces west.

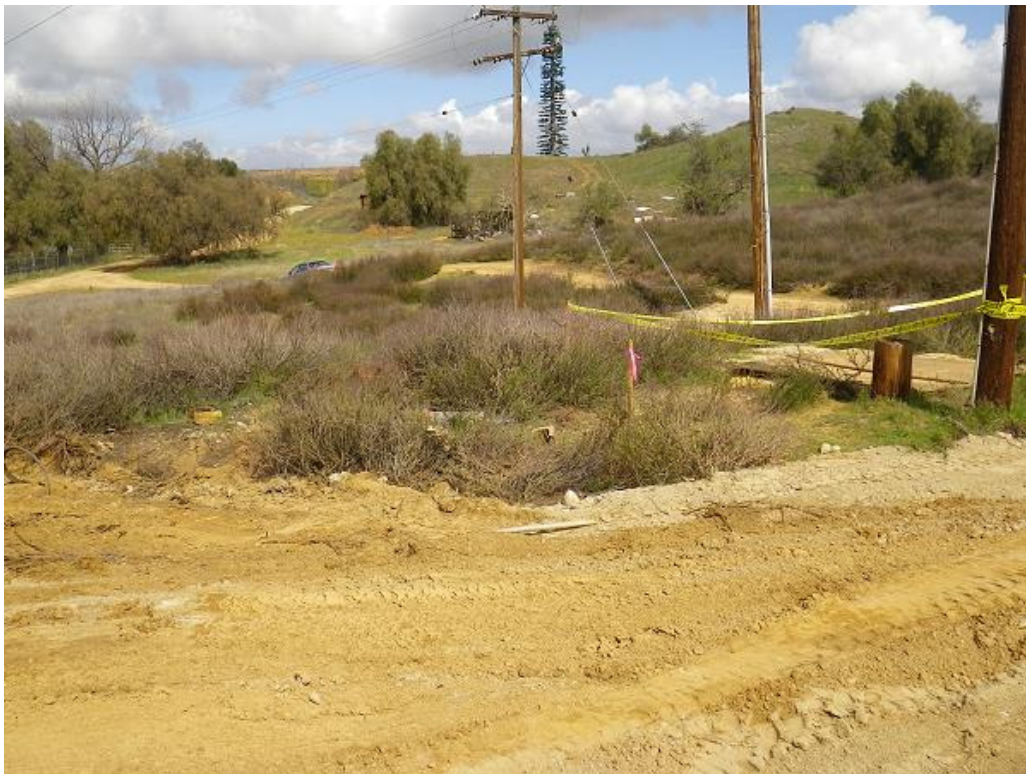
Figure 4: A partial view of the work area around pole 205 on Segment 7, note the cleared sage scrub in the left portion of the photo. The photograph faces northwest.
