PROJECT MEMORANDUM

PG&E EMBARCADERO-POTRERO 230 kV TRANSMISSION PROJECT

To: Billie Blanchard, Project Manager, CPUC
From: Vida Strong, Aspen Project Manager
Date: June 12, 2015
Subject: Monitoring Report #38 – June 1 to June 7, 2015

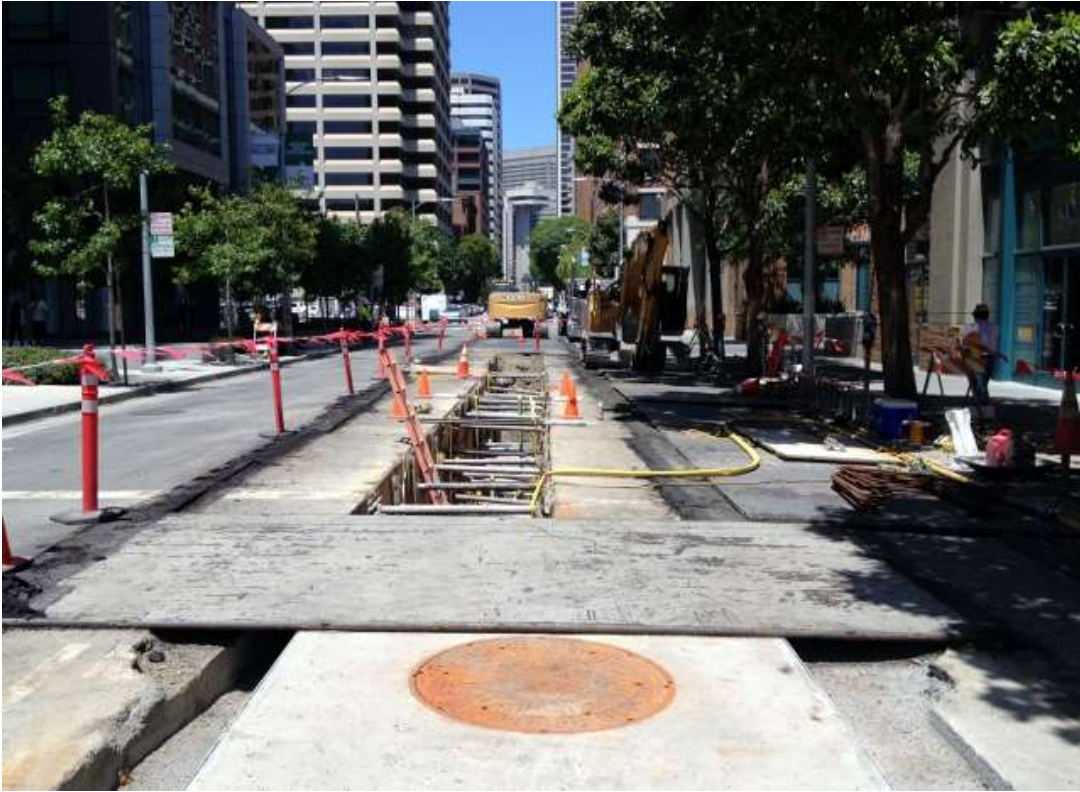
1. Underground Construction Co. excavated the duct bank trench Monday through Thursday.
2. Underground Construction Co. installed rebar Monday and Wednesday through Friday.
3. Underground Construction Co. installed shoring in the duct bank trench on Wednesday and Thursday.
4. Underground Construction Co. installed conduit on Friday.
5. PSC dewatered the duct bank trench on Monday and Wednesday through Friday.
6. New River Electric installed pull anchors in the pull box on Tuesday.
7. New River Electric pulled messenger wire on Friday and Saturday.
8. Clean Harbors hauled off excavated material and pavement for disposal Monday through Thursday.
9. Street sweeping occurred Monday through Friday.
10. At the time of the CPUC EM site visit on June 4th, crews were excavating trench between the vault and Folsom Street (see Figure 1).
11. No construction activities occurred on Sunday.

Figure 1 – Excavating duct bank trench on Spear Street between vault and Folsom Street. View west, June 4, 2015.

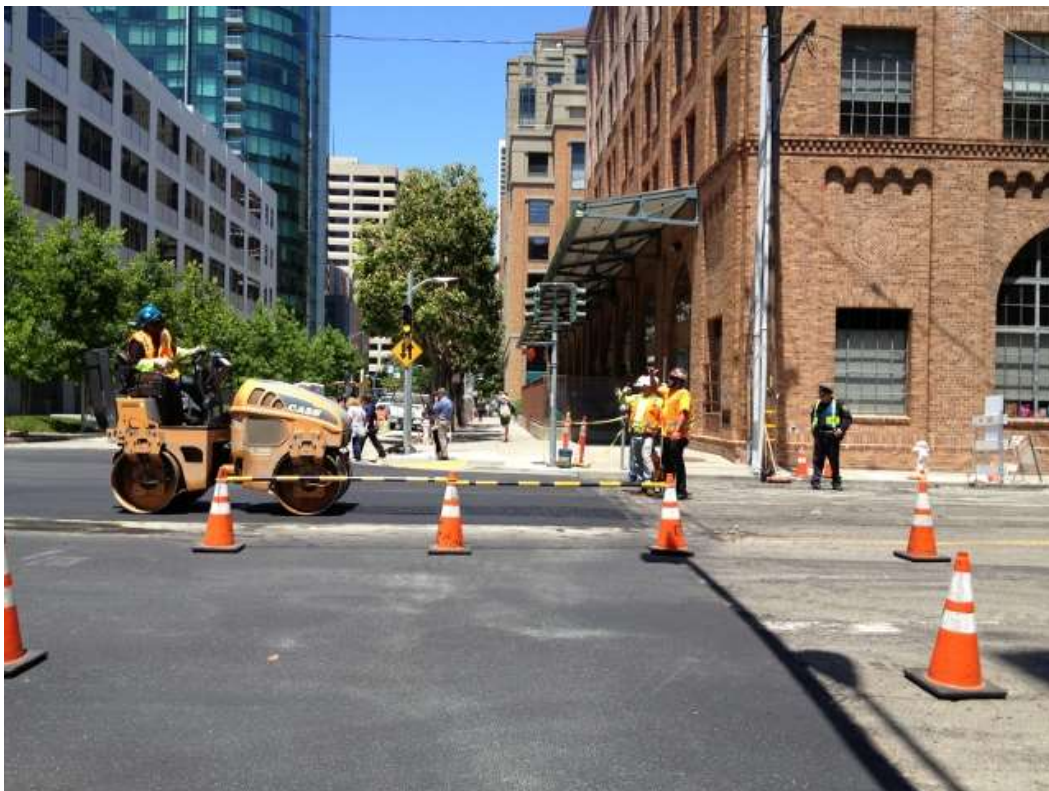
1. Underground Construction Co. and Annuzzi conducted grinding and pavement removal on Monday and Tuesday.
2. Underground Construction Co. and Annuzzi conducted paving on Tuesday and Thursday.
3. At the time of the CPUC EM site visit on June 4th, paving was taking place at the intersection of Spear Street and Harrison Street (see Figure 2).
4. Street sweeping occurred Monday through Friday.
5. No construction activities occurred on Sunday.

Figure 2 – Paving at the intersection of Spear Street and Harrison Street. View west, June 4, 2015.

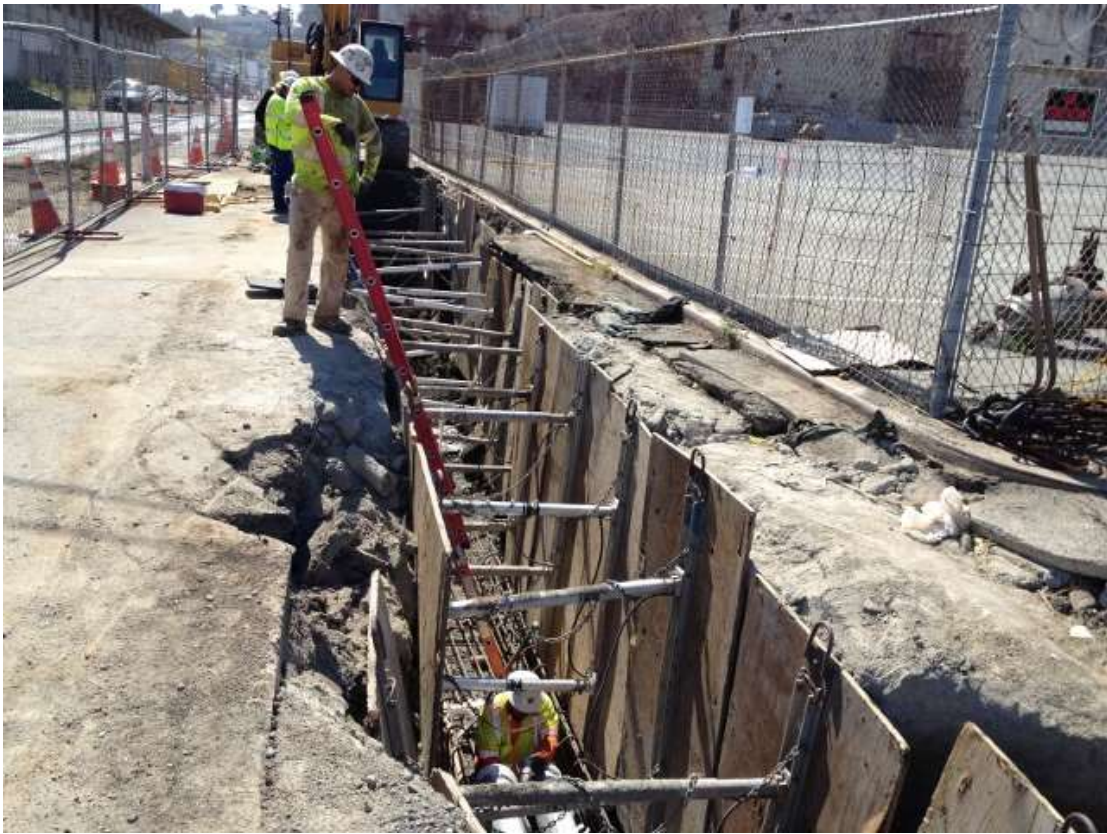
8. Clean Harbors hauled off excavated materials Monday through Friday.
9. Street sweeping occurred Monday through Friday.
10. Fencing was installed around the open trench at the end of each day.
11. At the time of the CPUC EM site visit on June 4th, crews were excavating the duct bank trench and installing conduit (see Figure 3).
12. No construction activities occurred Saturday or Sunday.

Figure 3 – Excavating duct bank trench on 23rd Street. View west, June 4, 2015.

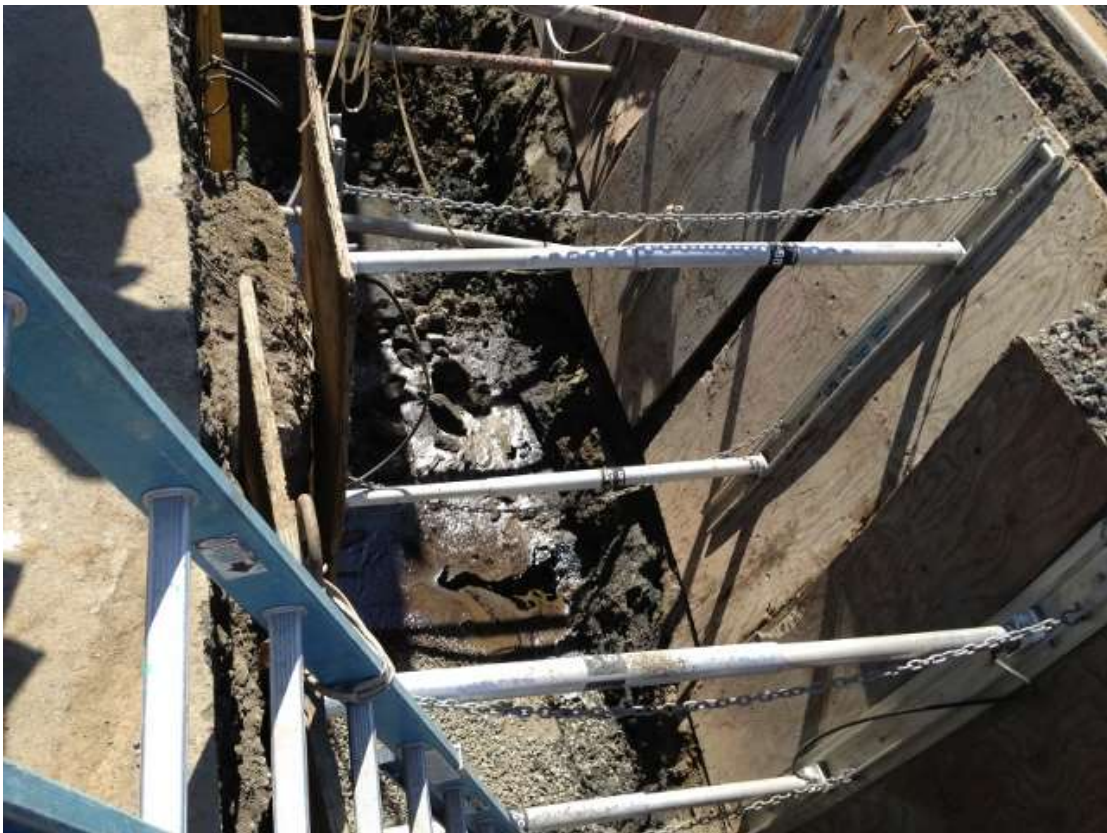
5. PG&E's Environmental Inspectors noted one potential compliance issues at this location. On June 4th, an unknown oily black substance was observed by the Black & Veatch/Underground Construction Co. crew seeping into the trench from the trench wall. The CPUC EM was on site and also noted the oily substance (see Figure 4) and recommended that Black & Veatch notify Marc Morolla (PG&E). The Black & Veatch Inspector informed Marc Morolla (PG&E) and the PG&E Environmental Inspector. PG&E informed Black & Veatch that the soils have been adequately profiled for disposal to a hazardous waste facility, and the onsite treatment system at the Potrero Switchyard has the capacity to remove any free phase product and secondary aqueous phase constituents prior to discharging under the existing SFPUC permit. PG&E stated that going forward, if the seep remains minimal, soils can continue to be off hauled under the current process. However, if flow increases and there is significant accumulation of liquids in the base of the trench, a vacuum truck should be utilized to remove the liquids for input to the treatment system in the Potrero Switchyard prior to any additional excavation activities. In addition, Marc Morolla notified the PG&E remediation group about the observation.

Figure 4 – Oily black substance in trench on 23rd Street. View northwest, June 4, 2015.

6. The CPUC EM observed the oily substance and recommended that Black & Veatch notify Marc Morolla (PG&E). The CPUC EM noted that the site was neat and clean and that SWPPP measures were in place. All observed work activities were in compliance with the mitigation measures (MMs), Applicant Proposed Measures (APMs), and other permit requirements.
