PROJECT MEMORANDUM

PG&E EMBARCADERO-POTRERO 230 kV TRANSMISSION PROJECT

To: Billie Blanchard, Project Manager, CPUC
From: Vida Strong, Aspen Project Manager
Date: November 23, 2015
Subject: Monitoring Report #60 – November 2 to November 8, 2015

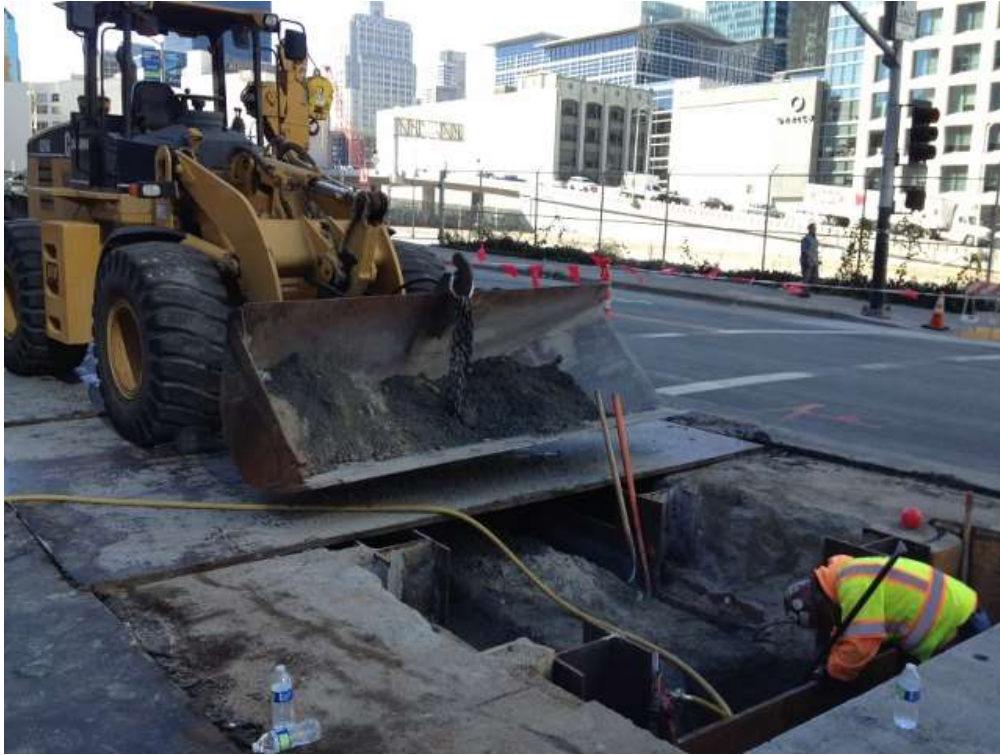
1. Underground Construction Co. exposed I-beam shoring on Monday and Tuesday, and removed it Monday and Tuesday nights.
2. Underground Construction Co. installed mule tape inside conduit pipe Tuesday through Thursday.
3. Underground Construction Co. mandreled conduit pipe Tuesday through Thursday.
4. Underground Construction Co. pillow-cleaned conduit pipe on Thursday.
5. Underground Construction Co. saw-cut pavement on Wednesday and removed pavement on Thursday.
6. Underground Construction Co. backfilled with concrete on Friday.
7. Underground Construction Co. conducted street sweeping Monday through Friday.
8. At the time of the CPUC EM site visit on November 3rd, a crew was exposing the I-beam shoring for removal that night (see Figure 1) and installing mule tape in the conduit.
9. No work activities occurred on Saturday or Sunday.

Figure 1 – Exposing I-beam shoring on Folsom Street in front of Embarcadero Substation. View southwest, November 3, 2015.

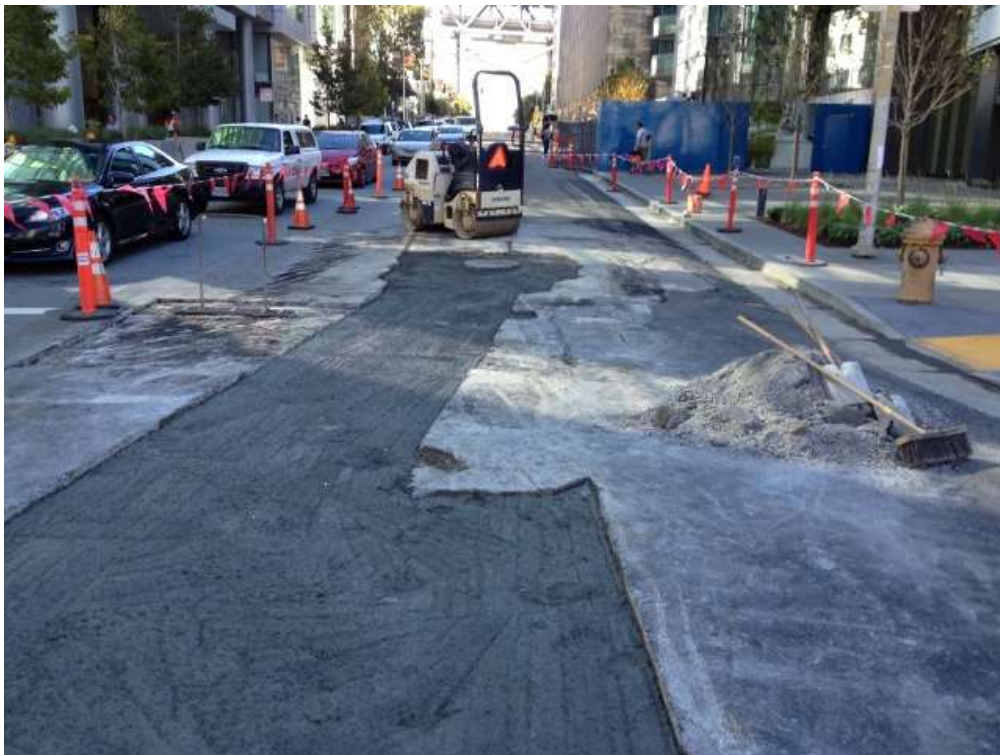
15. Underground Construction Co. backfilled the trench with concrete Tuesday, Wednesday, and Friday.
16. Underground Construction Co. removed pavement on Wednesday and Friday.
17. Underground Construction Co. conducted temporary paving on Thursday and Friday.
18. At the time of the CPUC EM site visit on November 3rd, a crew was backfilling with concrete at the Main Street intersection (see Figure 2).
19. No work activities occurred on Saturday or Sunday.

Figure 2 – Backfilling with cement at Main and Folsom Streets intersection. View east, November 3, 2015.

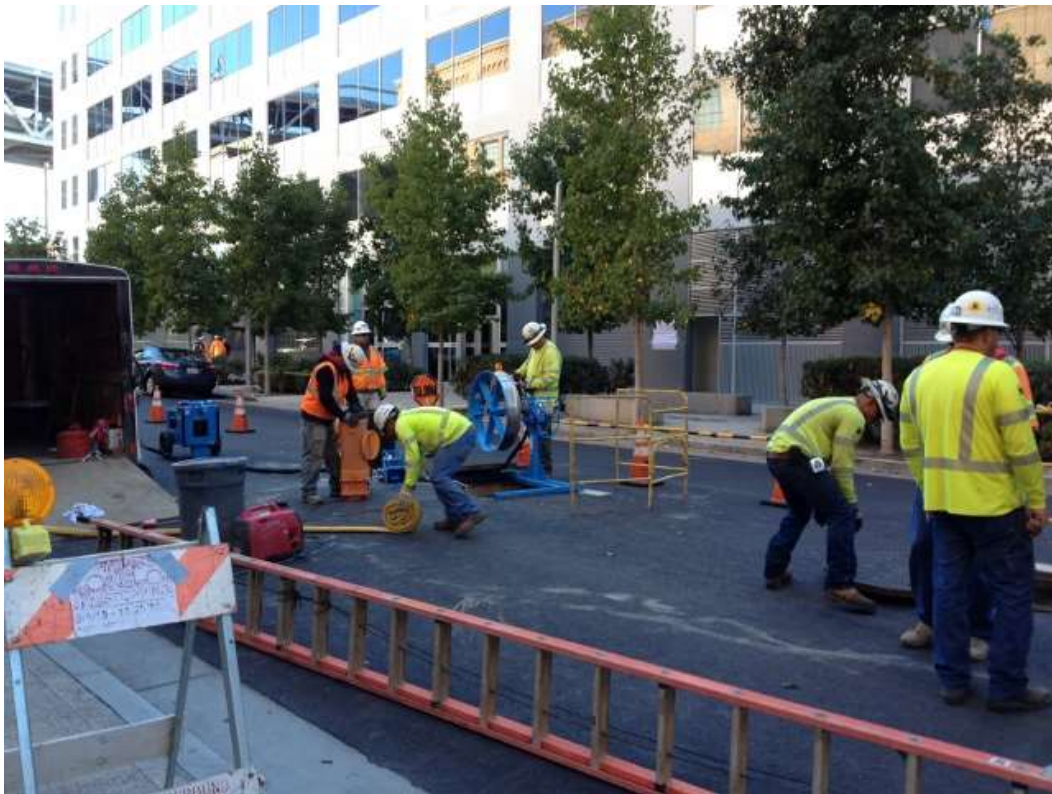
1. Spear Street has been paved and temporary striping applied.
2. Underground Construction Co. installed mule tape inside the conduit pipe from inside the transition vault Tuesday through Thursday.
3. Underground Construction Co. mandreled conduit pipe from inside the transition vault Tuesday through Thursday.
4. Underground Construction Co. pillow-cleaned conduit pipe on Thursday.
5. Underground Construction Co. removed mule tape on Friday.
6. Underground Construction Co. camera scoped a conduit pipe on Friday.
7. At the time of the CPUC EM site visit on November 3rd, a crew was installing mule tape and mandreling conduit pipe from within the transition vault (see Figure 3).
8. No work activities occurred Monday, Saturday or Sunday.

Figure 3 – Installing mule tape and mandreling conduit at transition vault on Spear Street. View southeast, November 3, 2015.

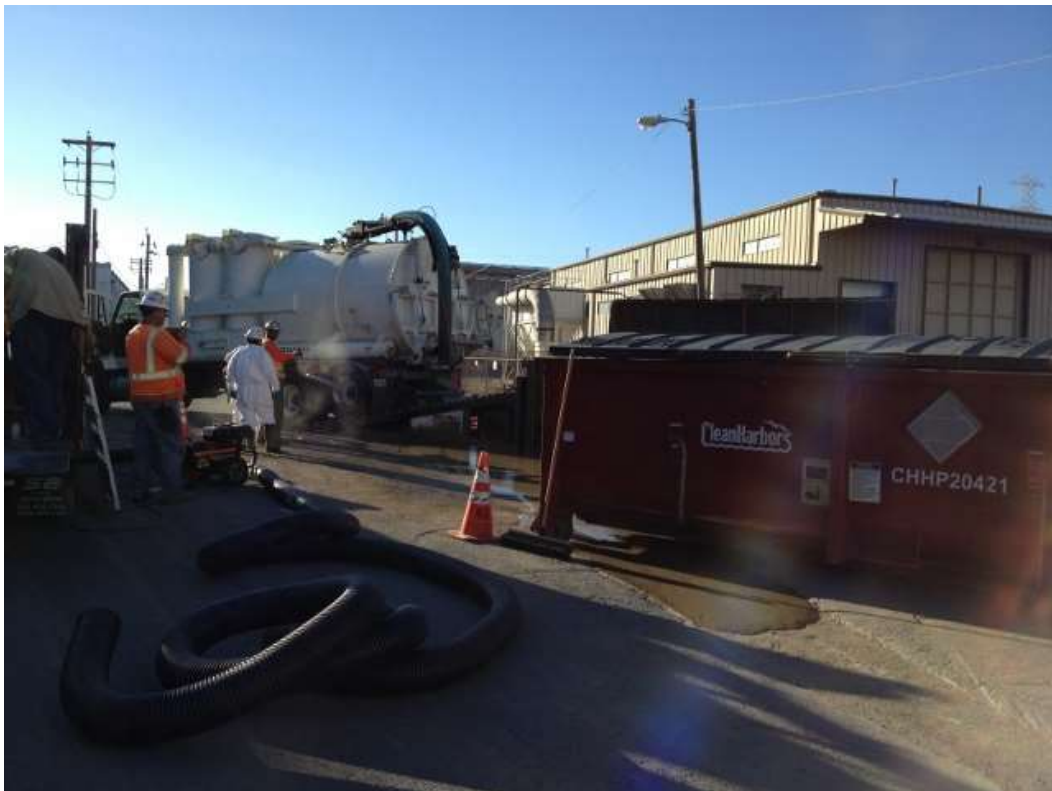
- On November 3rd and 4th, PSC spilled approximately 100 gallons of mud onto the pavement on 23rd Street near the Clean Harbor roll off bins (see Figure 4). The mud came from the Potrero Switchyard BTI water filtration tanks that were being emptied prior to the tanks removal; the mud was being transferred via Vac-truck between the BTI tank and the Clean Harbors roll off bin. Cleanup activities included watering and vacuuming; no chemicals or soap were used.

4. The CPUC EM observed PSC attempting to contain and clean up the spill on November 3rd. Other than the spill, the CPUC noted that the site was neat and clean, and that SWPPP measures were in place. All observed work activities were in compliance with the mitigation measures (MMs), Applicant Proposed Measures (APMs), and other permit requirements.

Figure 4 – PSC working on cleaning up spoils spill on 23rd Street. View west, November 3, 2015.

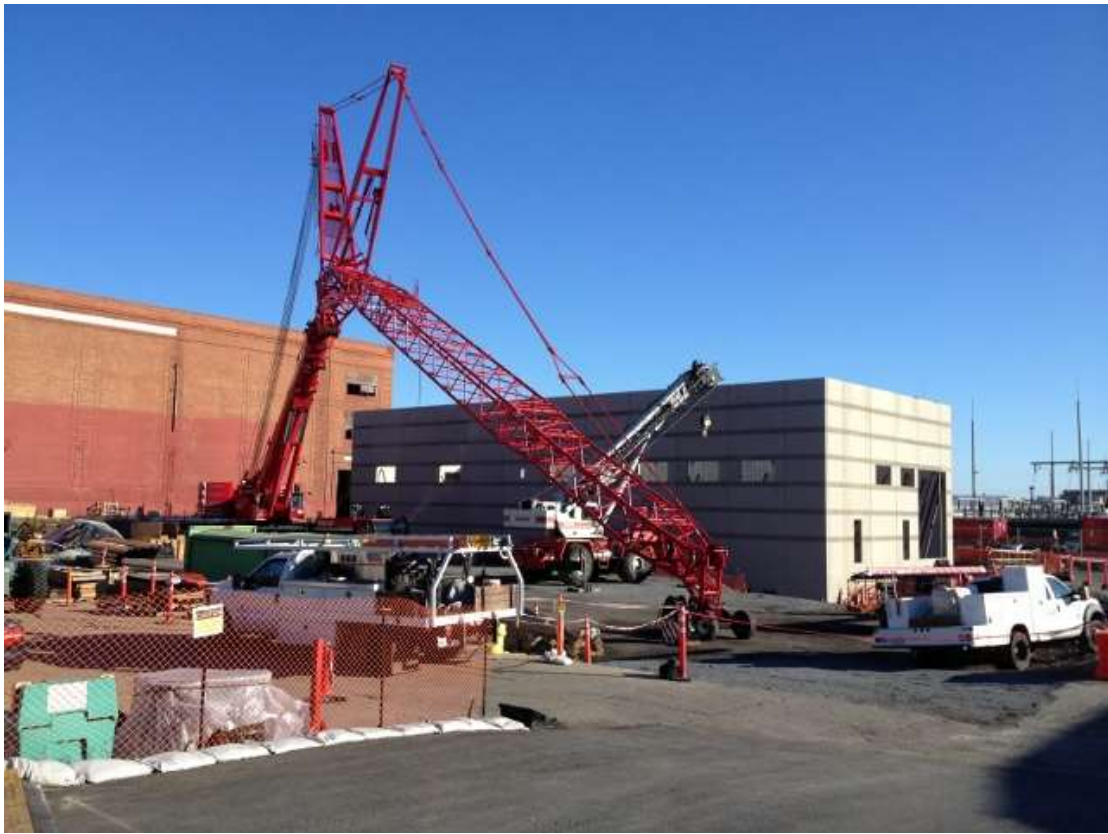
6. Mid State grouted and welded wall panels to the foundation Tuesday through Saturday.
7. PSC cleaned and removed water filtration equipment Monday through Thursday.
8. APEC excavated to expose and remove conduit pipe in the adjacent substation on Monday.
9. APEC excavated to expose and demolish concrete foundations in the adjacent substation Monday through Friday.
10. APEC and CCE conducted dust control activities in the adjacent substation Monday through Friday.
11. APEC hauled off concrete for disposal on Thursday.
12. At the time of the CPUC EM site visit on November 3rd, crews were demobilizing the crane (see Figure 5), and excavating foundations in the adjacent substation.

Figure 5 – Demobilizing crane at Potrero Switchyard. View southeast, November 3, 2015.
