**PROJECT MEMORANDUM
PG&E JEFFERSON-MARTIN 230KV TRANSMISSION PROJECT**

To: Billie Blanchard, CPUC
From: Vida Strong, Aspen Project Manager
Date: February 9, 2006
Subject: Monthly Report #6: January 1, 2006 – January 31, 2006
CPUC Environmental Monitor (EM): Jody Fessler

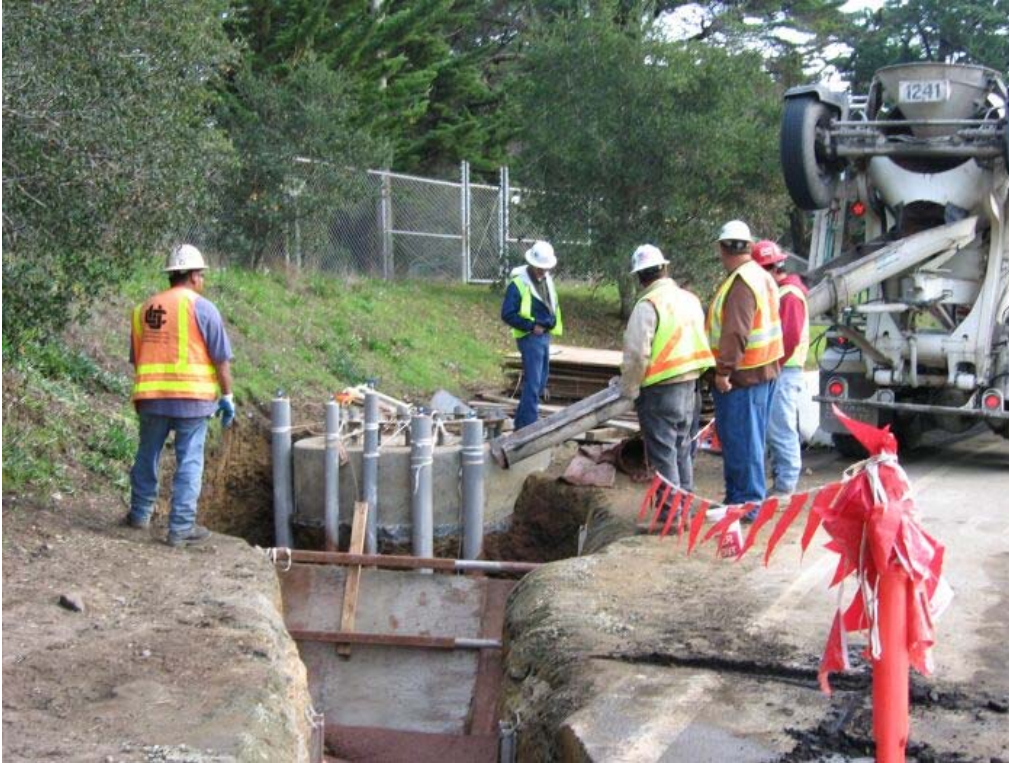
Figure 1 – Crews pouring cement slurry around the transition tower foundation on the north side of Crystal Springs Dam, Segment 1, January 10, 2006.

Throughout the month of January, trenching activities and conduit installation took place on either side of Crystal Springs Dam to the temporary transition towers for the dam crossing (Figure 1). During the fourth week of January, both of the temporary transition towers for the dam crossing were erected.

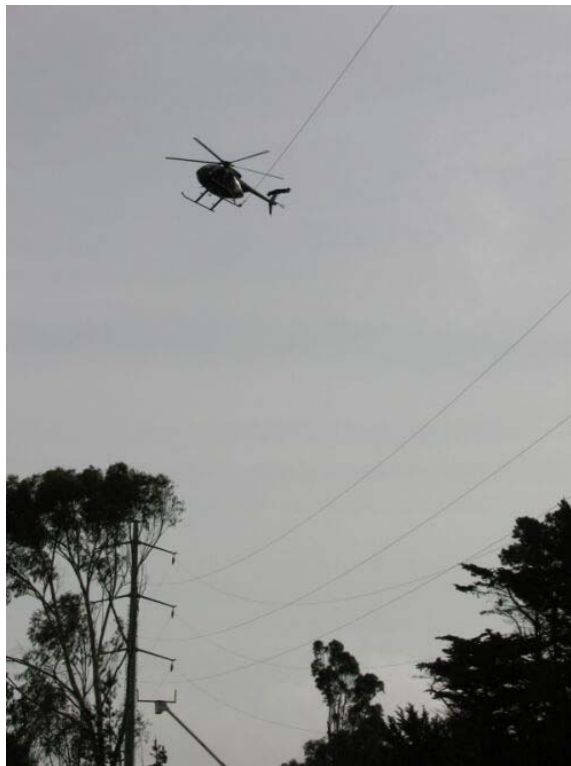
Figure 2 – Helicopter flying sock line toward Tower #76 from Tower #77, Segment 2 Overhead, January 11, 2006.

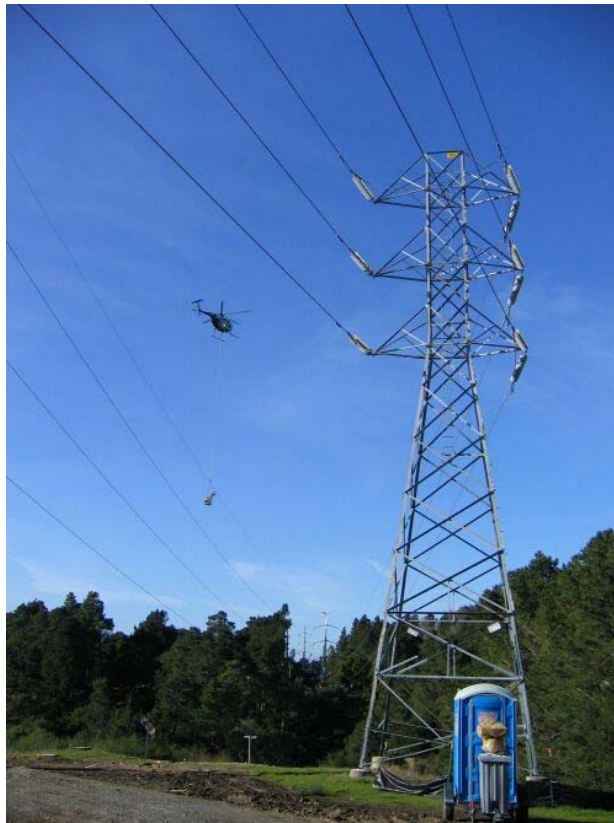
Figure 3 – Helicopter dangling a man in a basket who is attaching bird diverters to the OPGW line between Towers #70A and #71, Segment 2 Overhead, January 19, 2006.

Table 3A presents the overhead construction activities along Segment 2 Overhead in the SFPUC Watershed during January. The line builder crew (ILB) worked Monday through Saturday of each week, and the tree clearing crews worked Monday through Friday of each week. ILB crews erected new towers, installed travelers, moved transmission lines from the old towers to the new towers, performed dead-ending work, installed insulators, and removed some of the old lattice towers and their concrete footings. On January 10th and 11th, sock line was flown by helicopter from Tower #70A through Tower #77 (Figure 2). On January 19th, a helicopter with a man in a basket was used to install bird diverters on the OPGW line (Figure 3). Burrow excavation continued throughout the month of January at various locations in the watershed.

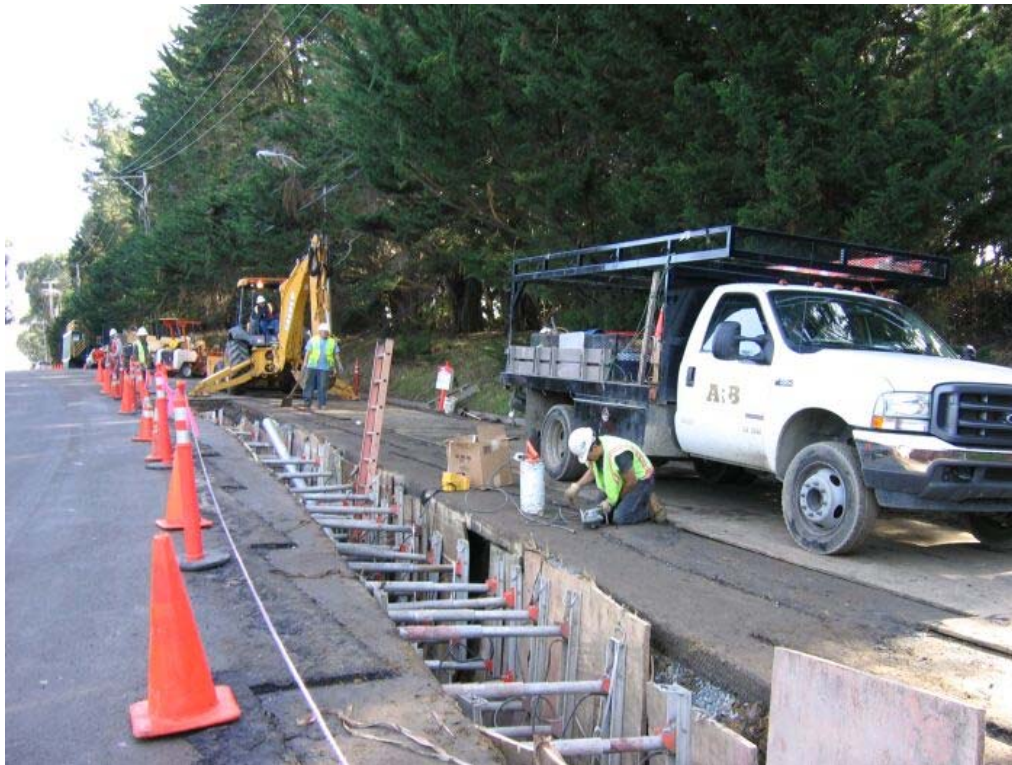
Figure 4 – Trenching activities on Glenview Drive, Segment 3, January 18, 2006.

Table 4A presents the underground construction activities along Segment 3 during January. Crews worked Monday through Friday during the day on Glenview Drive, San Bruno Avenue, and Huntington Drive conducting trenching operations (see Figure 4). Nighttime work was conducted Sunday night through Thursday nights. A PG&E EI was on-site during construction activities to inspect environmental compliance at the work sites. Traffic controls were in place at the construction sites including flaggers, signs, and cones.

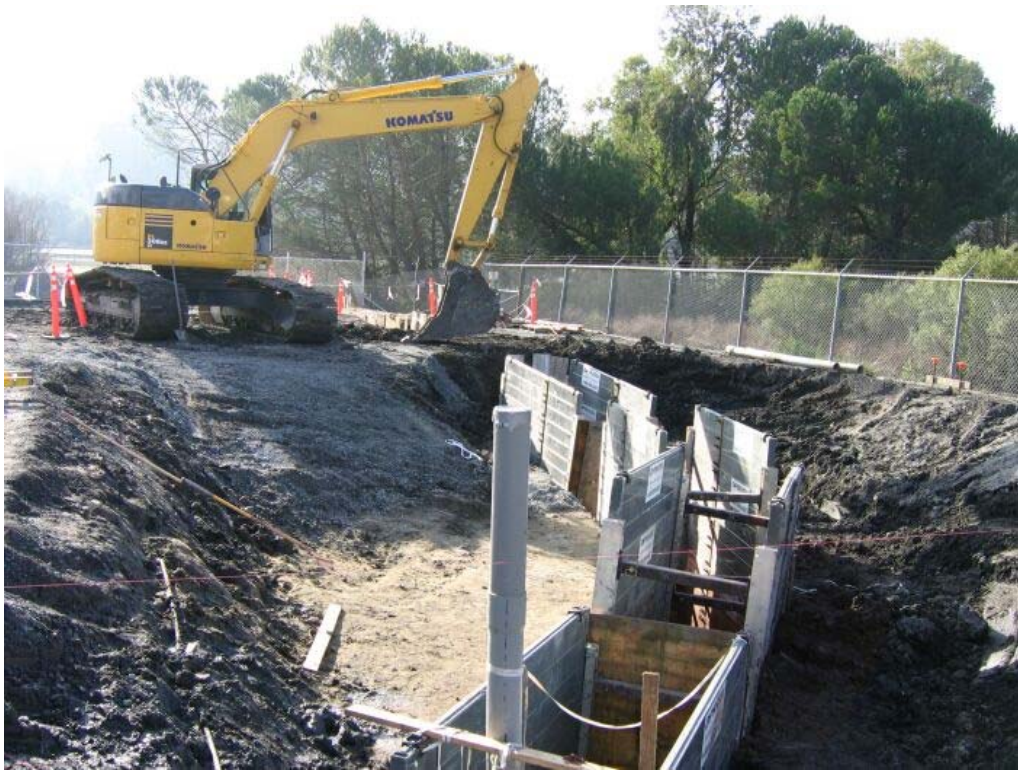
Figure 5 – Trenching activities into the Jefferson Substation, January 10, 2006.

During the month of January, crews continued to work at the Jefferson Substation Mondays through Saturdays and a few Sundays. Trenching activities continued from Manhole #1 southeast into the substation (see Figure 5). Work within the substation also continued and included trenching for the installation of

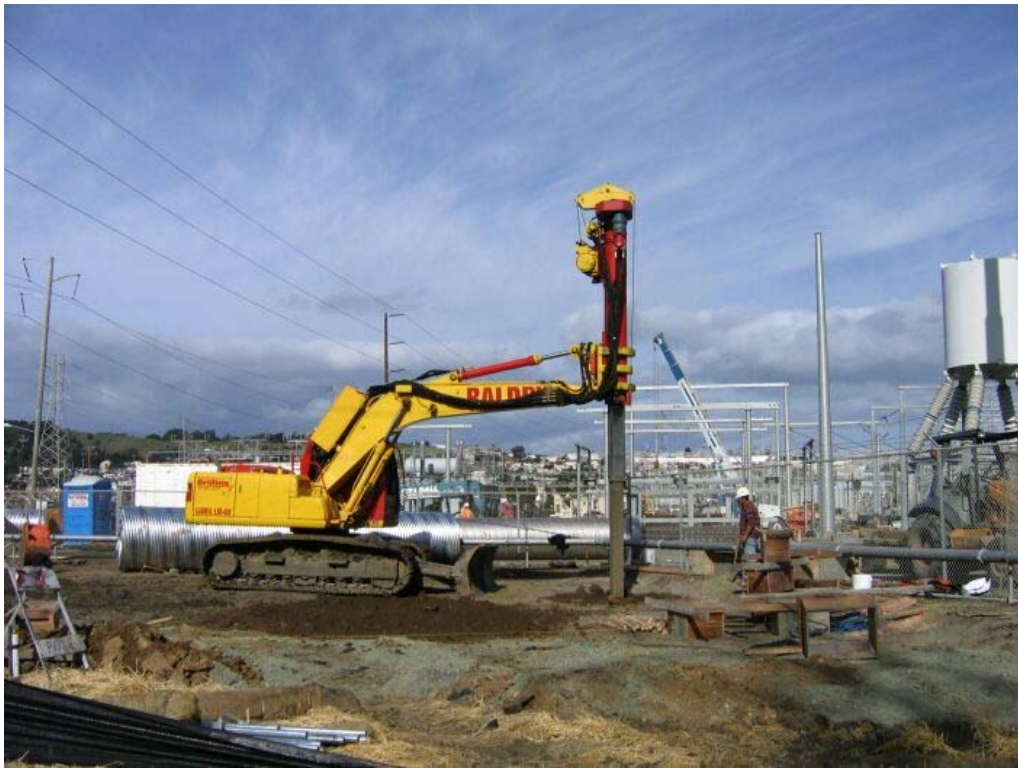
Figure 6 – Drilling tower foundation pits at the Martin Substation, January 25, 2006.

During the month of January, crews continued to work at the Martin Substation, Monday through Friday. Work at the Martin Substation included trenching, conduit installation, cable tray installation, construction of footings and forms, construction of bus-line support structures. Construction of circuit-breaker structures and installation of circuit breakers also occurred. During the fourth week of January, the drilling of foundation pits for the towers were started and the fence expansion began (see Figure 6).
