PROJECT MEMORANDUM

PG&E JEFFERSON-MARTIN 230KV TRANSMISSION PROJECT

Subject: Weekly Report #17: May 8, 2005 – May 14, 2005

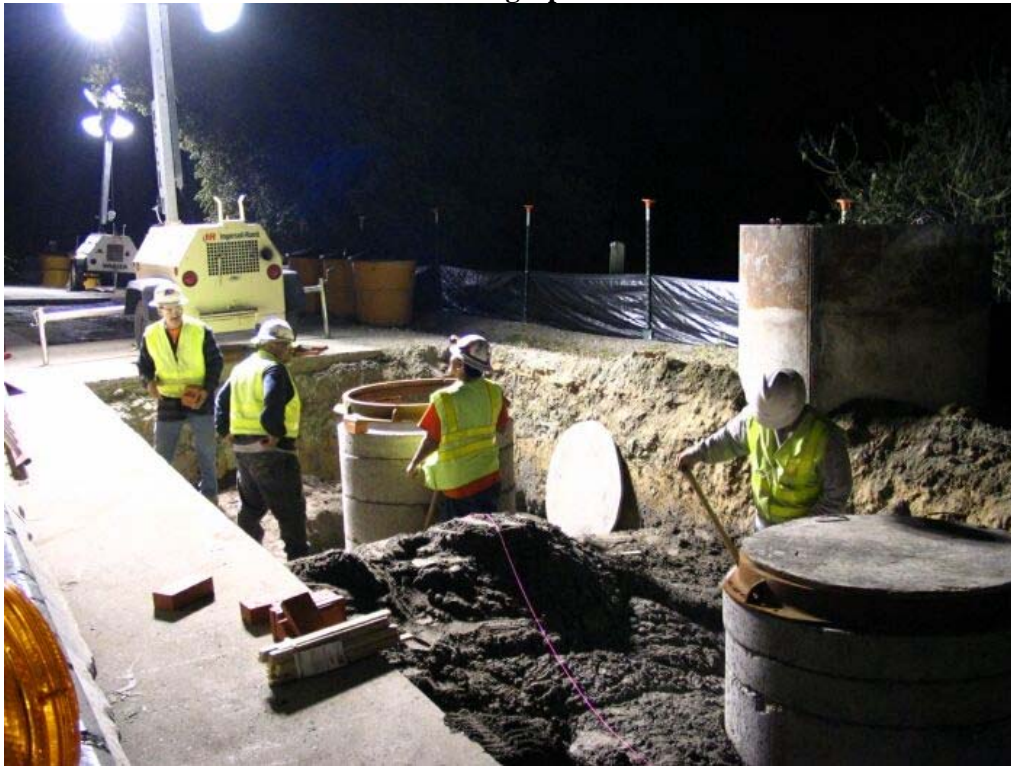
Figure 1 – Crews setting manhole rings at Manhole #21 in the Caltrans right-of-way on Skyline Boulevard, Segment 1, May 11, 2005

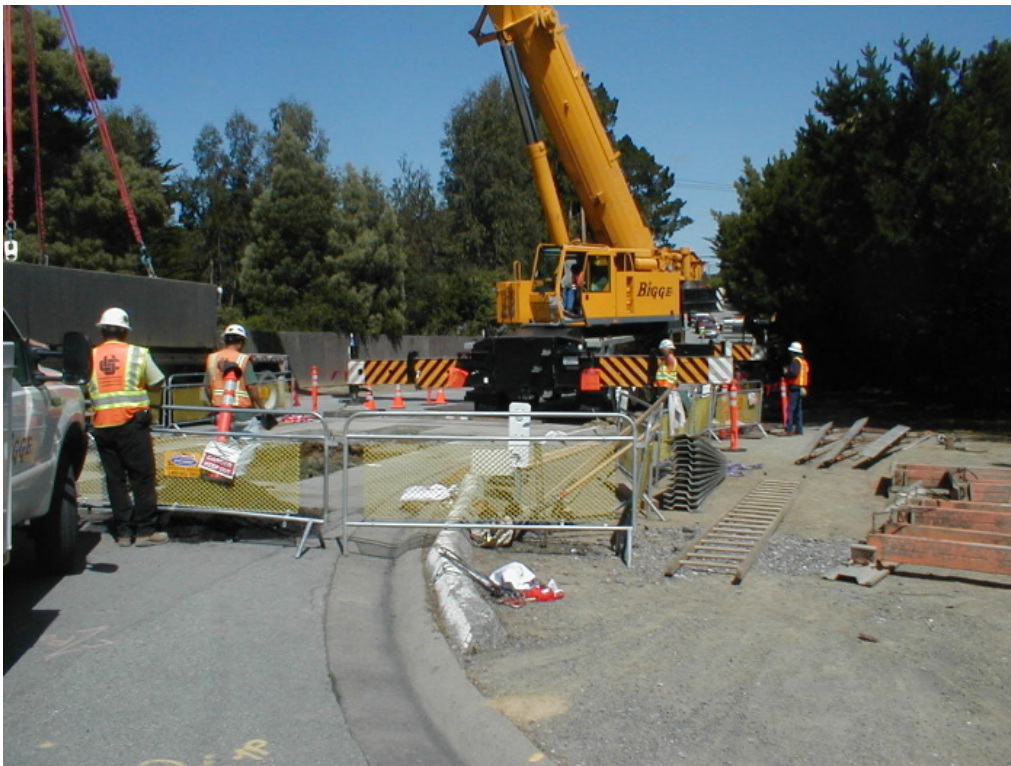
2. On Tuesday, May 10th, Manhole #33 pit was excavated and shored and gravel placed in the bottom of the pit. The vault was set in the manhole on Wednesday, May 11th (Figure 2), and cement slurry poured on Thursday and Friday. Steel plates were set over the manhole on Friday.

Figure 2 – Crews setting manhole vault at Manhole #33 on Skyline Boulevard, Segment 2 Underground, May 11, 2005

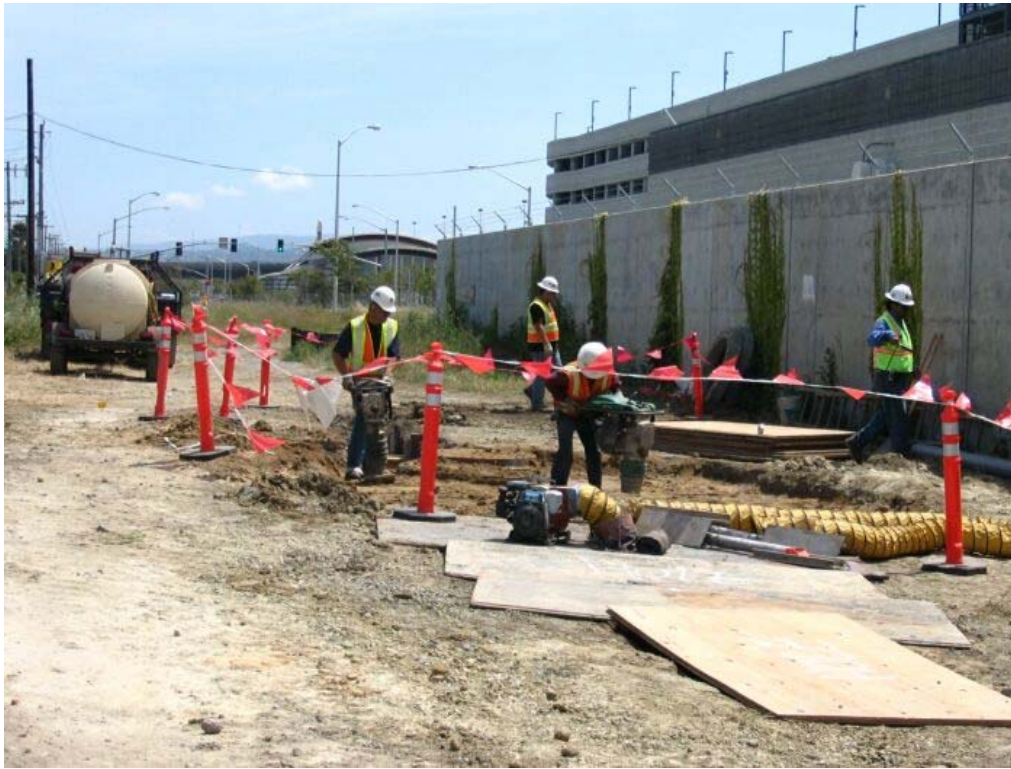
1. On Monday, May 9th, excavation of stub-outs began on either side of Manhole #48 and Manhole #49 in the BART right-of-way. Crews continued to work at these locations throughout the week (Figure 3). On Tuesday evening, the CPUC EM noticed that the stub-outs were covered with plywood at Manhole #49 and no chain link fence was surrounding the work area as it was at Manhole #48. The CPUC EM spoke with the Black & Veatch Safety Manager who informed her that steel plates should be used to cover pits or trenches if no fencing is installed around the construction area. From Wednesday forward, crews used steel plates to cover the stub-out trenches where chain link fence was not in place. Plywood could be used to cover the pits and trenches if chain link fencing is in place around the construction areas.

Figure 3 – Crews compacting soil over Manhole #48 in the BART right-of-way, Segment 4, May 12, 2005

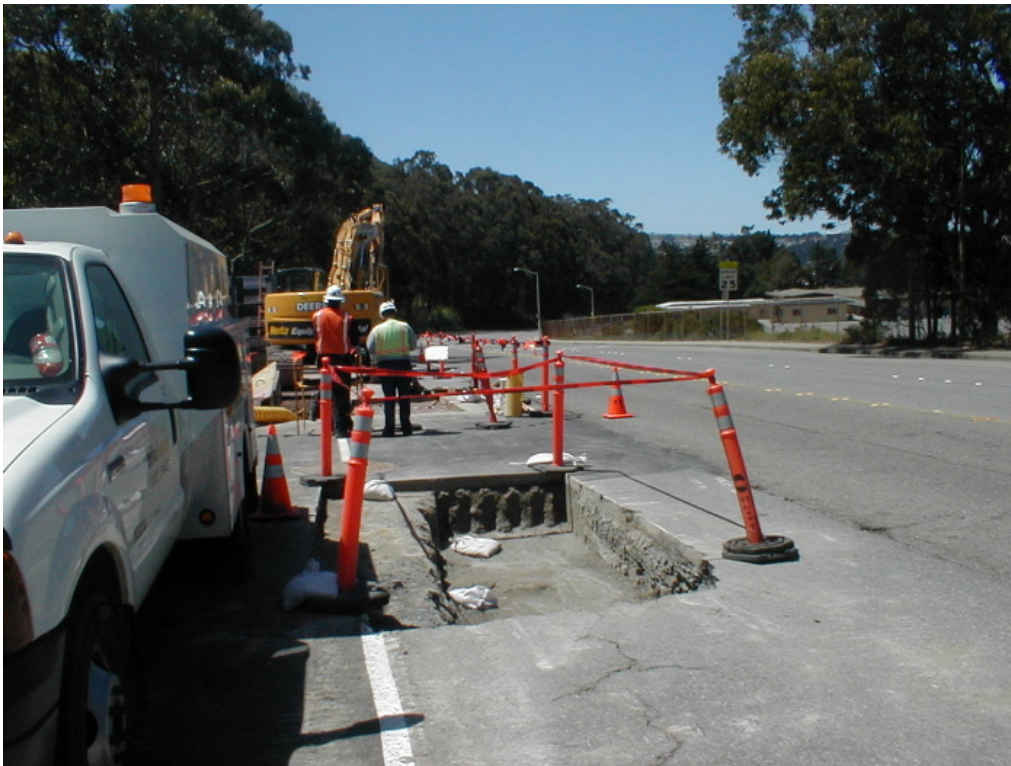
2. On Wednesday, May 11th, crews conducted some repair of asphalt around Manhole #66 on Guadalupe Canyon Parkway (Figure 4).
3. Conduit still has to be attached to the bridge at the top of San Bruno Mountain on Guadalupe Canyon Parkway. Once the brackets are made, construction crews will complete the bridge work.

Figure 4 – Crews working on asphalt repairs at Manhole #66 on Guadalupe Canyon Parkway, Segment 5, May 10, 2005
