# **Aspen** Environmental Group

## **PROJECT MEMORANDUM PG&E JEFFERSON-MARTIN 230KV TRANSMISSION PROJECT**

**To:** Billie Blanchard, CPUC  
**From:** Vida Strong, Aspen Project Manager  
**Date:** June 8, 2005  
**Subject:** Weekly Report #20: May 29, 2005 – June 4, 2005  
**CPUC Environmental Monitors (EM):** Jody Fessler and Jenny Slaughter

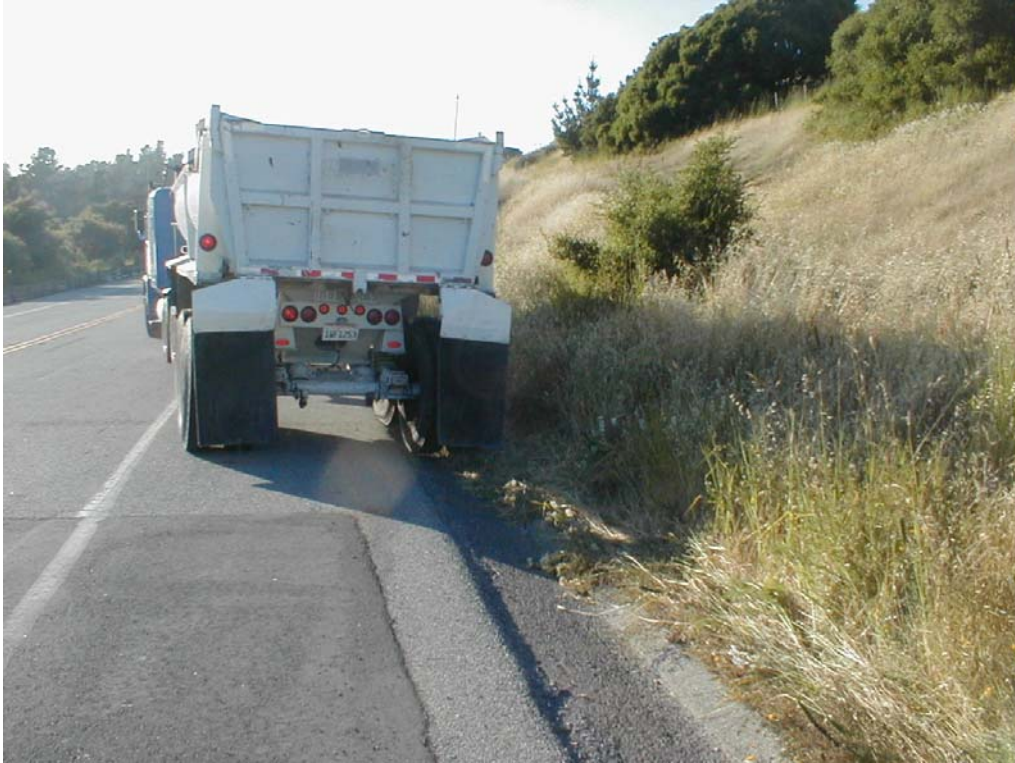
One non-compliance was issued by PG&E's EIs on May 31<sup>st</sup> when a vehicle left the approved right-of-way (paved roadbed and disturbed shoulder) and traveled within adjacent vegetation for a distance of approximately 200 feet (Figure 1).

**Figure 1** – Truck disturbing vegetation in Caltrans right-of-way on Skyline Boulevard, Segment 1, May 31, 2005

The CPUC EM issued a Project Memorandum on June 1<sup>st</sup> for the above mentioned activity.

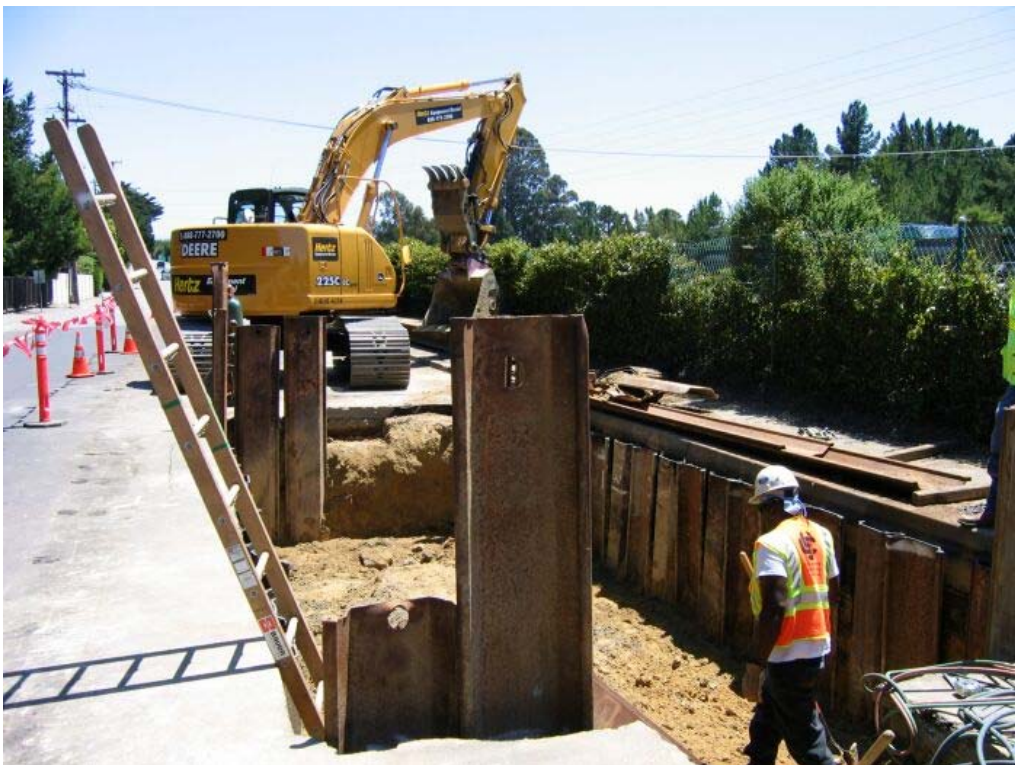
4. At Manhole #30, crews continued to excavate the pit throughout the week and install shoring (see Figure 2). They are having cave-in problems at this location. Steel plates were placed over the pit at the end of each day.

**Figure 2** – Crews shoring Manhole #30 on Skyline Boulevard, Segment 2 Underground, June 1, 2005

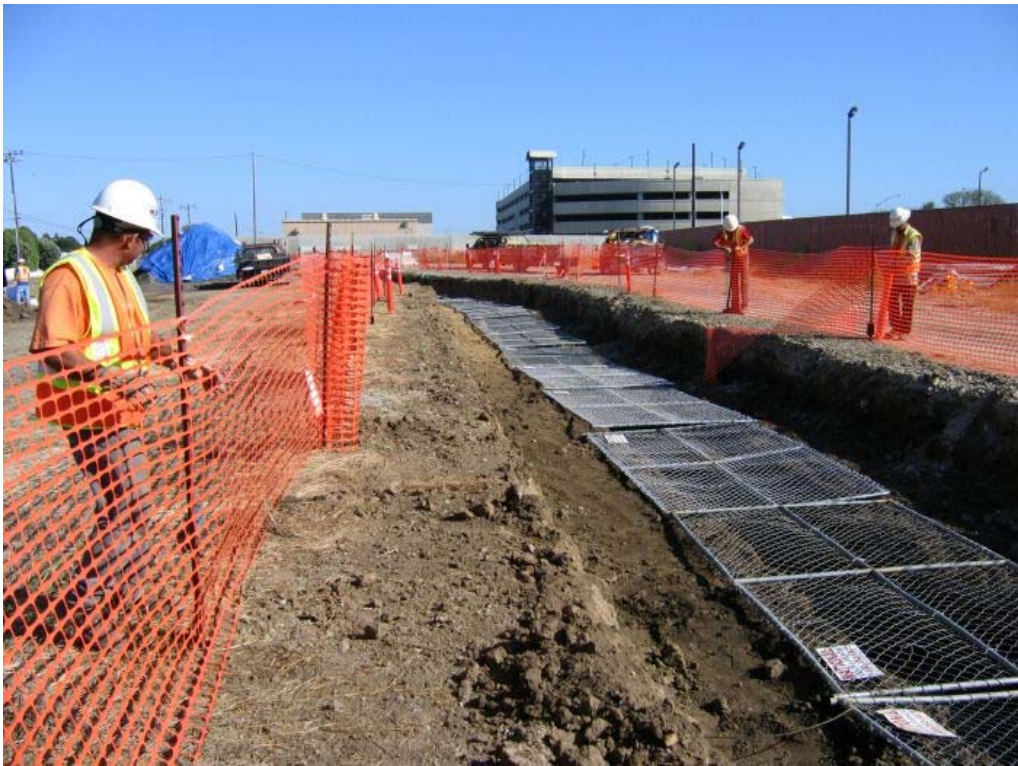
1. On Tuesday, May 31<sup>st</sup>, excavation of trench and installation of conduit continued between Manhole #48 and Manhole #49 in the BART right-of-way (see Figure 3). Crews continued to work at this location throughout the week. Approximately 350 linear feet of conduit was installed throughout the week. The trench area had chain link fence sections placed over the trenches at the end of each day and the construction zone was surrounded by snow fencing. No vehicles can access this area after work hours without unlocking a chain across the access road.

**Figure 3** – Crews securing trenching area north of Manhole #48 in the BART right-of-way, Segment 4, June 1, 2005

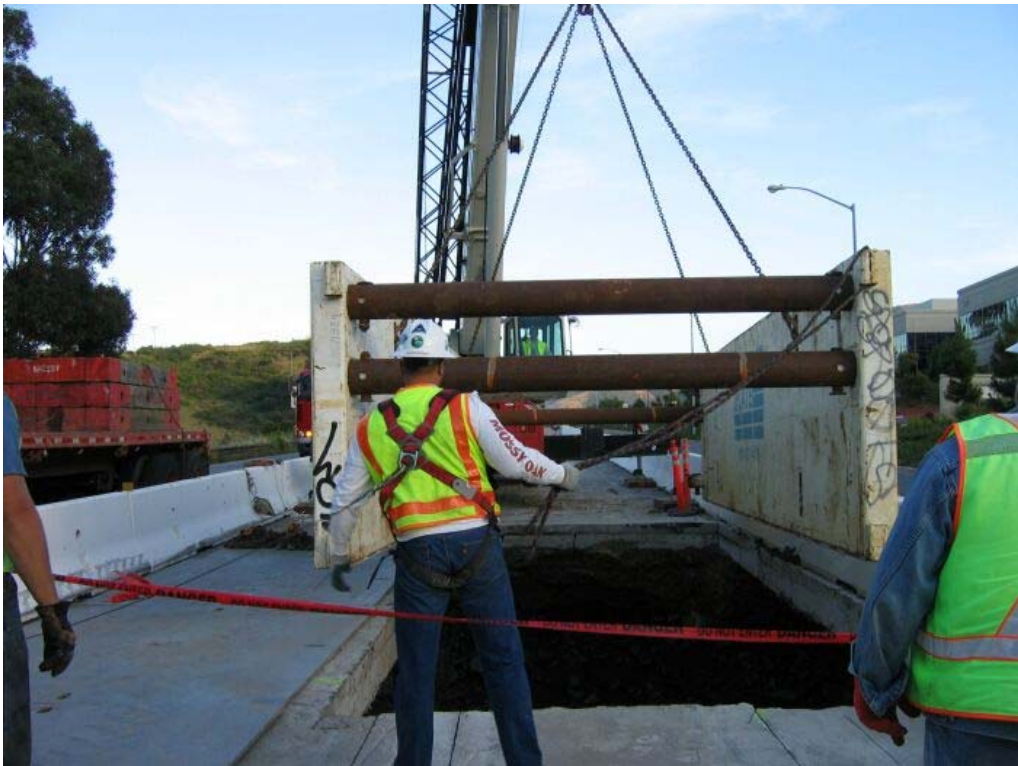
1. On Wednesday, June 1<sup>st</sup>, crews started working at Manhole #77 on Bayshore Boulevard in Brisbane. The pit was excavated throughout the week. On Friday, cave-in problems were jeopardizing the road and active traffic lanes. Crews shored the pit around 8:00 p.m. Friday night and poured cement slurry around the shoring to secure the active road (see Figure 4). Cement slurry was finished being poured around the shoring Saturday morning and gravel was placed in the pit throughout the rest of the day.

**Figure 4** – Shoring being installed at Manhole #77 on Bayshore Boulevard, Segment 5, June 3, 2005
