# Aspen Environmental Group

## PROJECT MEMORANDUM PG&E JEFFERSON-MARTIN 230KV TRANSMISSION PROJECT

**Subject:** Weekly Report #22: June 12, 2005 – June 18, 2005

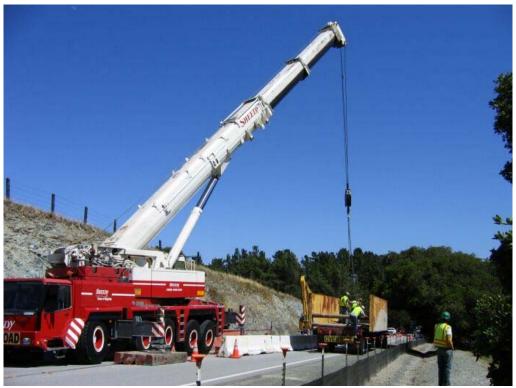
- 2. On June 13<sup>th</sup>, crews began the excavation of Manhole #24 pit on Skyline Boulevard during the day shift. The manhole vault was installed on Tuesday and partially backfilled with cement slurry (see Figure 1). On Wednesday, backfilling with cement slurry over the vault was completed, and on Thursday, the manhole area was paved over.

**Figure 1** – Removing shoring at Manhole #24 with a large crane, Segment 1, June 14, 2005

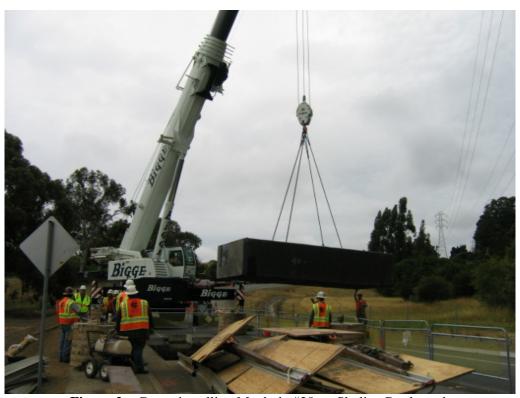
- 2. Two manhole vaults were set this week. On Tuesday, June 14<sup>th</sup>, the vault was set at Manhole #31 with a large crane. The vault pit was backfilled throughout the rest of the week with cement slurry and the area paved over on Friday. On Thursday, June 16<sup>th</sup>, the vault was set at Manhole #28 with a large crane (see Figure 2). The vault pit was partially backfilled with cement slurry and plated with steel plates on Friday.

**Figure 2** – Crews installing Manhole #28 on Skyline Boulevard, Segment 2 Underground, June 16, 2005

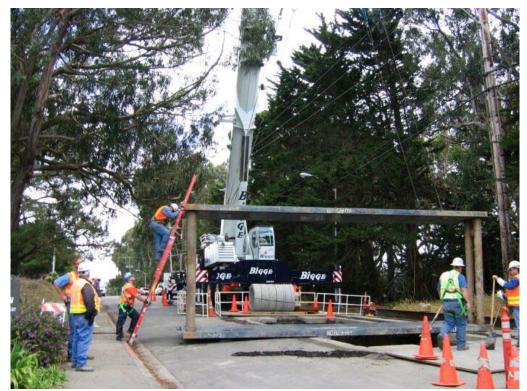
- 1. The excavation of Manhole #39 pit continued this week on Glenview Drive at the western end of the segment. Crews encountered water about 7 feet down. A baker tank was brought onto the site on Wednesday for the dewatering of the pit. The vault was set on Friday with a large crane and the shoring dismantled and removed from the area (see Figure 3). The pit was plated with steel plates at the end of each day.
- 2. Traffic controls were set up around the work area. Signs and cones were set up around the work area and a flagger was in place at the construction site to help direct traffic.

**Figure 3** – Crews dismantling and removing shoring from Manhole #39, Segment 3, June 17, 2005

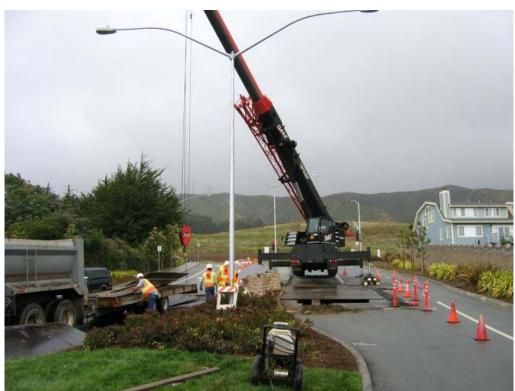
- 2. Two vaults were set this week along Lawndale Drive. On Monday, June 13<sup>th</sup>, crews continued to work at Manhole #57 in preparation to set the vault. On Tuesday, the Manhole #57 vault was set by a large crane. Crews continued to work at that location throughout the week setting manhole rings and backfilling the vault with cement slurry. Manhole #58 was excavated early in the week and the vault set by a large crane on Thursday (see Figure 4). The vault pit was covered with steel plates at the end of the day, and no work was done on Friday.

**Figure 4** – Crews plating Manhole #58 pit after vault was set on Lawndale Drive, Segment 4, June 16,2005.

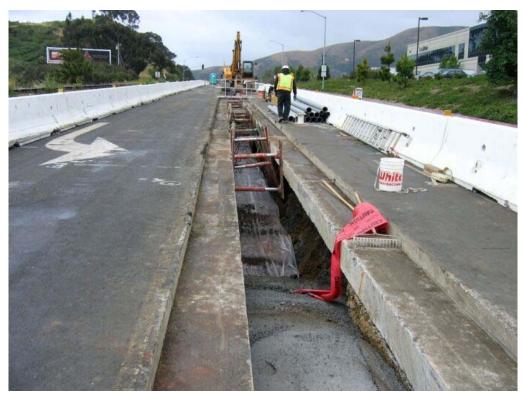
- 1. Trench was excavated throughout the week between Manholes #77 and #78 on Bayshore Boulevard (see Figure 5). The trench was excavated and shored, conduit installed, rebar installed around the conduit, cement slurry poured over the conduit, and the trench paved throughout the week. Approximately 846 linear feet of conduit was installed throughout the week.

**Figure 5**- Trench along Bayshore Boulevard in the City of Brisbane, Segment 5, June 16, 2005
