## **PROJECT MEMORANDUM SDG&E – MIGUEL-MISSION 230 kV #2 PROJECT**

**To:** Michael Rosauer, CPUC  
**From:** Vida Strong, Aspen Project Manager  
**Date:** October 6, 2004  
**Subject:** Weekly Report #9: September 26, 2004 – October 2, 2004  
**CPUC Environmental Monitor (EM):** Christopher Meyer

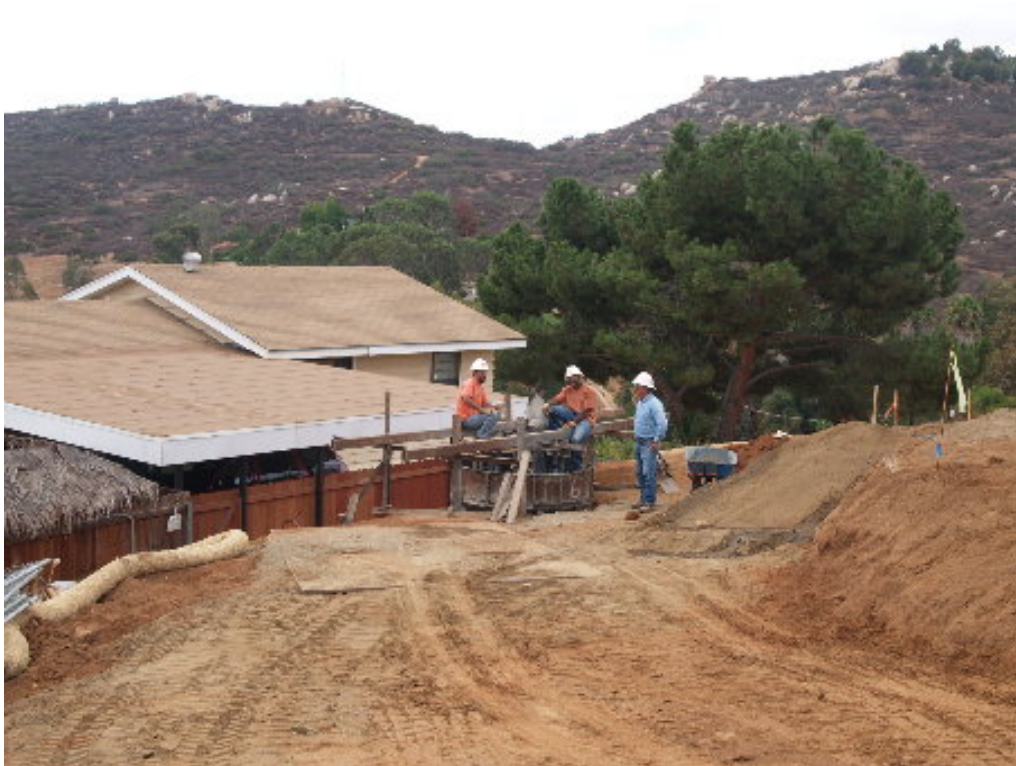
The transmission line contractor, PAR, placed anchor bolts and poured the foundation at Tower Site 1270 during the subject week (see Figure 1). The tower location is immediately adjacent to a carport that may have encroached on the SDG&E easement. An Essex EI was on-site with the PAR crew.

**Figure 1** – The PAR crew at Tower Site 1270 started the concrete pour adjacent to the carport.

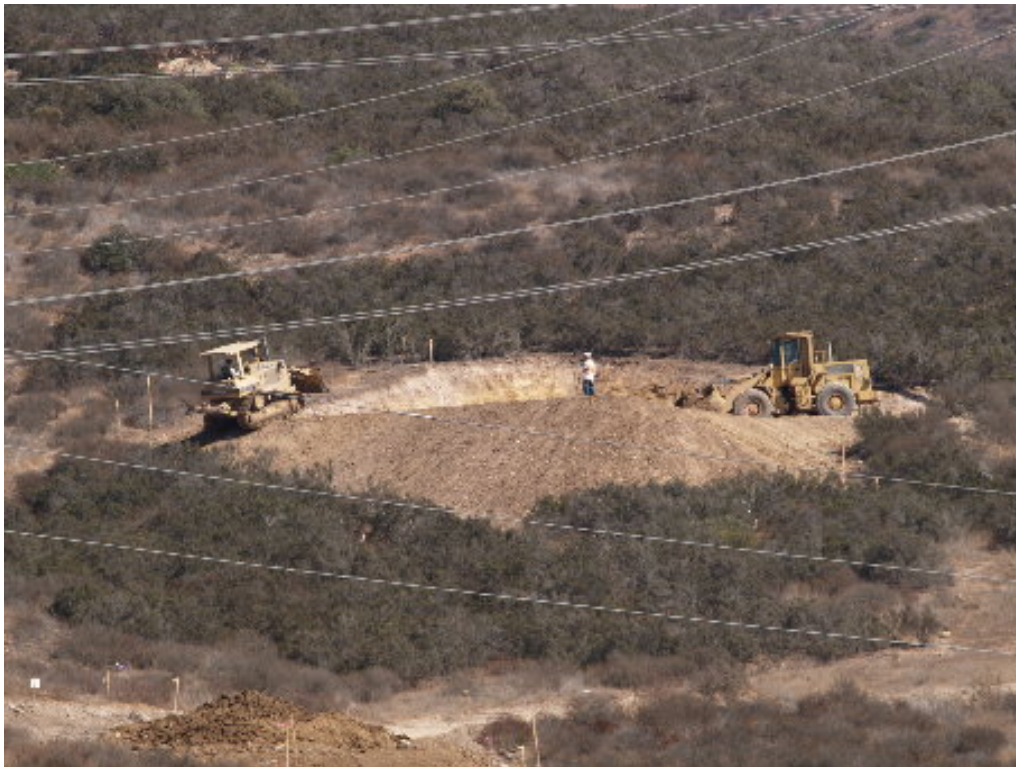
The grading crew at Tower Site 10 worked with several pieces of equipment to prepare the pad and the access road (see Figure 2). The contractor brought in fill from other areas on the project to build up the pad for Tower Site 5/7.

**Figure 2** – The grading crew worked to finish the pad at Tower Site 10. The spoil pile below is material imported to build up Tower Site 5/7.

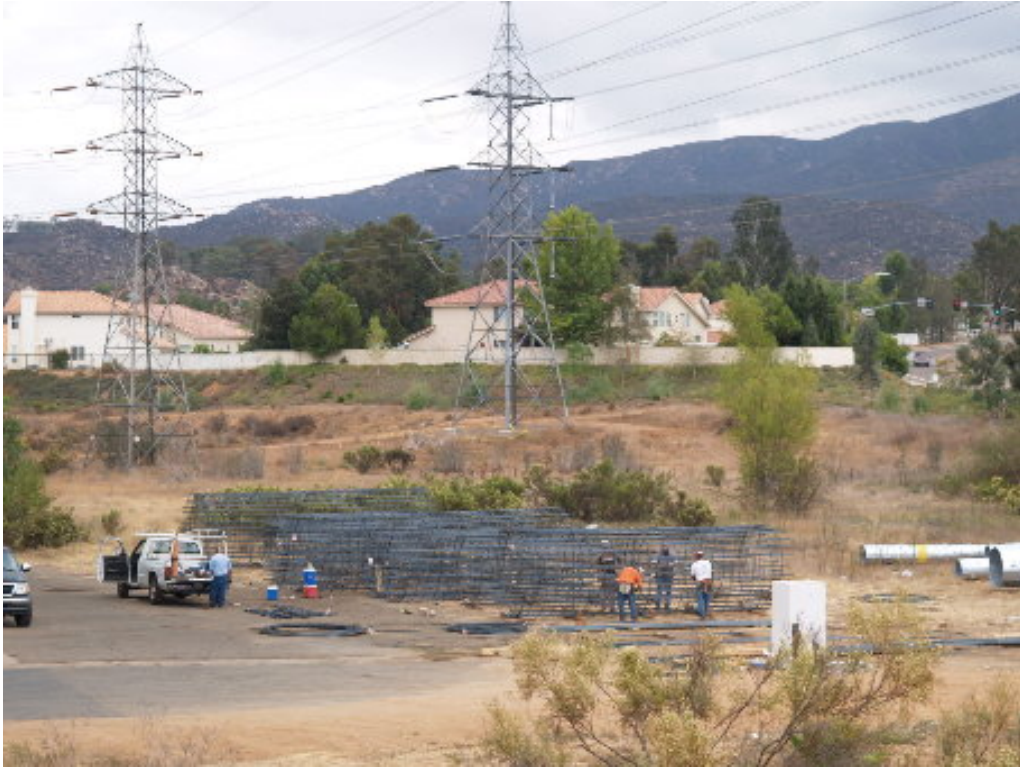
Iron workers worked to build the rebar cages for the foundations at the staging area off Steele Canyon Road (see Figure 3). The boring rigs set up south of Highway 8 at Tower Site 990. The crew encountered hard rock and the drilling proceeded slowly (see Figure 4). The Essex EI worked with the crews to minimize dust and noise for the houses adjacent to the work.

**Figure 3** – Ironworkers built cages at the staging area adjacent to the special-needs school. The cages will be placed in the completed bore holes.

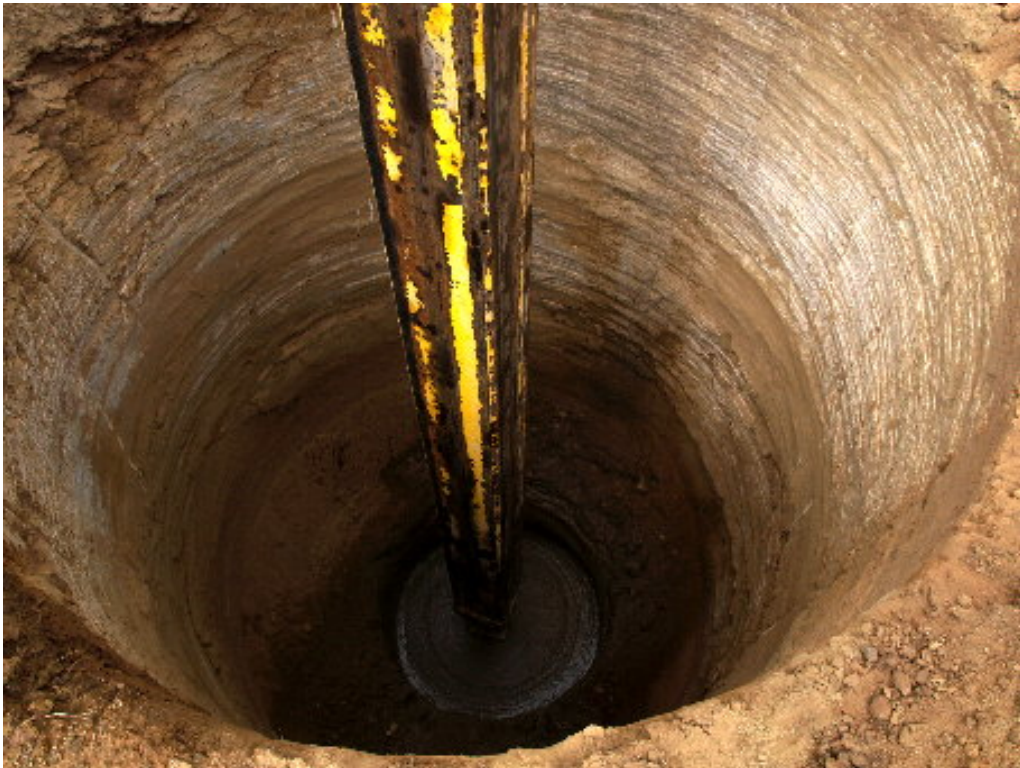
**Figure 4** – The boring crew at Tower 990 encountered dense rock and drilling proceeded slowly. Water is used to keep the drill head cool during boring.

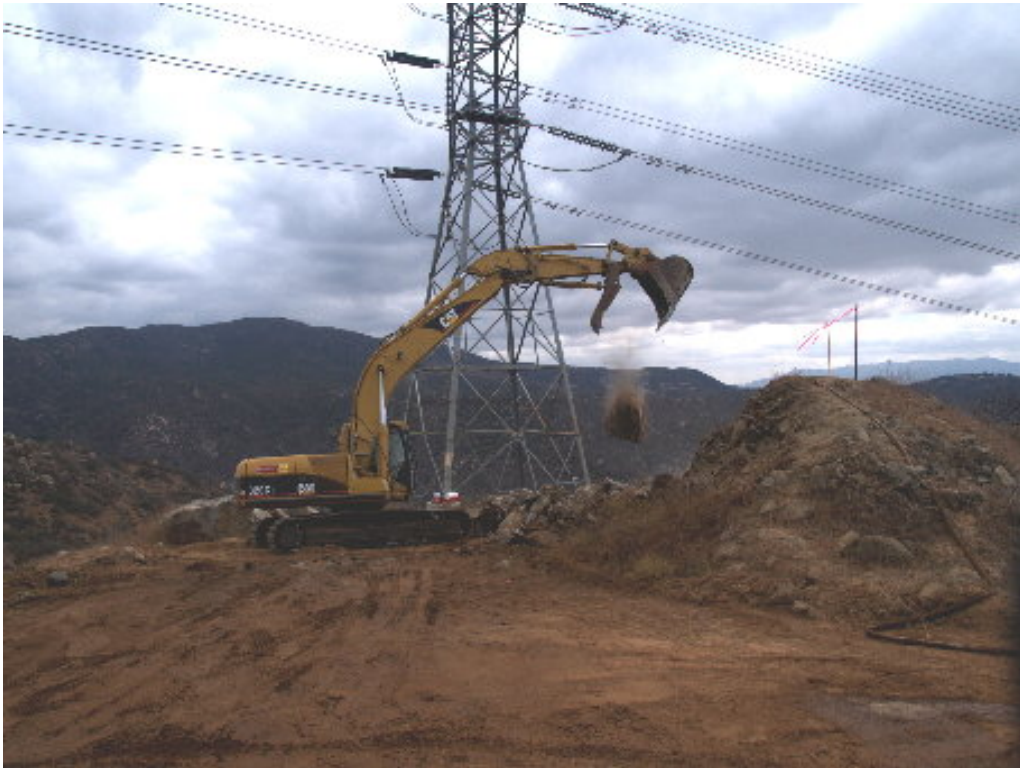
An operator worked at Tower Site 611 to move rocks off the pad and load them onto trucks to be removed from the site (see Figure 5). A water truck worked to reduce fugitive dust during the work with the rocks and watered the road to prevent fugitive dust from impacting the local residences. A small crew completed the retaining wall at Tower Site 932 (see Figure 6). The grade on the access road above the site needs to be re-engineered to account for changes in the grade due to seasonal grading by maintenance crews.

**Figure 5** – The excavator operator at Tower Site 611 moved rock from the pad and loaded it in trucks for removal.

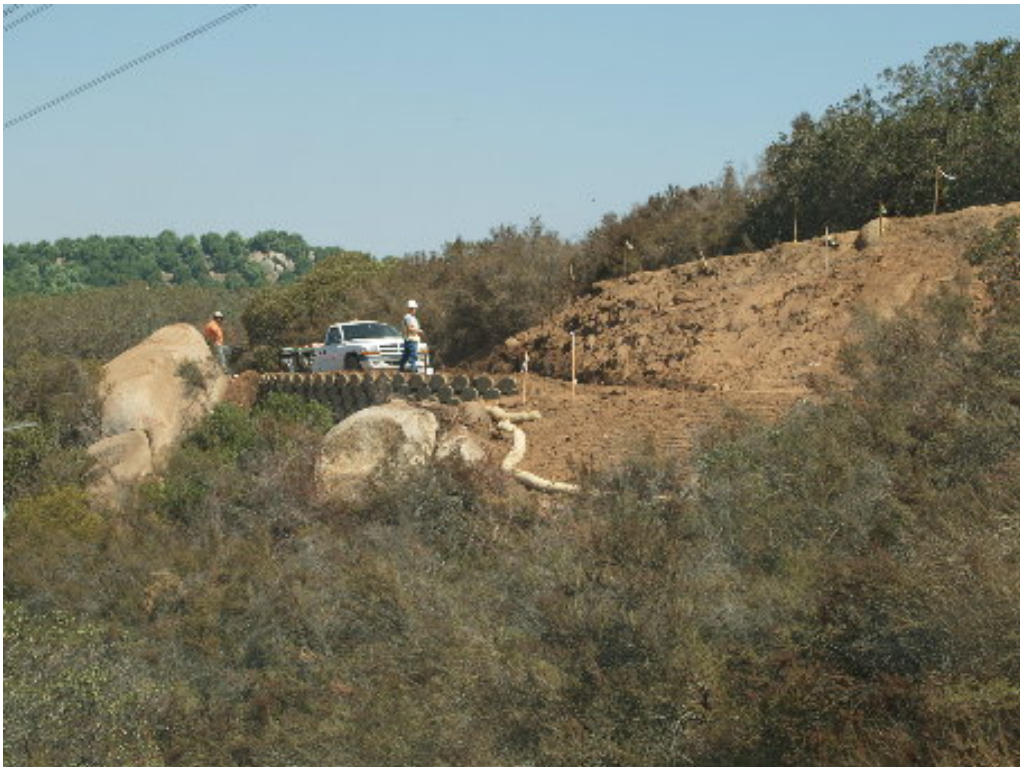
**Figure 6** – The crew at Tower Site 932 completed the retaining wall and installation of the erosion control devices.
