## **PROJECT MEMORANDUM SDG&E – MIGUEL-MISSION 230 kV #2 PROJECT**

**To:** Jensen Uchida, CPUC  
**From:** Vida Strong, Aspen Project Manager  
**Date:** October 25, 2004  
**Subject:** Weekly Report #12: October 17, 2004 – October 23, 2004  
**CPUC Environmental Monitor (EM):** Christopher Meyer

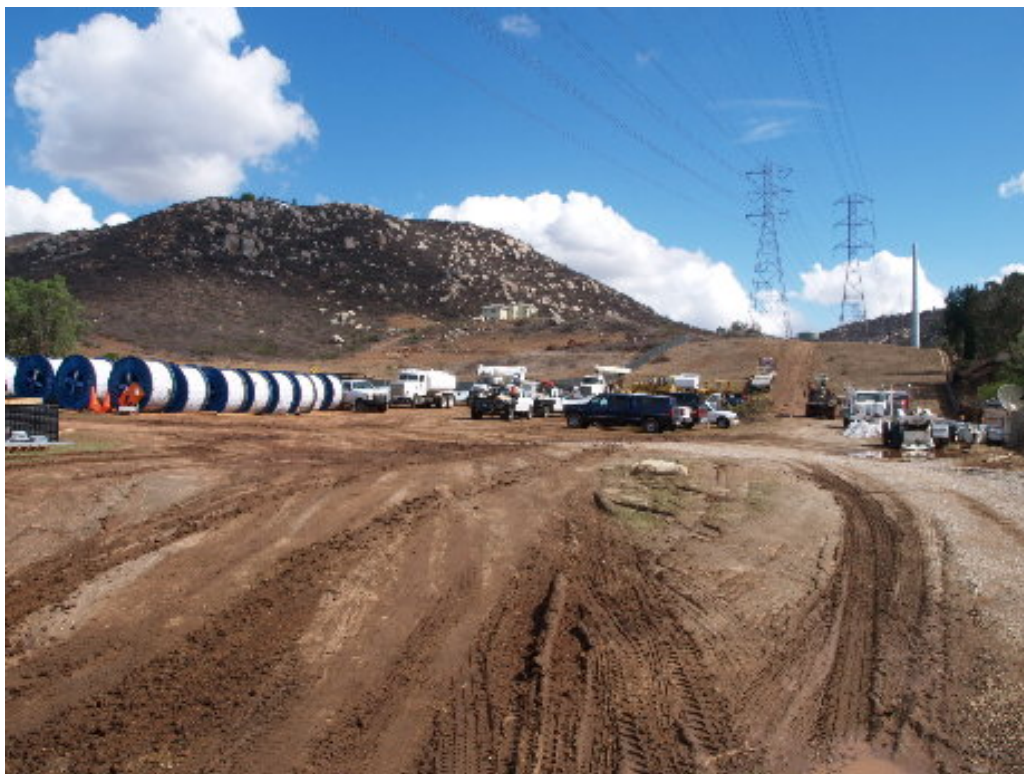
A small crew worked at the Summit Road yard assembling sections of the upper portion of the towers. The crews attached the arms to the upper section of the towers to prepare for connection to the lower sections of the towers that have already been erected (see Figure 1).

**Figure 1** – The transmission line contractor worked at the Summit Road yard. Note the lower tower section erected on the upper right of the photograph.

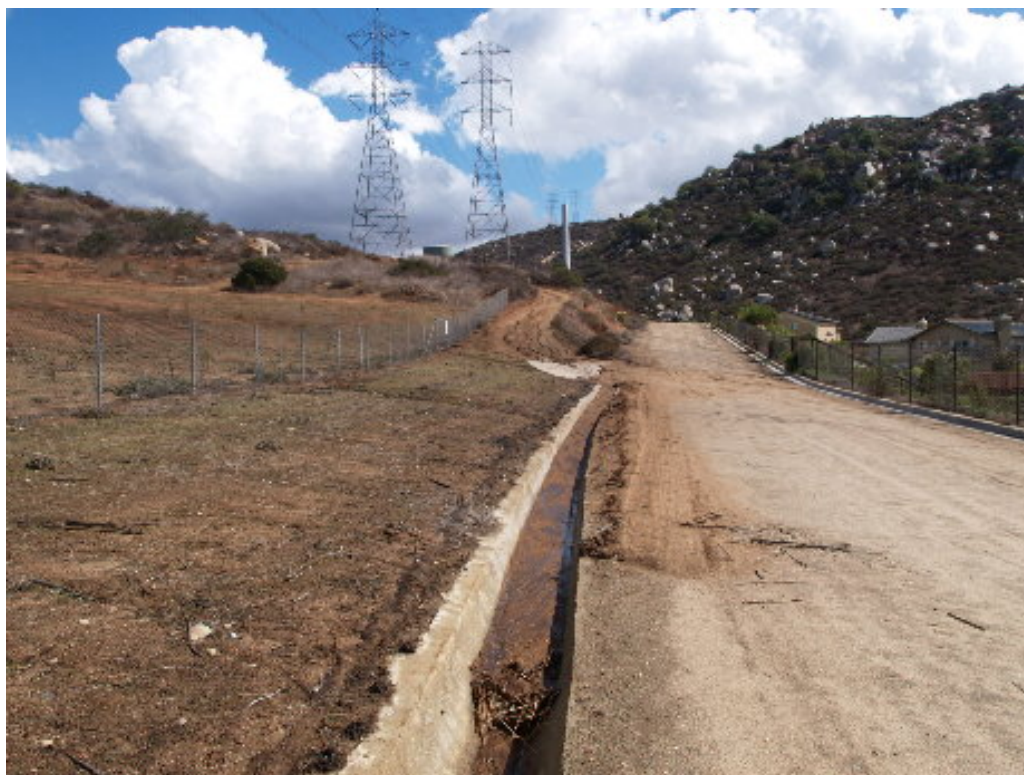
Although Temporary Best Management Practices (BMPs) have been installed around the pad locations, the heavy rains have caused erosion and sediment along the segment. Erosion from Tower Site 1310 flowed off the upper access road and into an adjacent concrete v-ditch (see Figure 2). Erosion off the tower pad itself caused minor deposition of sediment on the lower access road. No evidence of impacts to the adjacent houses was noted during the site visit.

**Figure 2** – Sediment from Tower Site 1310 flowed into an adjacent concrete V-ditch.

The CPUC EM spoke with SDG&E about the BMP concerns following the site visit. SDG&E will be working to address the issues and modify the procedures to avoid future erosion and sedimentation problems.

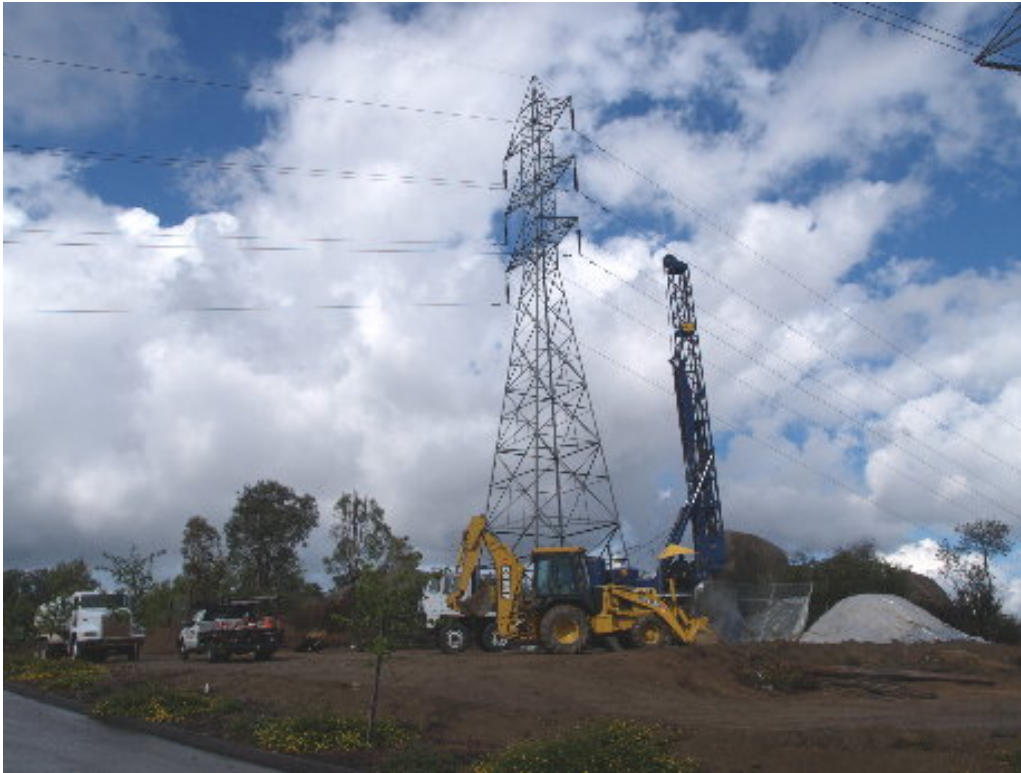
The other drilling machine worked at Vista Rodeo despite the rain due to the proximity to the road and the fact the equipment was in place prior to the rains (see Figure 3). The drilling machine was set up near several houses and the crew is required to be off the road by 7pm. No noise complaints have been received despite the loud drilling due to the hardness of the bedrock. The operation was briefly stopped when the rain grew heavier on October 20. Several sites throughout the project are on hold until blasting plans can be developed and implemented.

**Figure 3** – The drilling crew continued on the foundation at Vista Rodeo during the subject week, stopping only briefly for heavy rainfall.

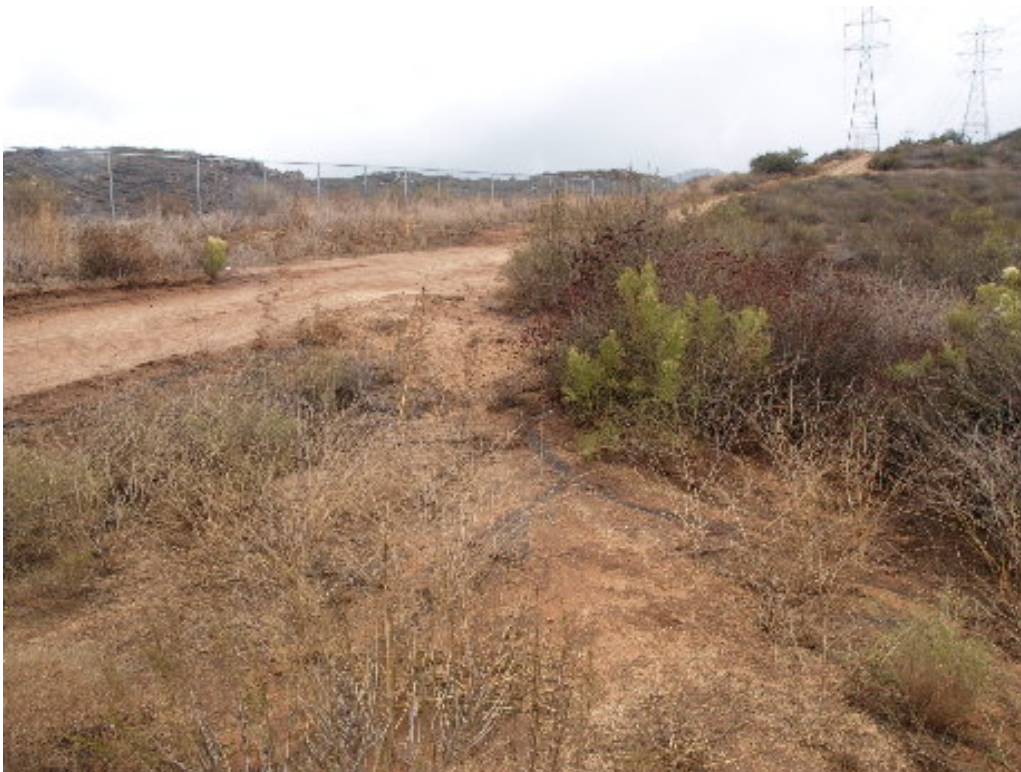
The CPUC EM noted that many of the water bars installed by the operations crews were only loosely compacted and ran at grades much steeper than the 5–7 percent slope appropriate for this type of soil. Loose soil was piled at the outlet of many water bars, resulting in the transportation of sediment into the surrounding habitat (see Figure 4). No sediment containment was noted on the outlets of any of the water bars. The water bars on the steep access road to Tower Site 440 were completely washed away, resulting in sediment on the public road and into the adjacent storm drain (see Figure 5). In situations such as at Tower Site 342, the rain run-off down the maintenance/access road was not diverted away from the pad and eroded a section of the crane pad (see Figure 6). At this site and others, the straw wattles either floated or were undercut by the erosion.

**Figure 4** – Sediment flowed off the access road into the adjacent coastal sage scrub habitat. Water bars were excessively steep and lacked sediment traps.

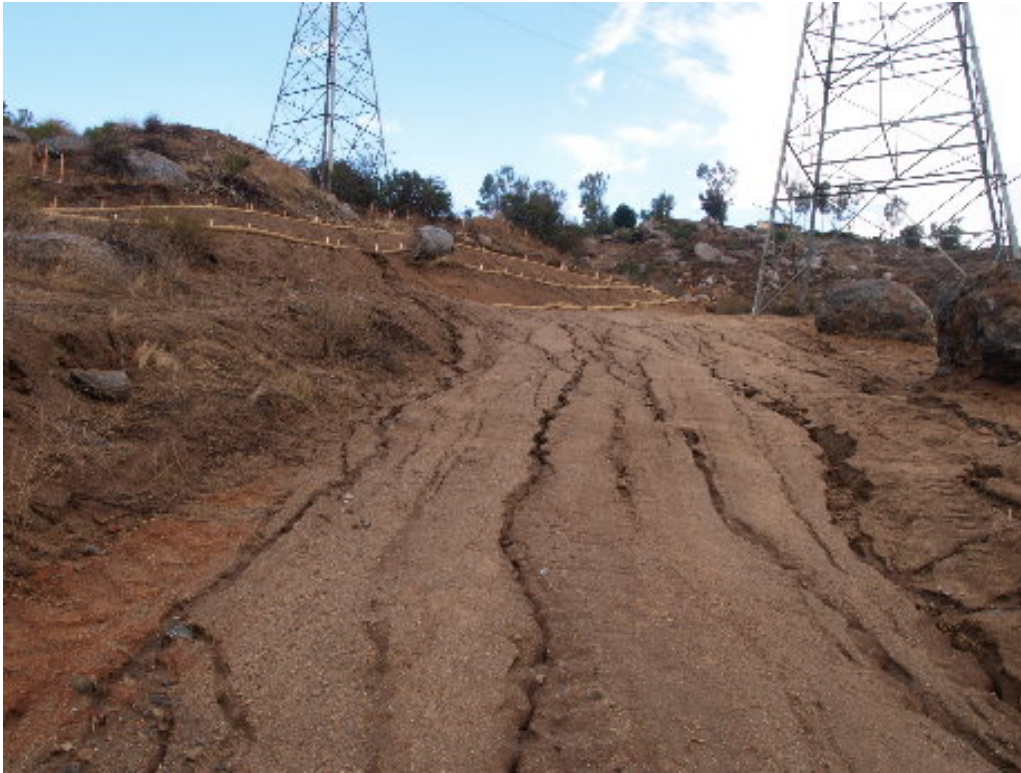
**Figure 5** – The water bars at Tower Site 440 were completely washed away and sediment flowed onto the public right-of-way and into the storm drain.

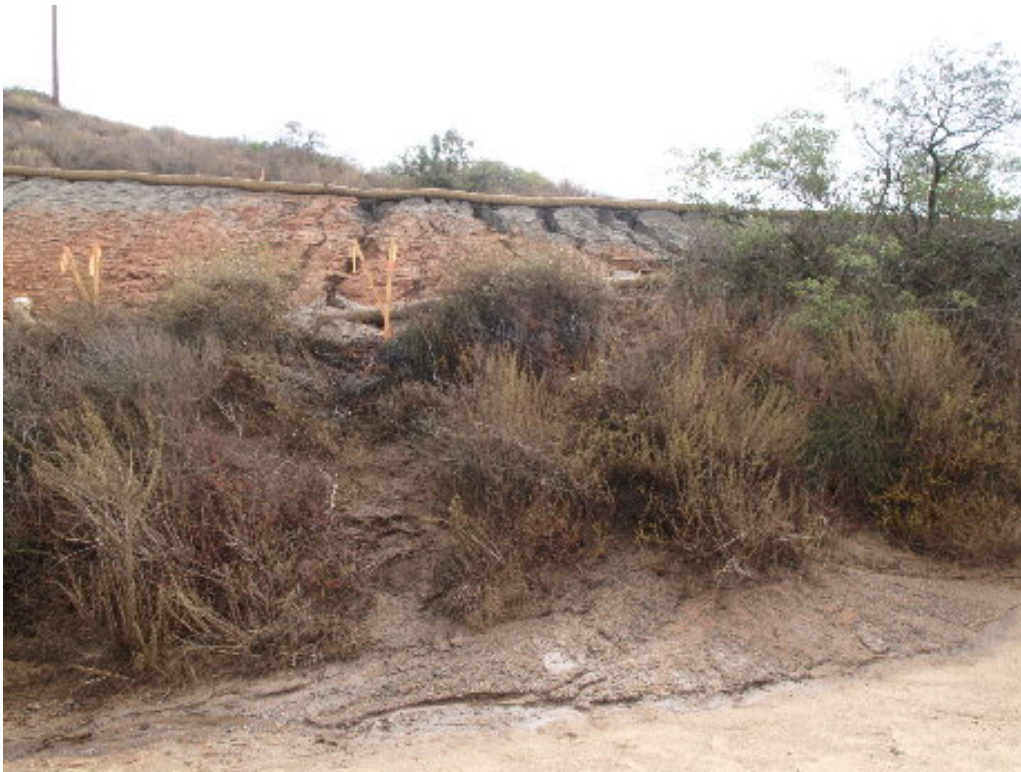
**Figure 6** – The straw waddles at Tower Site 325 were undercut as run-off from the access road flowed over the crane pad and sediment flowed down through the vegetation.
