PROJECT MEMORANDUM SDG&E – MIGUEL-MISSION 230 kV #2 PROJECT

To: Jensen Uchida, CPUC
From: Vida Strong, Aspen Project Manager
Date: December 1, 2004
Subject: Weekly Report #17: November 21, 2004 – November 27, 2004
CPUC Environmental Monitor (EM): Christopher Meyer

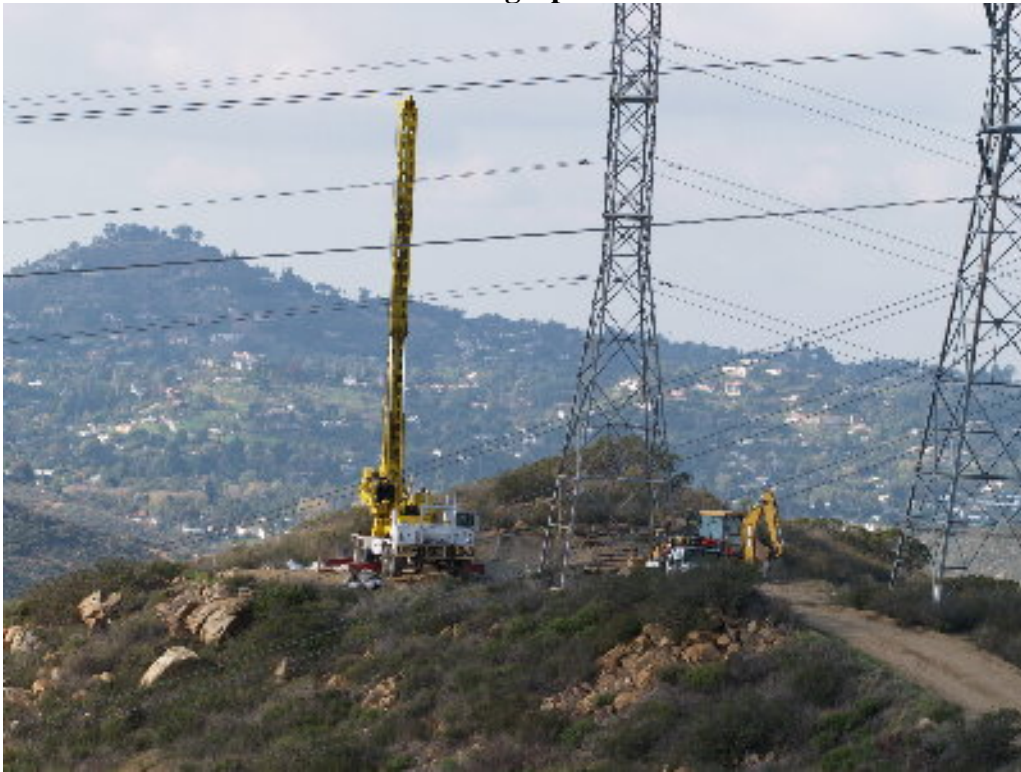
The drilling machine continued work at Tower Site 221 during the week (see Figure 1). The crew worked with the medium size auger expanding the diameter of the hole. The site was wet from light rains over the weekend.

Figure 1 – Drilling continued at Tower Site 221.

The recent light rains have kept dust down on the right-of-way. No significant erosion or sediment issues were noted during the site visit. The Essex EI was notified that the crew at Tower Site 221 breached the earthen berm to allow rainwater to leave the right-of-way. The berm needs to be repaired or BMPs need to be placed.

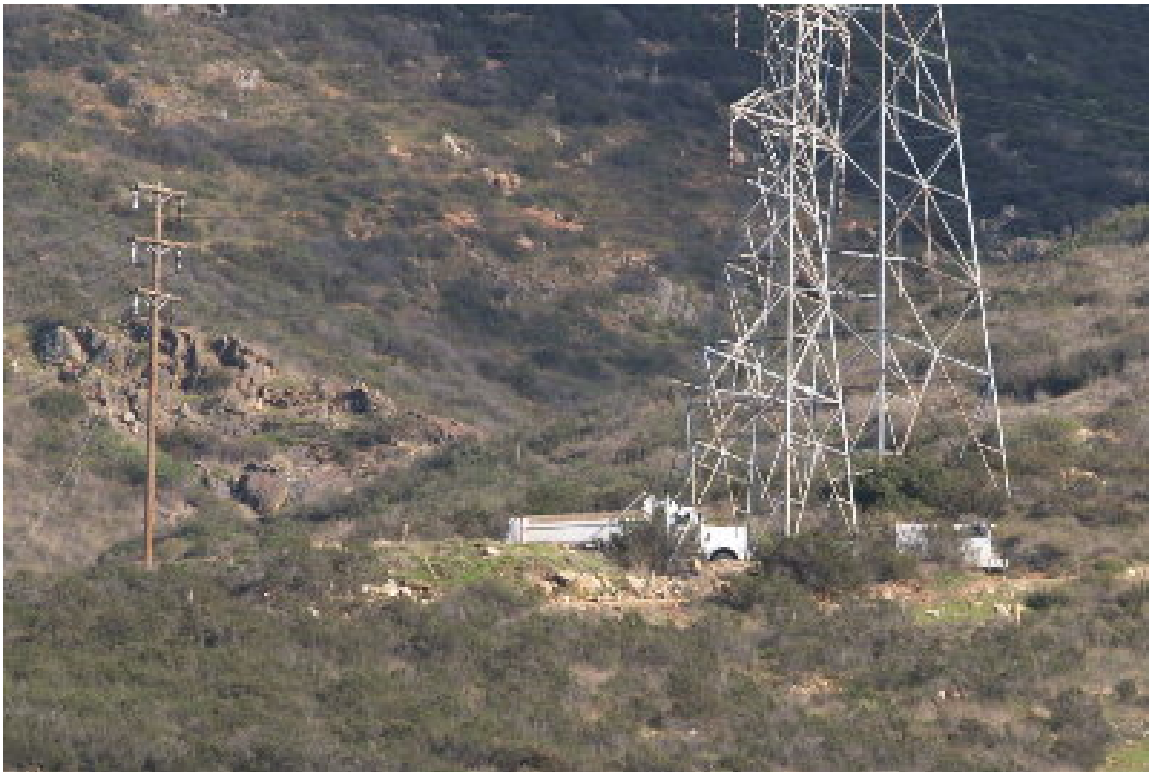
No work occurred at Tower Site 151 while the mechanic worked on the dump truck that was broken (see Figure 3).

Figure 2 – A mechanic worked on the broken dump truck at Tower Site 151.

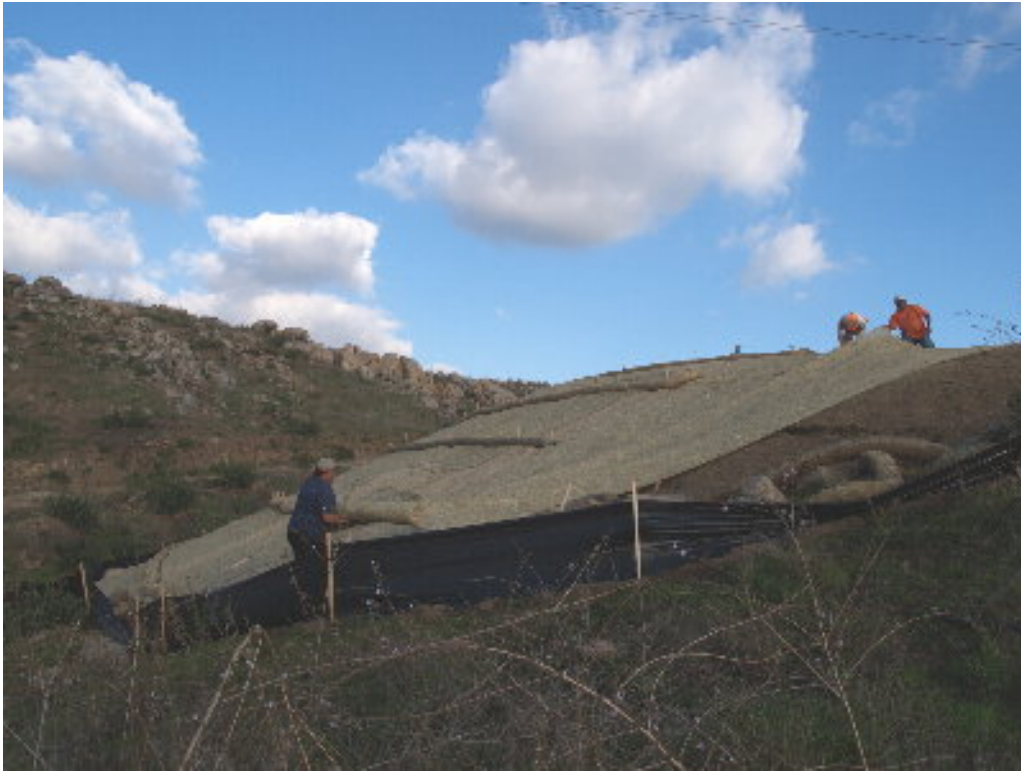
A crew started reseeding and installing the permanent BMPs at Tower Site 797 (see Figure 2). The crew raked the slope and then placed the native seed mix. The seed mix was raked into the slope and the slope covered with the straw mat. The straw mat was keyed into the slope with straw waddles. The erosion control specialist noted that the waddles needed to be deeper in the trench to avoid undercutting.

Figure 3 – The Union crew started reseeding and placing straw matting.

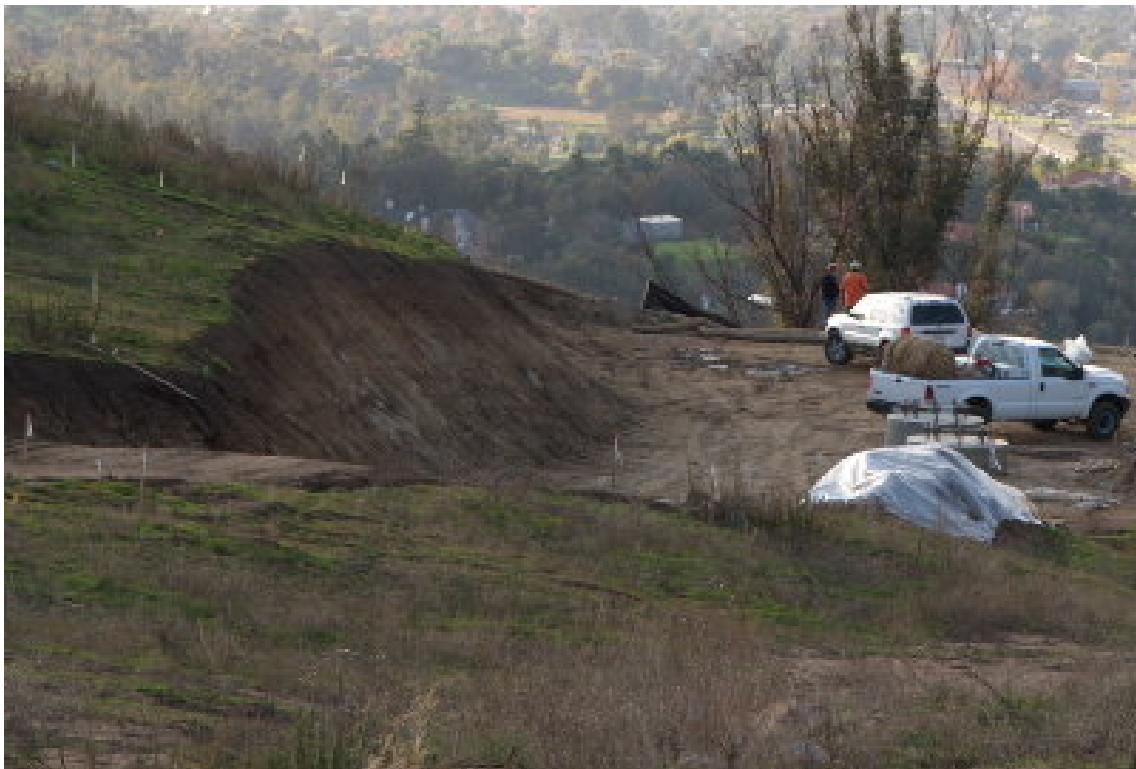
SDG&E is looking at ways to stabilize the cut slopes that are partially rock (see Figure 4). These slopes are a mix of topsoil and bedrock and cannot be easily stabilized by matting.

Figure 4 – The cut slope at Tower Site 797 is primarily bedrock and cannot be stabilized by matting.
