## **PROJECT MEMORANDUM SDG&E – MIGUEL-MISSION 230 kV #2 PROJECT**

**To:** Jensen Uchida, CPUC  
**From:** Vida Strong, Aspen Project Manager  
**Date:** December 6, 2004  
**Subject:** Weekly Report #18: November 28, 2004 – December 4, 2004  
**CPUC Environmental Monitor (EM):** Christopher Meyer

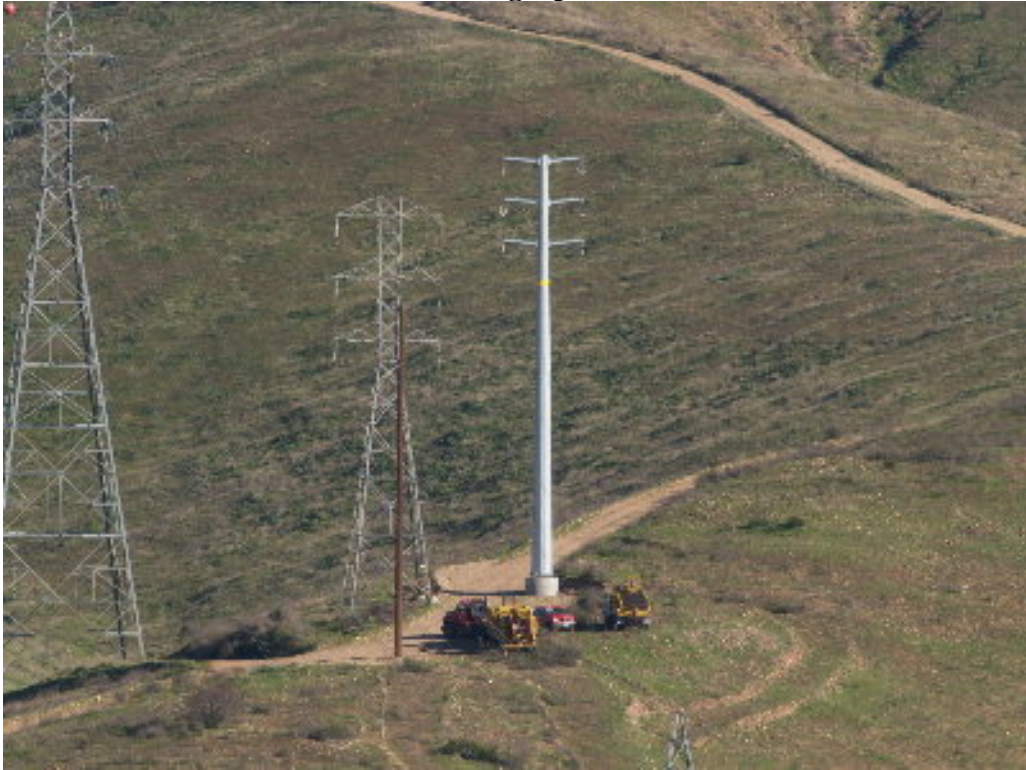
**Figure 1** – Cable puller and reel truck set up north of Santee Lakes during stringing operation.

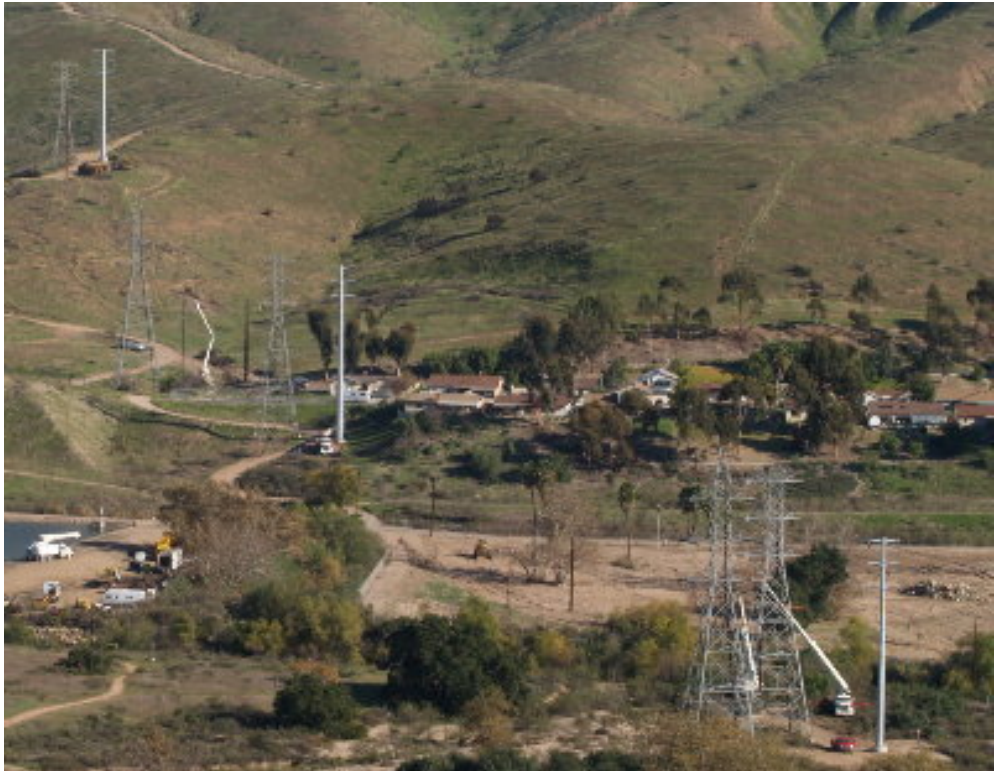
The stringing of transmission line cable started at Fanita Junction during the subject week. The stringing crew worked with a helicopter to thread the cable through the supports on the relatively open section in preparation for future stringing between existing towers. Unfortunately, the helicopter stringing was completed during the weekly meeting and the CPUC EM was not able to observe the activity. The cable reels were set at Fanita Junction and the puller was set east of Santee Lakes (see Figure 1). Several support trucks are used along the string operation to protect other lines and support the cable during the pull (see Figure 2).

**Figure 2** – Support vehicles protected other utilities and the cable during stringing operation.

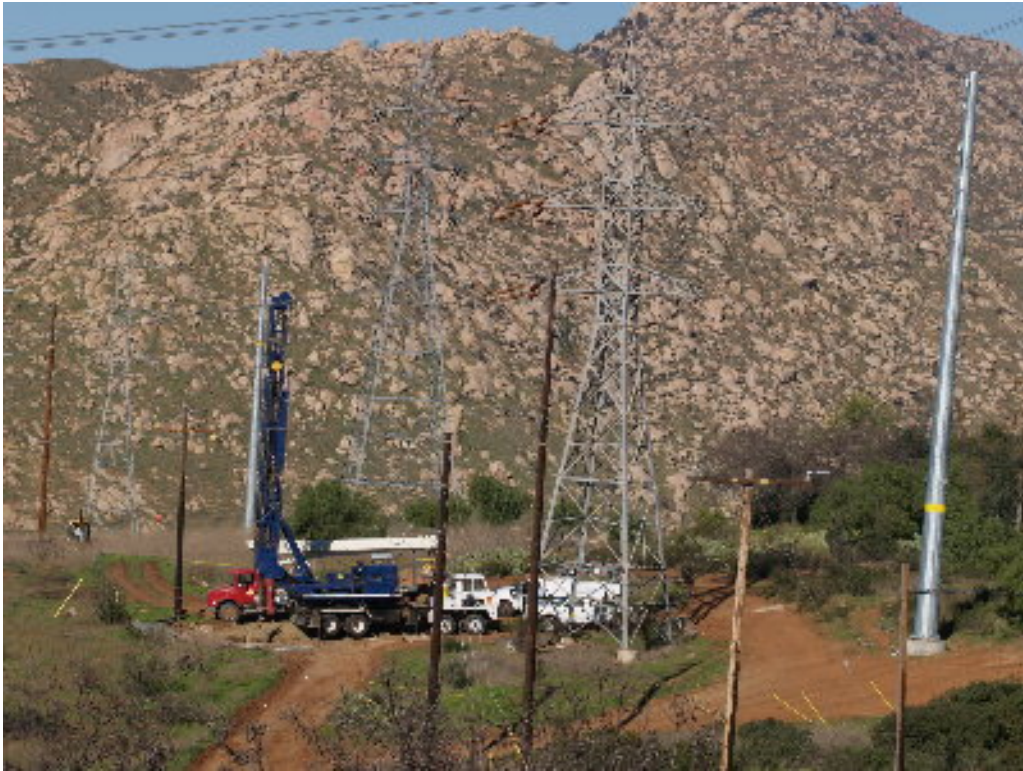
A drilling machine worked above the Los Coches Substation at Tower Site 1140 during the site visit (see Figure 3). The access roads to the sites have been repaired and are passable by all vehicles.

**Figure 3** – A drill continued work above the Los Coches Substation at Tower Site 1140.

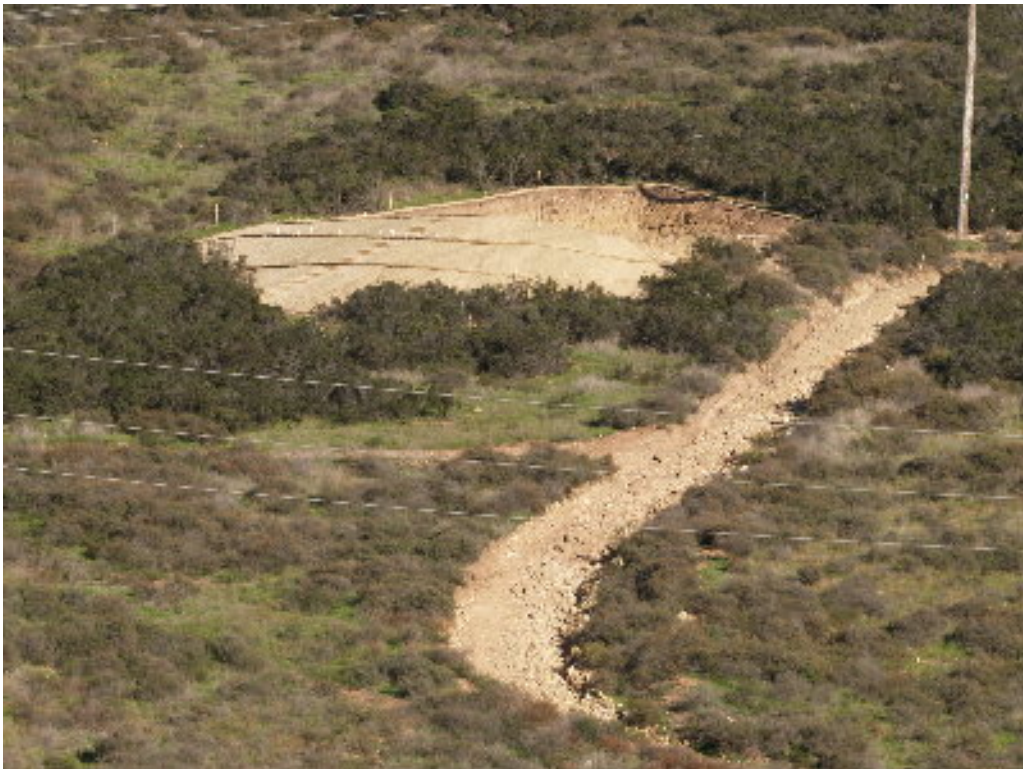
A crew started reseeding and installing the permanent BMPs at Tower Site 10 (see Figure 4). The crew raked the slope and then placed the native seed mix. The seed mix was raked into the slope and the slope covered with the straw mat. The straw mat was keyed into the slope with straw waddles.

**Figure 4** – The Union crew reseeded Tower Site 10 east of the Miguel Substation.  
Note the condition of the access road following the heavy rainfall.

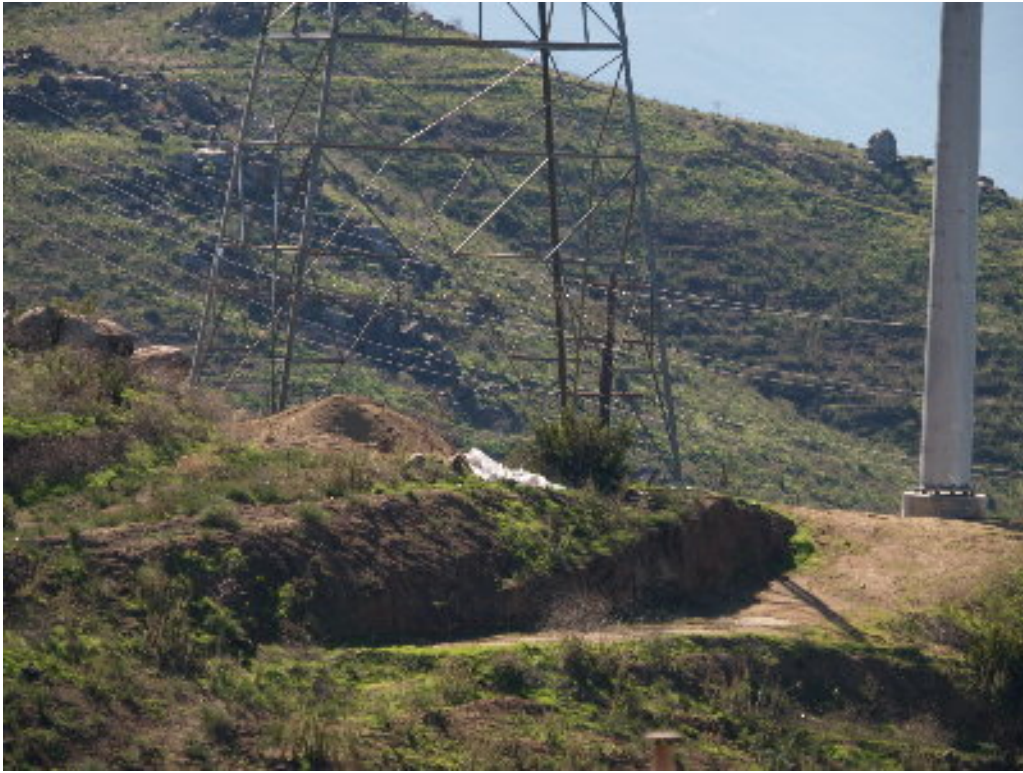
The timing and right-of-way preparation for permanent restoration and reseeded was one of the main topics of the weekly meeting. The drilling and foundation crews typically leave the pads and slopes with excess spoil piles and debris that prevents the small reseeded crew from completing the sites (see Figure 5). In addition, the loose soil on the fill slopes needs to be removed in many cases and the slope re-compacted. Several different contractors are working at each site and have different responsibilities under the conditions of their contracts. SDG&E is trying to coordinate getting the proper contractor to address the clean-up and repair work on the pads without significantly impacting construction progress. The Essex EI informed SDG&E that the optimal window for permanent reseeded (use of native seed mix instead of the temporary stabilizing seed mix) is rapidly closing. SDG&E will determine whether temporary or permanent restoration during the current rainy season will best meet their construction schedule and restoration success criteria.

**Figure 5** – The Union reseeding crew is waiting for other contractors to remove spoil piles and repair most of the pad locations before proceeding with permanent restoration.
