PROJECT MEMORANDUM SDG&E – MIGUEL-MISSION 230 kV #2 PROJECT

To: Jensen Uchida, CPUC
From: Vida Strong, Aspen Project Manager
Date: December 14, 2004
Subject: Weekly Report #19: December 5–11, 2004

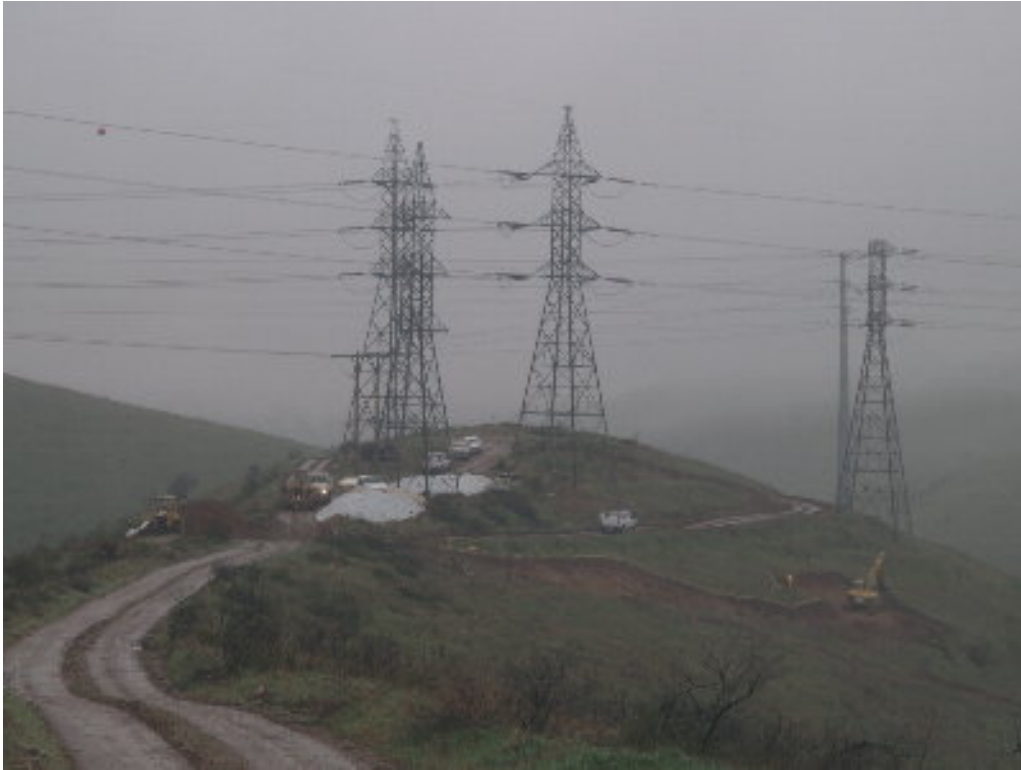
The grading of the pads for the 230 kV towers at Fanita Junction, on Miramar Naval Air Station, started during the subject week. Crews worked in the rain to excavate the pad on the side-hill for Tower Site G (see Figure 1). An operator worked with an excavator to remove the spoils from the cut bank (see Figure 2). Material hauling was suspended due to the slippery condition of the right-of-way. Haul trucks needed assistance up the slope from Tower Site G. The access road to the Fanita Junction locations was not easily accessible with the rain and the contractor graded the road and cut several outlets for water and graded mud (see Figure 3). SDG&E and the Essex Environmental Inspector (EI) reviewed the situation and required clean-up of several of the locations and straw waddle installation at the others.

Figure 1 – The Union crew worked on the activities covered under NTP #3, on Miramar Naval Air Station, during the subject week.

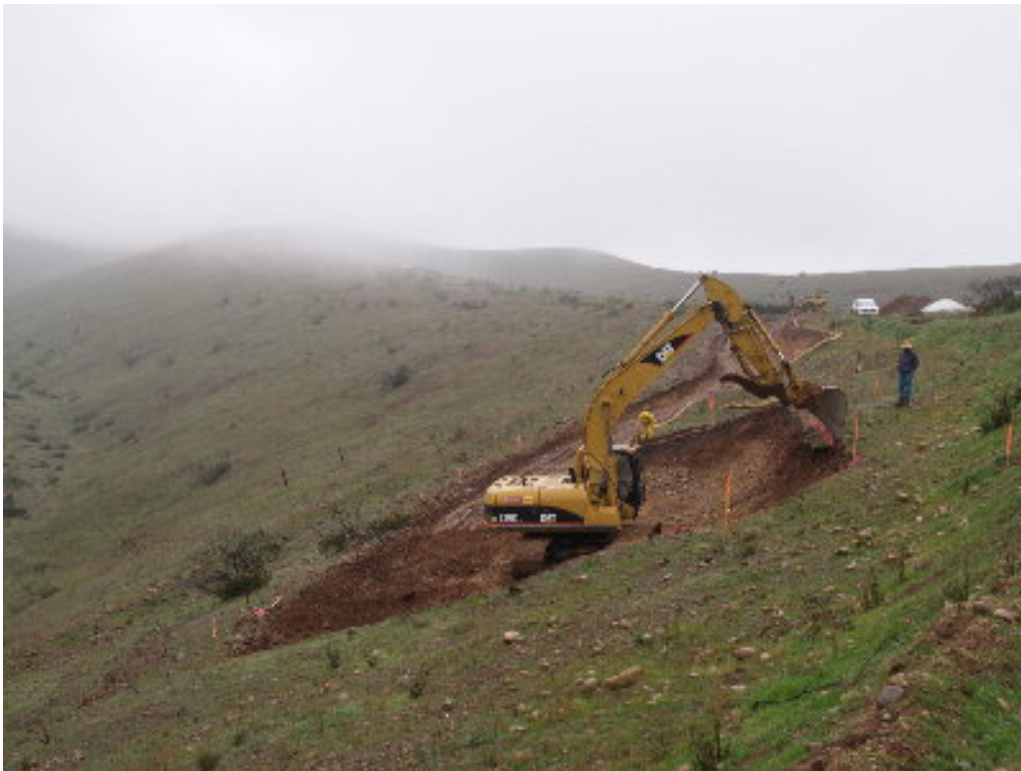
Figure 2 – The paleontologist was on-site at Tower Site G to monitor during excavation. No fossils or fossiliferous material was noted.

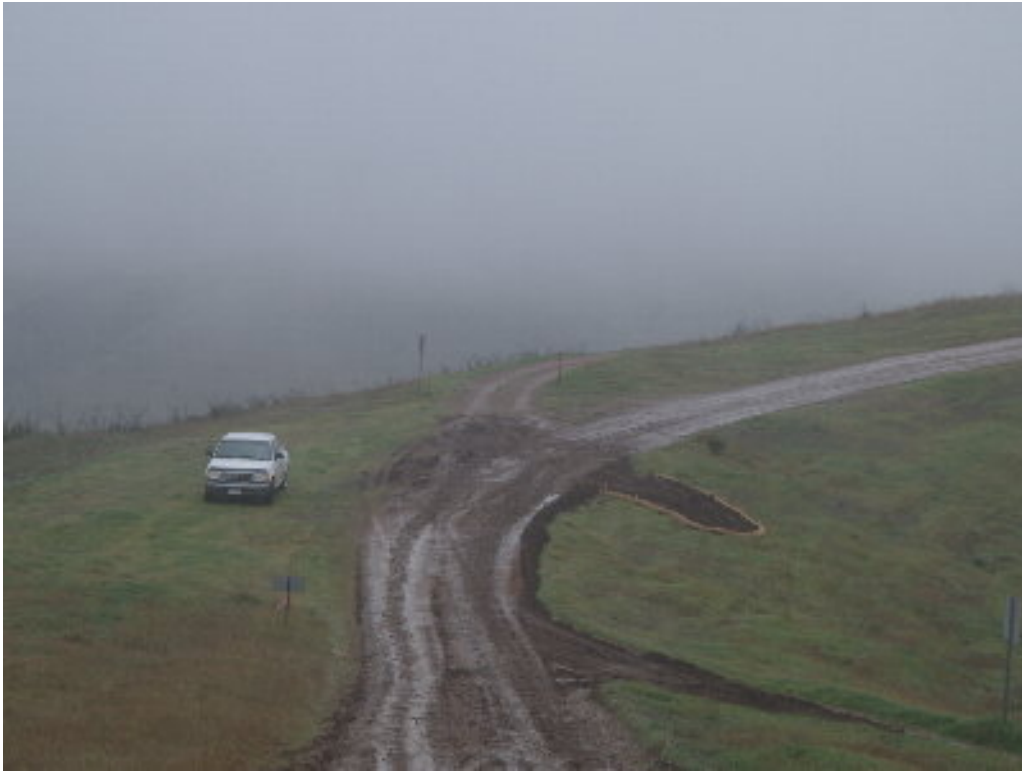
Figure 3 – The contractor worked on the access road to Fanita Junction and created erosion and sediment issues that were addressed by Essex and SDG&E.

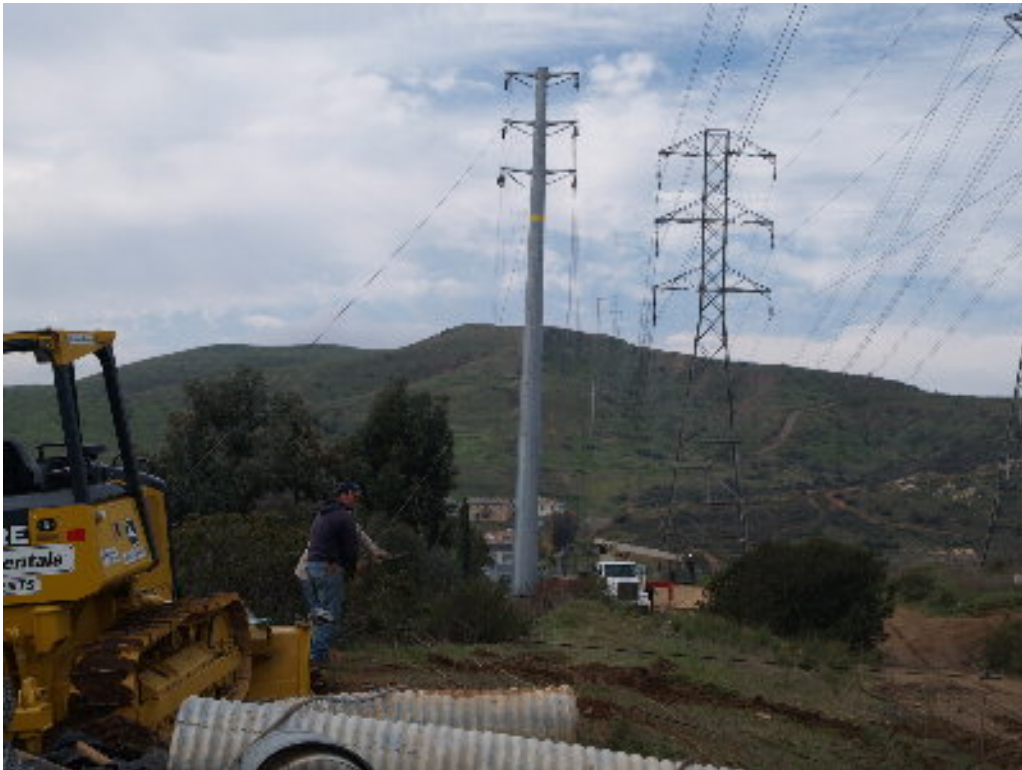
For the, 138/69 kV tower installation, stringing has reached the Summit Road yard and crews installed guy wires to keep the steel pole from deflecting under the pull of the cables (see Figure 4). Stringing cannot proceed until the upper section of Tower 1300 is placed. Guy wires were placed on the steel towers at Santee Lakes and also on poles that were deflected between 5 and 7 feet at the tops under the pull of the cable. The guy wires were placed in-line with the transmission line and impacts were limited to the approved project area.

Figure 4 – The PAR stringing crew worked to anchor the guy wire from the steel pole to the bulldozer to prevent the pole from bending under the pull of the cable.

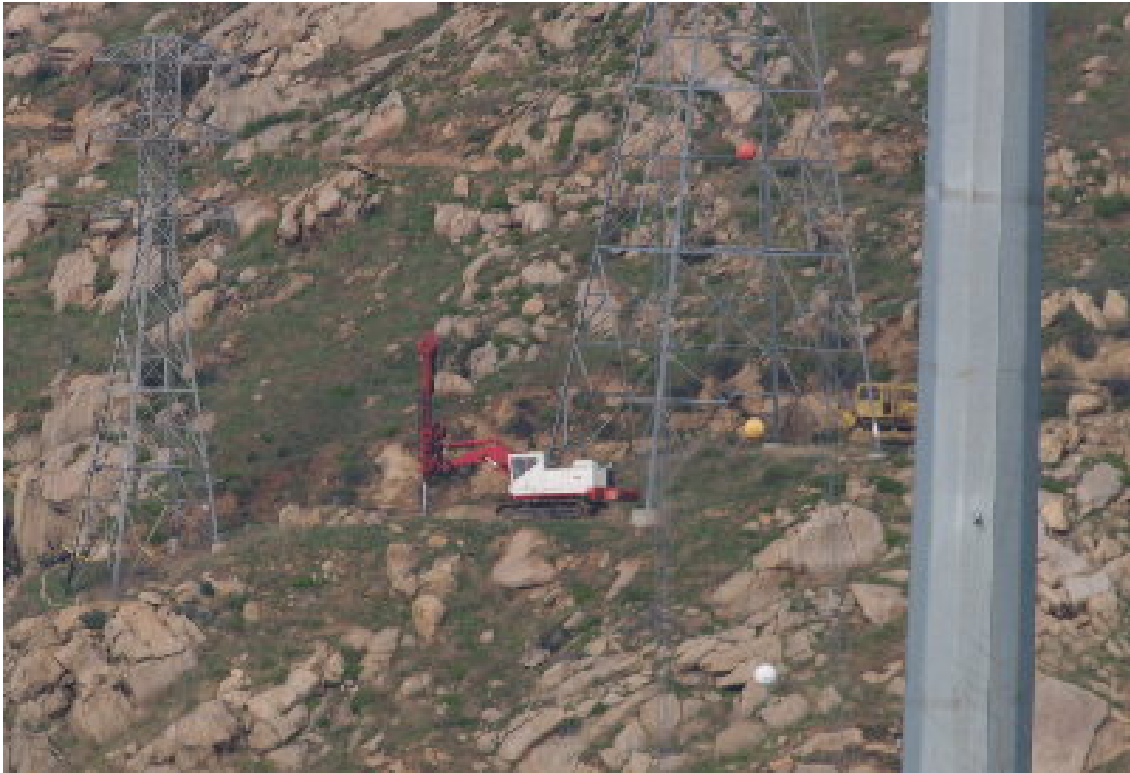
The Low Drill drilling machine worked at Tower Site 1160 during the site visit (see Figure 5). The access road to the site was not passable for the CPUC EM after the rain on Wednesday.

Figure 5 – The Low Drill moved to Tower Site 1160 and started drilling during the end of the previous week. Work continued on December 7.

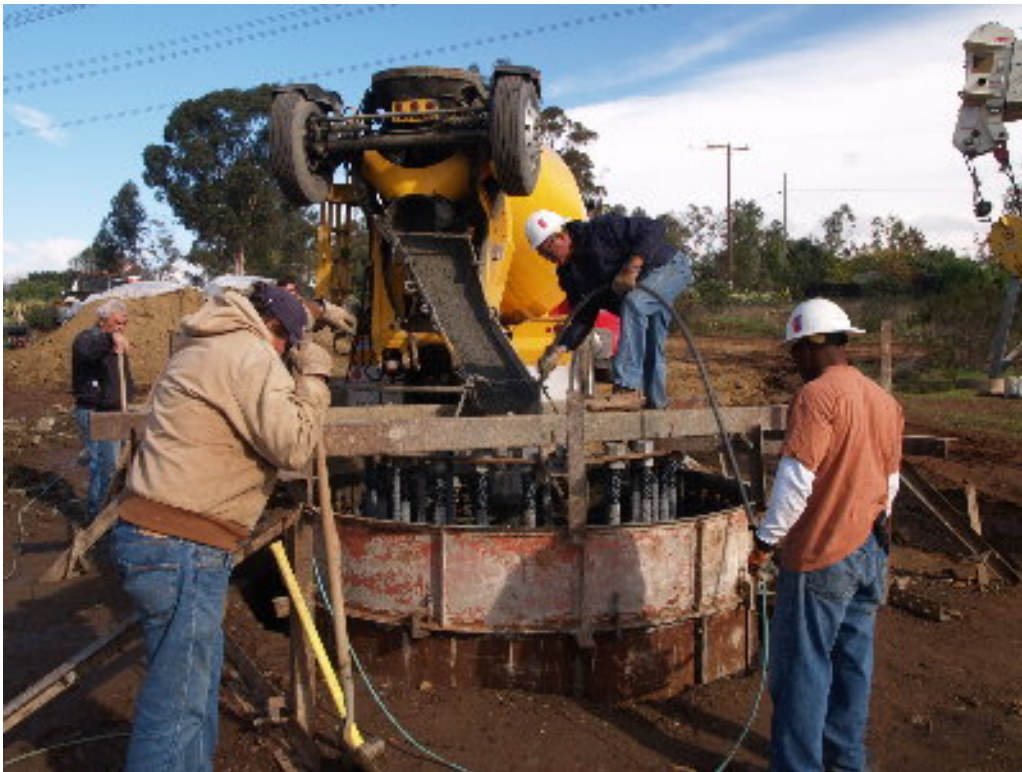
PAR worked above the Los Coches Substation at Tower Site 1140 on Tuesday pouring concrete for the foundation (see Figure 6). The access roads to the sites had been repaired and were passable by the concrete trucks on Tuesday.

Figure 6 – The PAR crew worked to pour concrete in the foundation forms at Tower Site 1140.

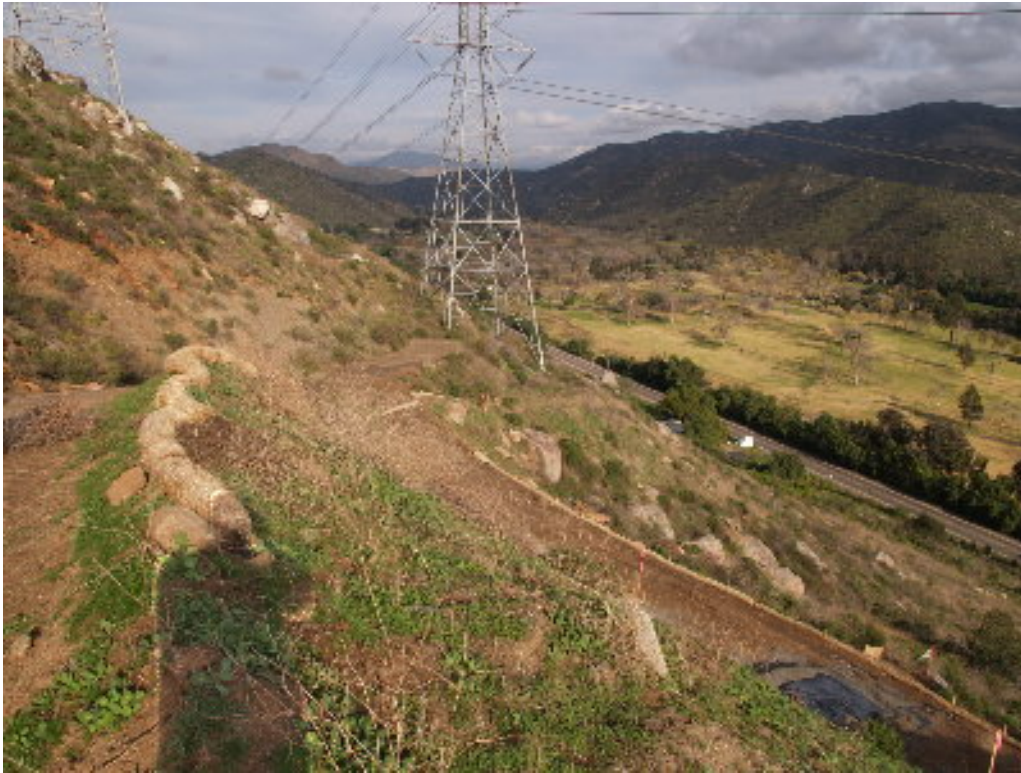
The CPUC EM met with the SDG&E Project Manager and transmission engineer to review site conditions at Tower Site 481. The field visit was in response to the letter from local residents received by the CPUC Project Manager with complaints about pole location. The steep side-slope in the area restricts the location of the pole location (see Figure 7). The existing poles are off-set and the potential sway of the existing and proposed lines restricts the safe location of the poles. The alternate location proposed by the property owners would move the visual impact to the view line of other property owners, one of which has expressed concern over the alternate location. The CPUC EM verified that the location where the pad grading and foundation drilling have been completed match the location in the project documents (Figures 2-2 and 4-10 in the Environmental Impact Report).

Figure 7 – Location of Tower Site 481 (excavation covered with black plastic on bottom right) relative to existing lattice towers. Note the steep side slope.
