PROJECT MEMORANDUM SDG&E – MIGUEL-MISSION 230 kV #2 PROJECT

To: Jensen Uchida, CPUC
From: Vida Strong, Aspen Project Manager
Date: January 13, 2005
Subject: Weekly Report #23: January 2, 2004 – January 8, 2005
CPUC ENVIRONMENTAL MONITOR (EM): Christopher Meyer

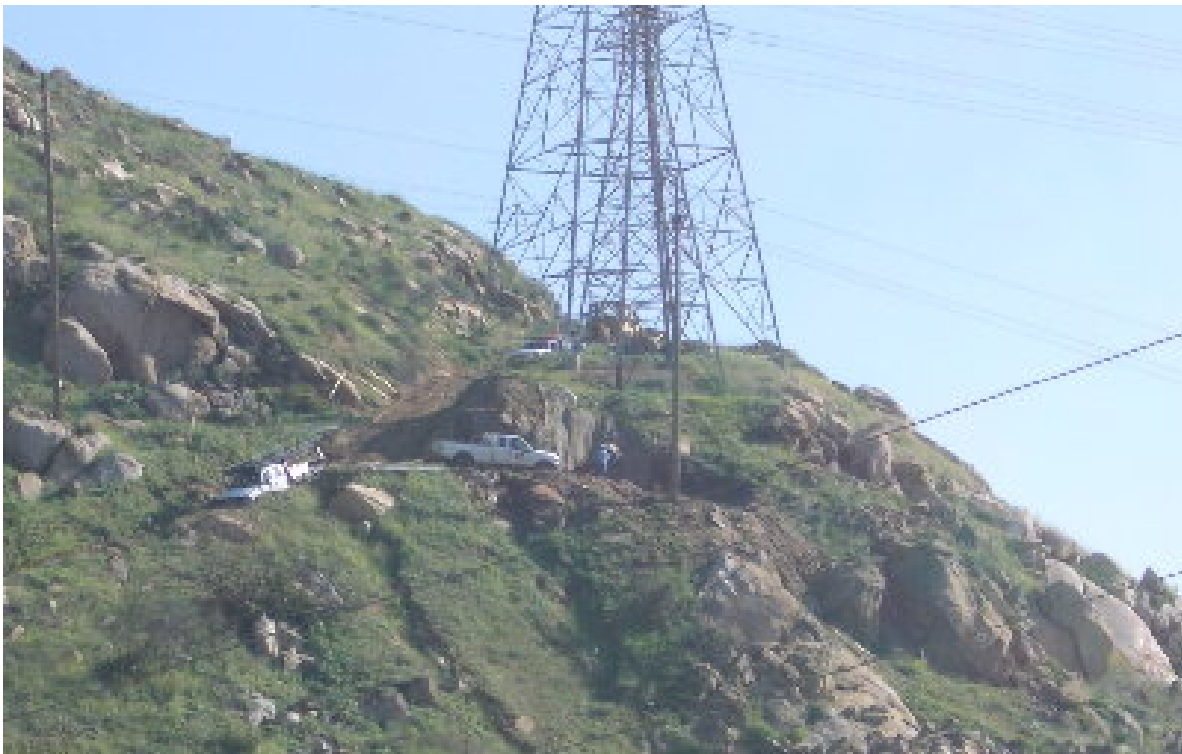
Figure 2 – The concrete crew prepared Tower Site 635c for pouring.

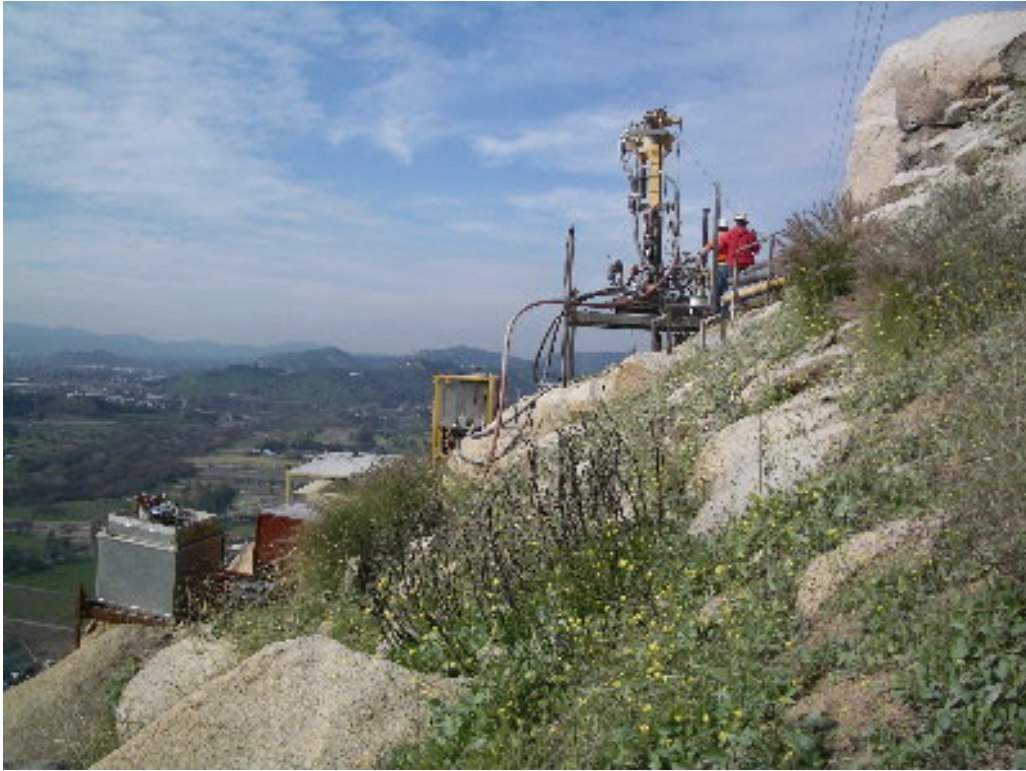
A crew worked on the micro-pile drilling at Tower Site 1170 during the subject week (see Figure 3). The site was originally slated for hand-digging, but the methodology was changed due to time and safety concerns. The holes will be carefully covered prior to the predicted storm to avoid getting sediment in the excavations. The broken concrete bags will be cleaned up and covered prior to the crew leaving the site. A water truck was used to clean the public road of material tracked from the muddy right-of-way by the various activities (see Figure 4).

Figure 3 – A crew worked to micro-pile Tower Site 1170 on the steep sidehill.

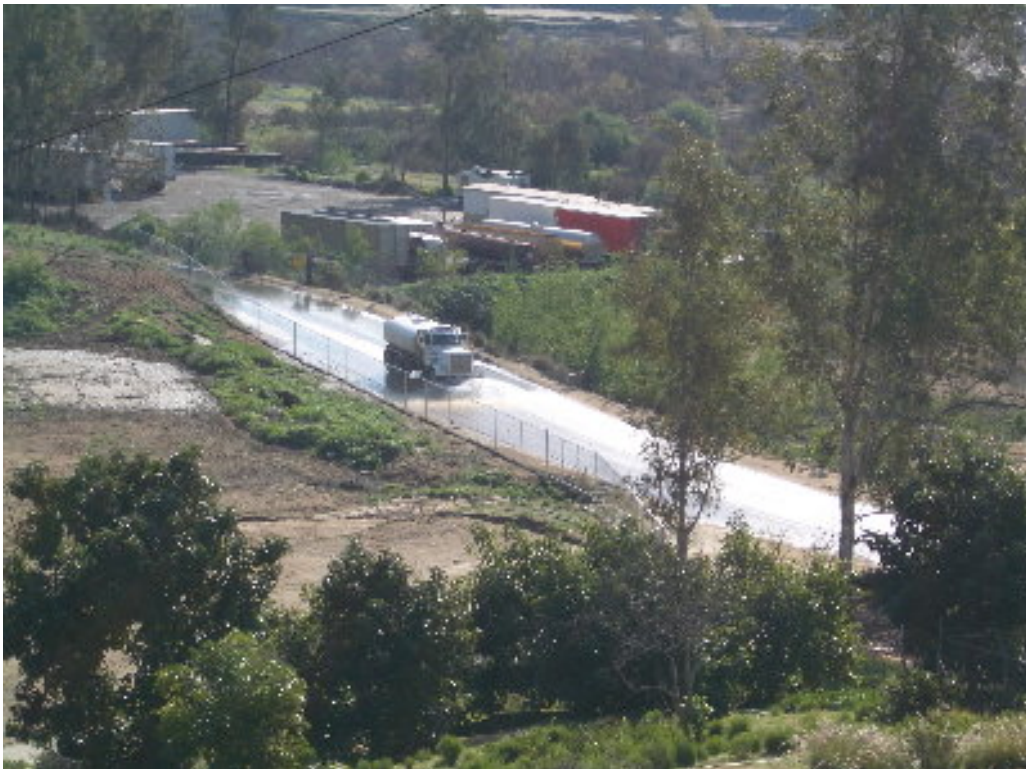
Figure 4 – The water truck was used to clean sediment transported onto the public road.
