PROJECT MEMORANDUM SDG&E – MIGUEL-MISSION 230 kV #2 PROJECT

To: Jensen Uchida, CPUC
From: Vida Strong, Aspen Project Manager
Date: March 2, 2005
Subject: Weekly Report #30: February 20, 2004 – February 26, 2005
CPUC Environmental Monitor (EM): Christopher Meyer

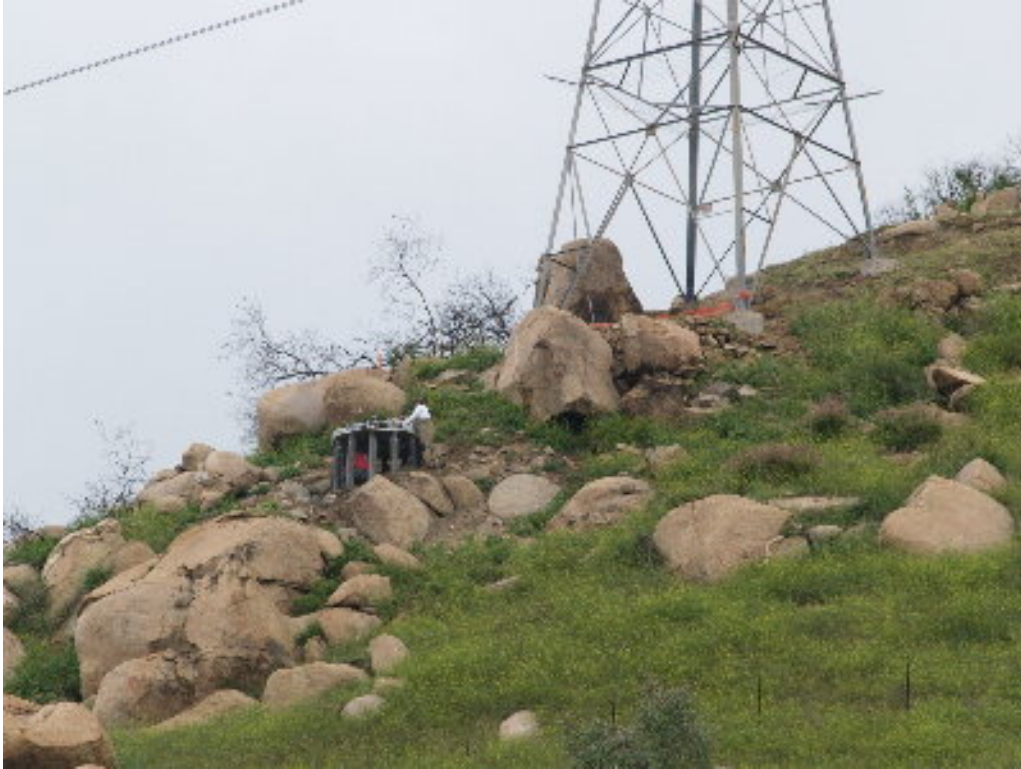
4. A testing crew worked at Pole Site 1170 (138/69 kV) to examine the micro-piles (see Figure 1). The foundation was constructed by use of the micro-pile technique due to the steep slope and access problems. The micro-pile technique uses multiple small diameter supports drilled into the bedrock at a very slight angle off vertical.

Figure 1 – A testing crew worked to check the micro-piles at Pole Site 1170.

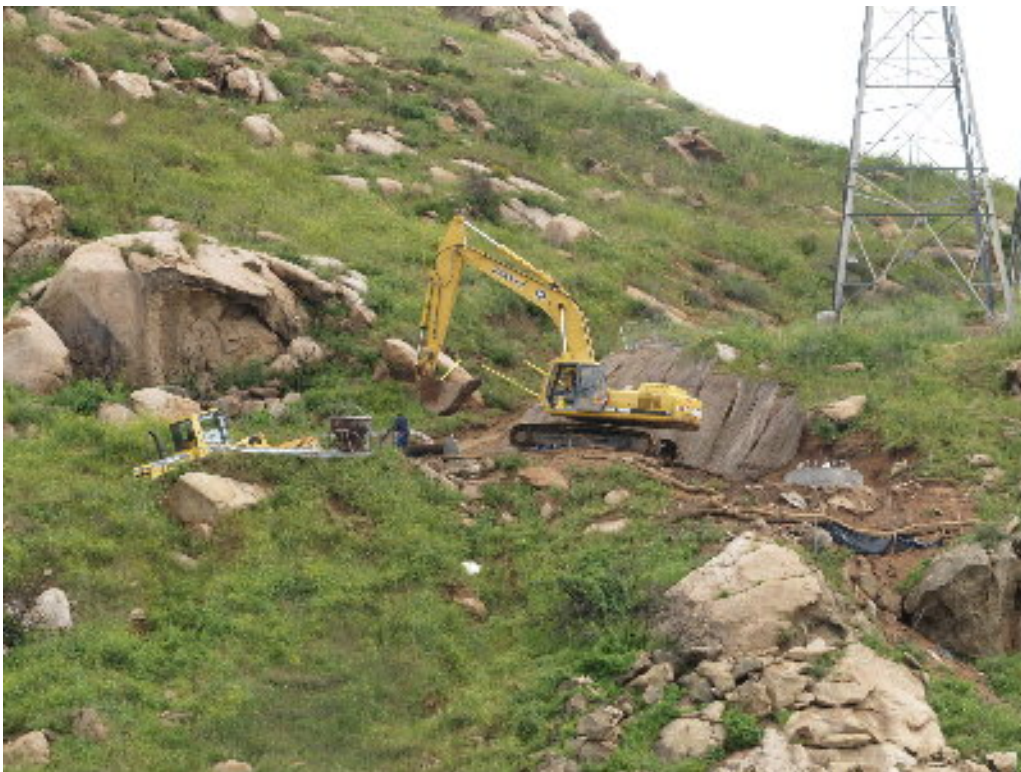
5. The crew at Pole Site 1160 (138/69 kV) worked to clean up the area following the pour and prepare for setting the pole using a sky crane helicopter (see Figure 2). The lower section of the steel pole at Pole 1160 was set using a helicopter due to the steep slope and roughness of the access road.

Figure 2 – The crew at Pole Site 1160 cleaned up after the pour and prepared for the sky crane with the lower pole section.

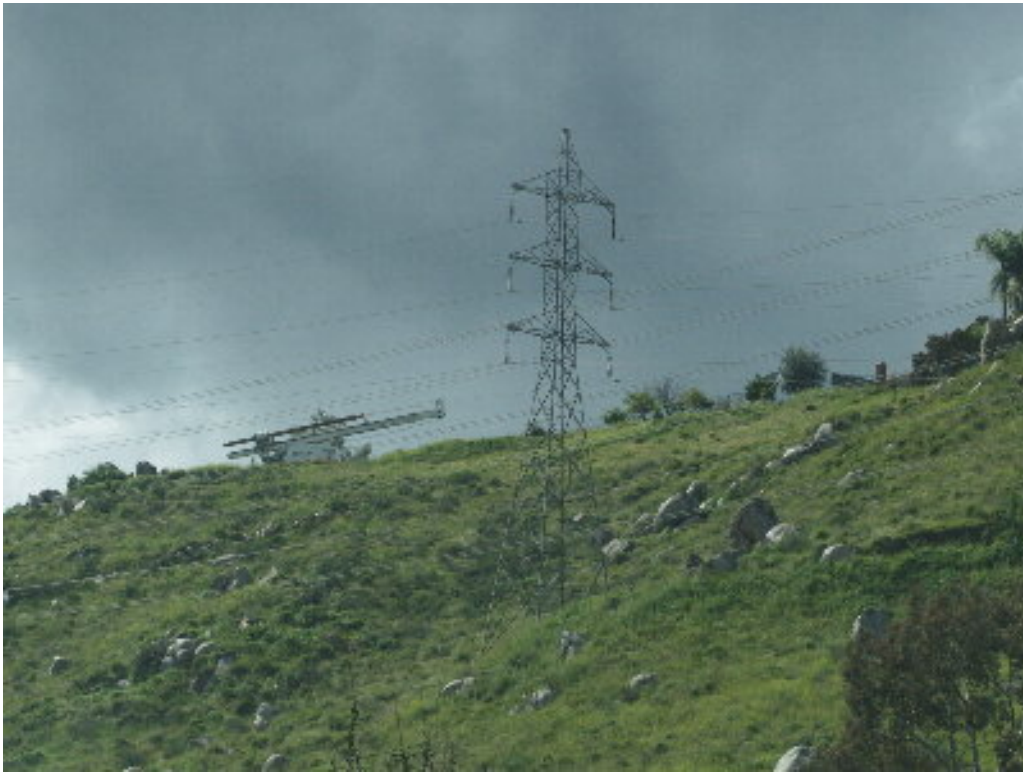
1. The drilling machine at Pole Site 481 completed the foundation excavation and was removed from the site (see Figure 3). The concrete crew moved to the site later in the week to prepare the forms for pouring the foundation.
2. The micro-pile crew worked on the drilling at Pole Site 522 during the site visit (see Figure 4). The crew will continue working on the drilling at Pole Site 522 next week.

Figure 3 – The drilling at Pole Site 481 was completed and the Madco drill was removed from the site.

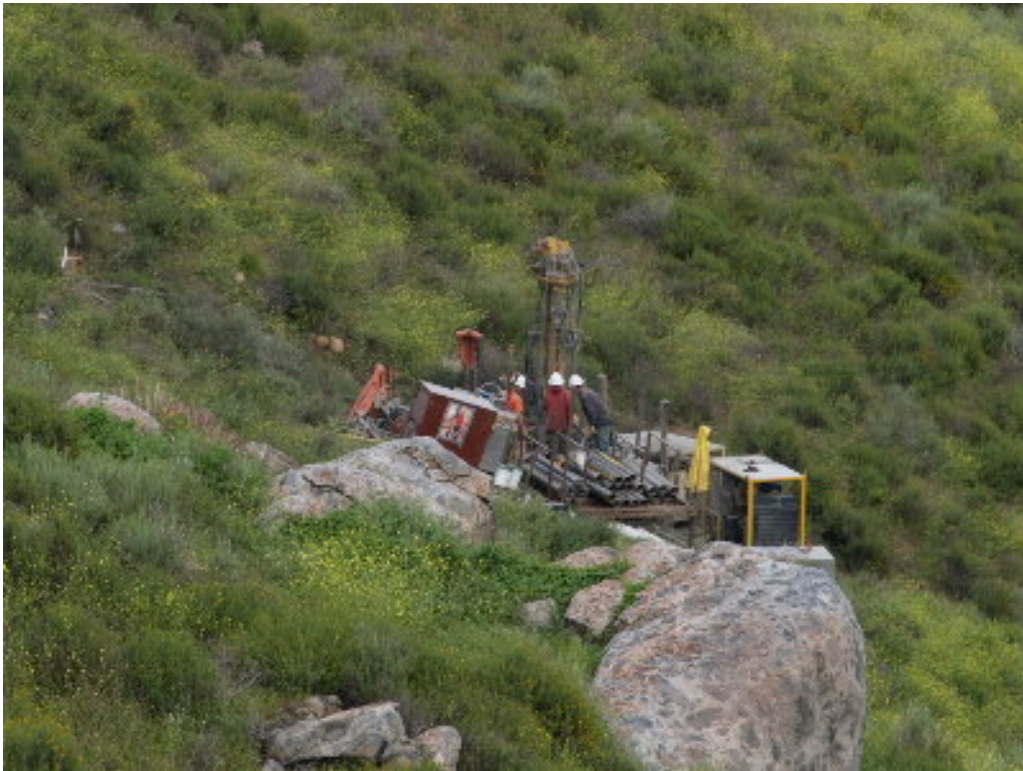
Figure 4 – The micro-pile crew set up at Pole Site 522 and started working.
