PROJECT MEMORANDUM

SDG&E – MIGUEL-MISSION 230 kV #2 PROJECT

To: Jensen Uchida, CPUC
From: Vida Strong, Aspen Project Manager
Date: April 6, 2005
Subject: Weekly Reports #35: March 27, 2004 – April 2, 2005
CPUC Environmental Monitor (EM): Christopher Meyer

FANITA JUNCTION TO MIGUEL 138/69 kV ACTIVITIES, NTP #1 AND #2

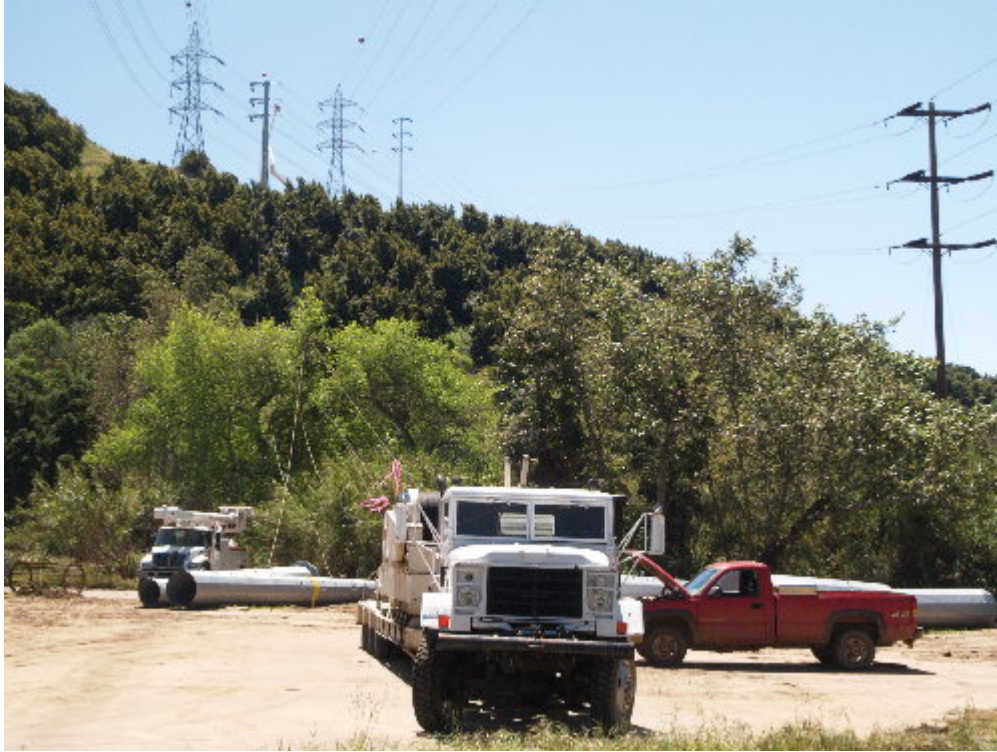
Figure 1 – An SDG&E transmission line crew pulled conductor south of Interstate 8.

2. PAR pulled conductor south of Interstate 8, from Pole Site 961 to Pole Site 881, during the subject week (see Figure 1). The crew also worked to prepare for the pull across Interstate 8 that will occur on Sunday, April 3 under Variance Request #14.

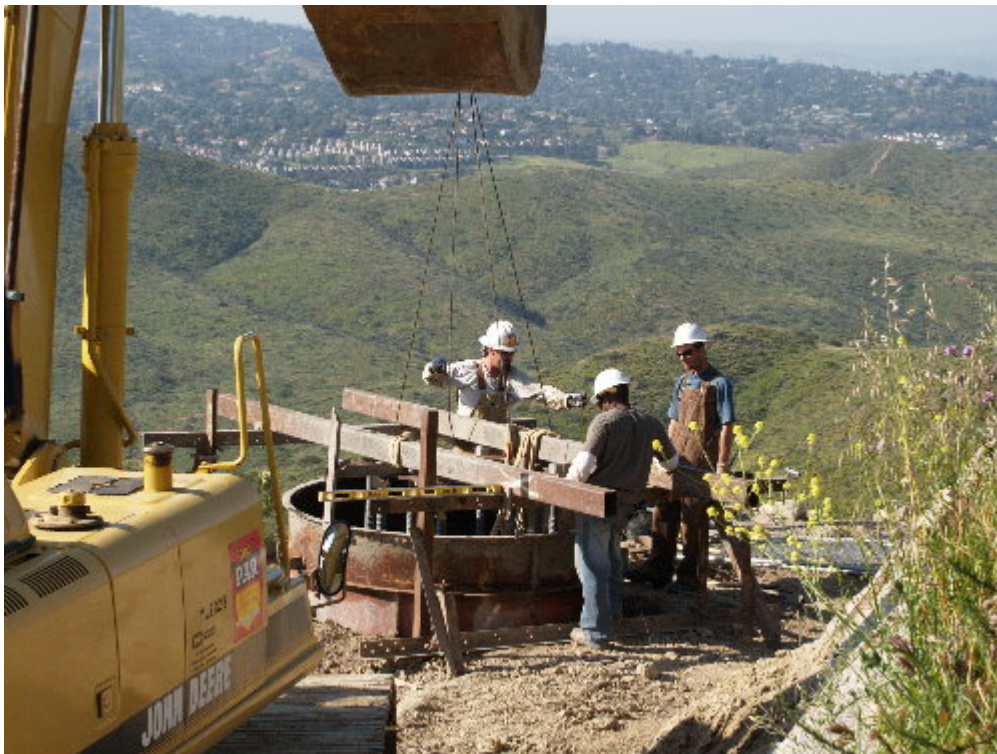
Figure 2 – PAR worked at Pole Site 181 to set the rebar cage and anchor bolts in preparation for pouring concrete.

4. A PAR crew worked to set the rebar cage and anchor bolts at Pole Site 181 during the site visit (see Figure 2). The crew completed the preparations at Pole Sites 100, 162, 172, 181 and 191 so that the concrete foundations could be poured during the subject week. The extensive road work and rock placed on the access road to the sites has made travel to these remote areas possible for light vehicles after rains; however larger vehicles still damage the road and limit access. PAR used the newly purchased 6-wheel drive to pour the more remote locations and the normal concrete trucks were used for the remainder of the foundations.

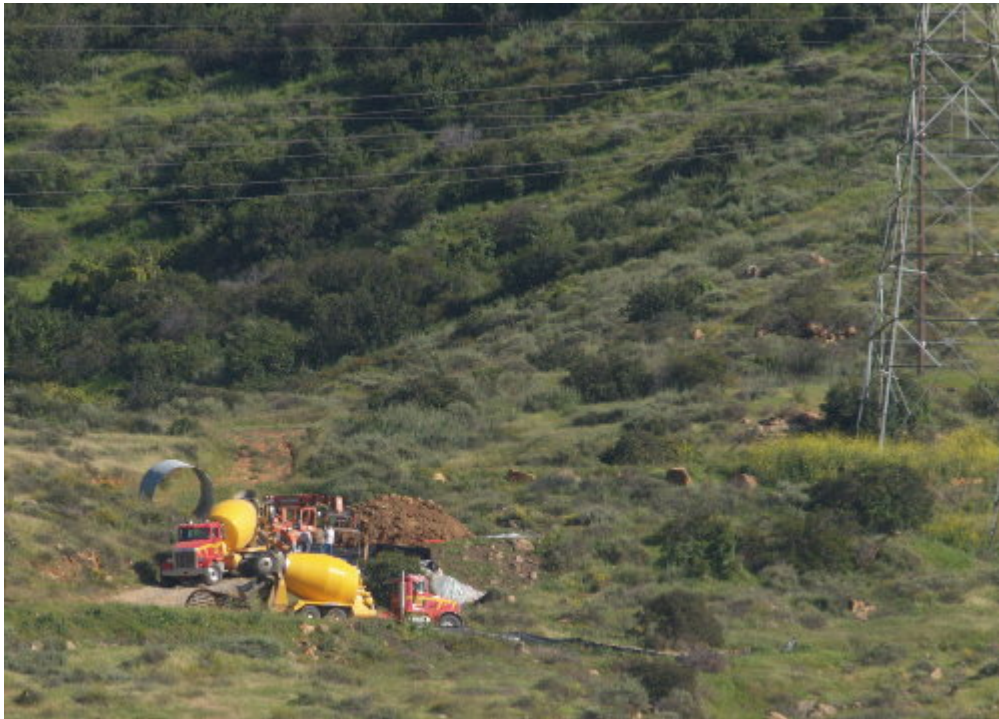
Figure 3 – Trucks delivered grout up the narrow access road to Pole Site 132 to stabilize the collapsed hole for drilling.

5. Concrete trucks filled with slurry mix were moved up to Pole Site 132 to fill the collapsed area around the foundation site to allow for drilling (see Figure 3). The partially completed excavation was severely degraded by storm water runoff during the heavy storms and the area needed to be stabilized prior to resuming the drilling operation. The slurry and a corrugated pipe section were used to stabilize the area to allow for Anderson Drilling to return to the site and excavate the foundation. Access to the site was coordinated due to the narrow road and difficulty passing vehicles in the opposite direction. Despite the attempts by the contractor to coordinate traffic on the access road, a newly mo-

bilized PAR crew moving an excavator up the road, left the approved right-of-way to allow downhill traffic to pass. The environmental impact of this action is discussed below in the Environmental Compliance section.

1. The PAR crew moving an excavator up the access road to Pole Site 132 moved off the clearly marked road to allow downhill traffic to pass, impacting undisturbed vegetation. The crew received environmental training within the previous five days and the access road was clearly marked with “Sensitive Resource Area, Stay on Access Road” signs. The Essex biologist on-site checked the impact and determined that the vegetation impacted was a mix of non-native grasses and ruderal vegetation. No coastal sage scrub habitat was lost and no impact to Quino checkerspot butterfly habitat was noted. A Project Memorandum will be issued to address this incident and other off right-of-way incidents. SDG&E has notified the CPUC EM of each off right-of-way incident.

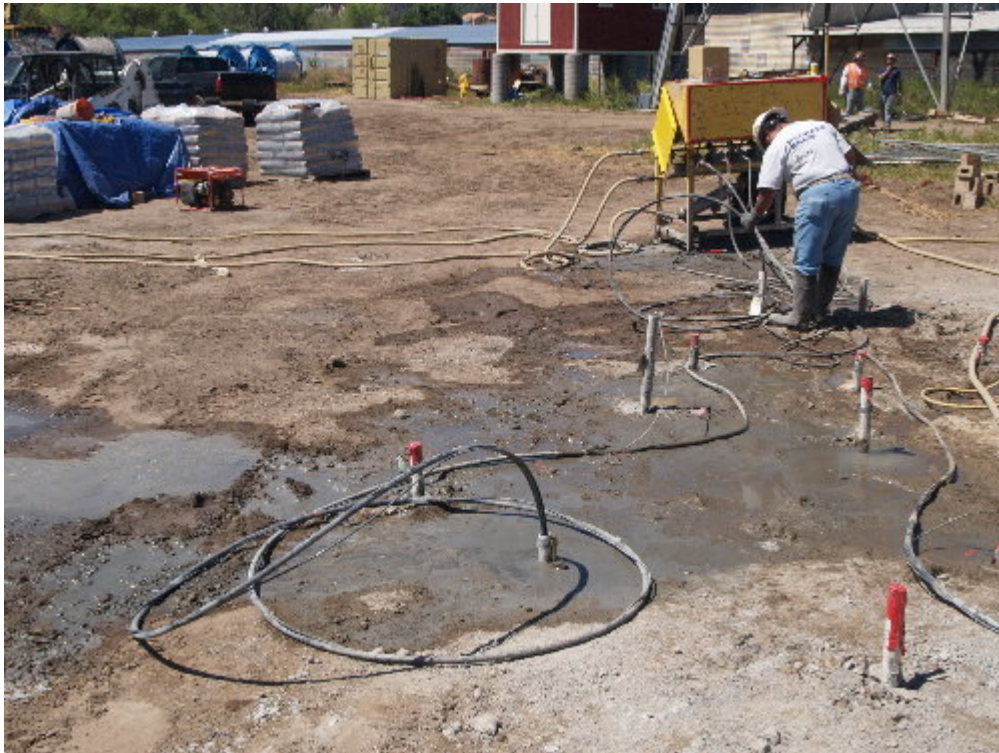
Figure 4 – Specialized equipment was used to pressure grout the annular spaces around the foundation at Pole Site 1210.

6. The drilling operation and foundation pouring was completed for the wet hole at Pole Site 1210 on March 22. The entire operation was completed in one day to prevent loss of the hole due to the high water table. The concrete pouring operation continued after 7:00 p.m. under Variance Request #8. The first two attempts at the site were not successful, one due to a failed test on the foundation and the second due to a collapsed hole prior to pouring any concrete. The crew at Pole Site 1210 worked on pressure grouting the annular spaces around the foundation during the site visit (see Figure 4). The wet spoils at the site were covered with plastic to prevent sediment travel in the event of predicted rains. Spilled and overflowing grout from the operation was spreading outside the work area into the adjacent grass (see Figure 5). This material will need to be removed from the site or stabilized prior to any rain events.

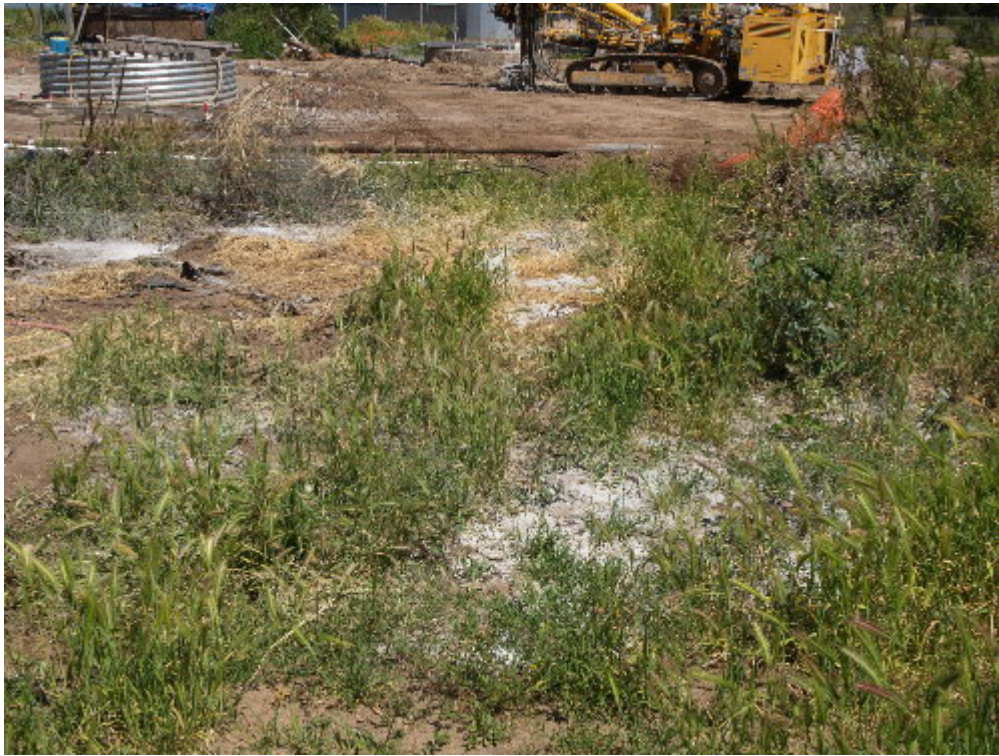
Figure 5 – Grout from the pressure grouting operation spread into the adjacent grasses on the property at Pole Site 1210.

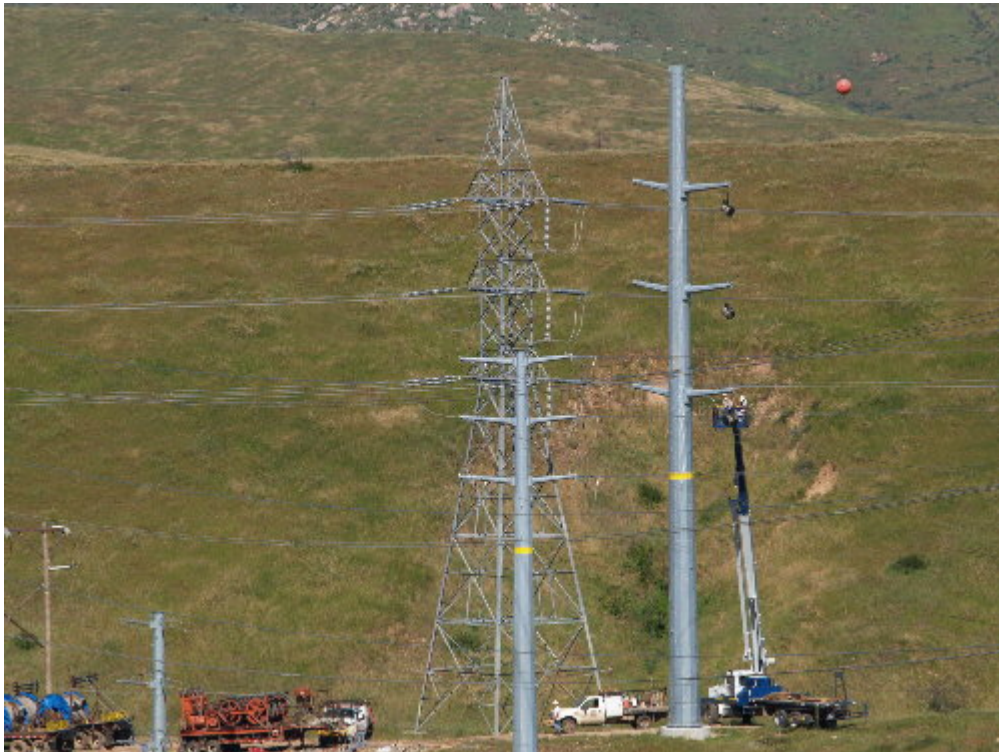
Figure 6 – Wilson crews worked at Fanita Junction to prepare for the pulling of conductor.

1. The Wilson transmission line crew prepared the poles for the conductor and then used a helicopter to pull the sock line from Fanita Junction to Tower 576654 (see Figure 6). The line dropped due to a problem with the reel truck and the operation was suspended. The line dropped onto the guard structures and into coastal sage scrub habitat. All other equipment and work activities were within the area previously disturbed by the 138 kV and 230 kV construction crews. Wilson crews also installed steel poles 593, 594, and 595 during the subject week.
2. The Wilson drilling subcontractor, Tri-State Drilling, is close to completing drilling and pouring the foundation at Pole Site 588, and blasting and drilling the for the foundations at Pole Sites 587 and 586. The micro-pile subcontractor, Crux, completed work on the micro-pile foundation at Pole Site 589.
