## **PROJECT MEMORANDUM SDG&E – MIGUEL-MISSION 230 kV #2 PROJECT**

**To:** Jensen Uchida, CPUC  
**From:** Vida Strong, Aspen Project Manager  
**Date:** May 24, 2005  
**Subject:** Weekly Report #42: May 15 – May 21, 2005.  
**CPUC Environmental Monitor (EM):** Christopher Meyer

### **FANITA JUNCTION TO MIGUEL 138/69 kV ACTIVITIES, NTP #1 AND #2**

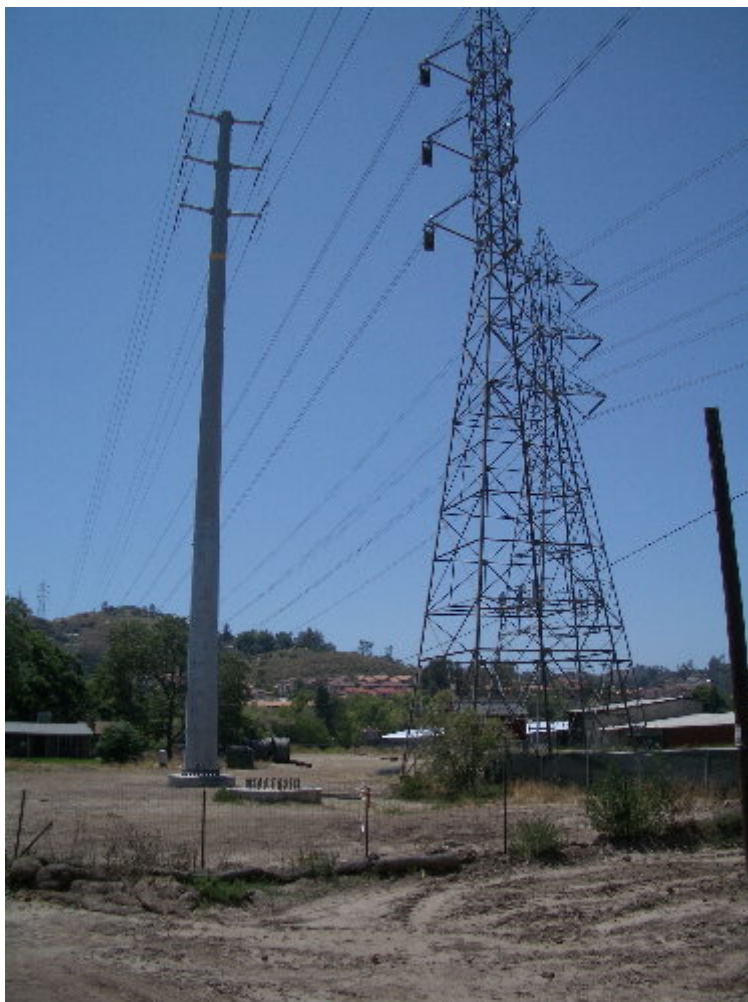
1. PAR crews worked on stringing and associated activities for the bundled 230 kV and 138 kV conductor during the subject week. These activities are described in the 230 kV section below.
2. The steel pole at Site 1210 was moved to the new foundation during a planned outage (see Figure 1). The old foundation was not sound due to a cave in before the concrete had set and will be removed to several feet underground.

**Figure 1** – The steel pole was relocated to the new foundation during a planned outage at Pole Site 1210. The bad foundation is in the foreground.

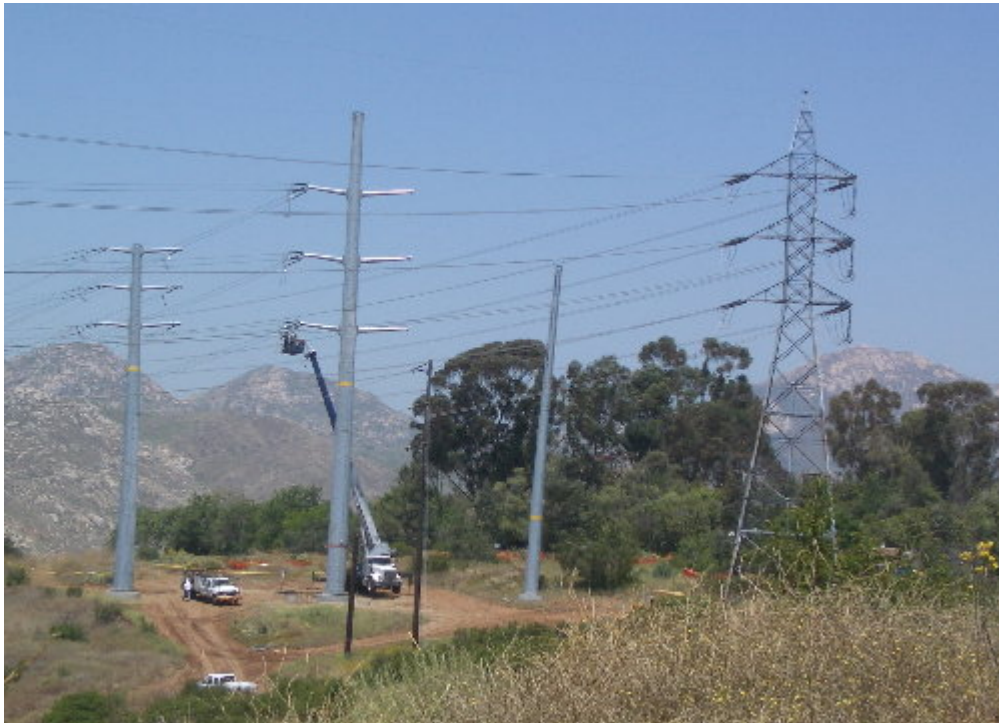
1. Wilson crews worked with man-lifts between the Los Coches Substation and Pole Site 1150, installing jumpers on the new poles (see Figure 2). The jumpers connect the conductor runs around the insulators at each pole. The Essex EI has marked the nesting bird areas with caution tape, fencing, and signs.

**Figure 2** – The Wilson stringing crew installing jumpers above the Los Coches Substation.

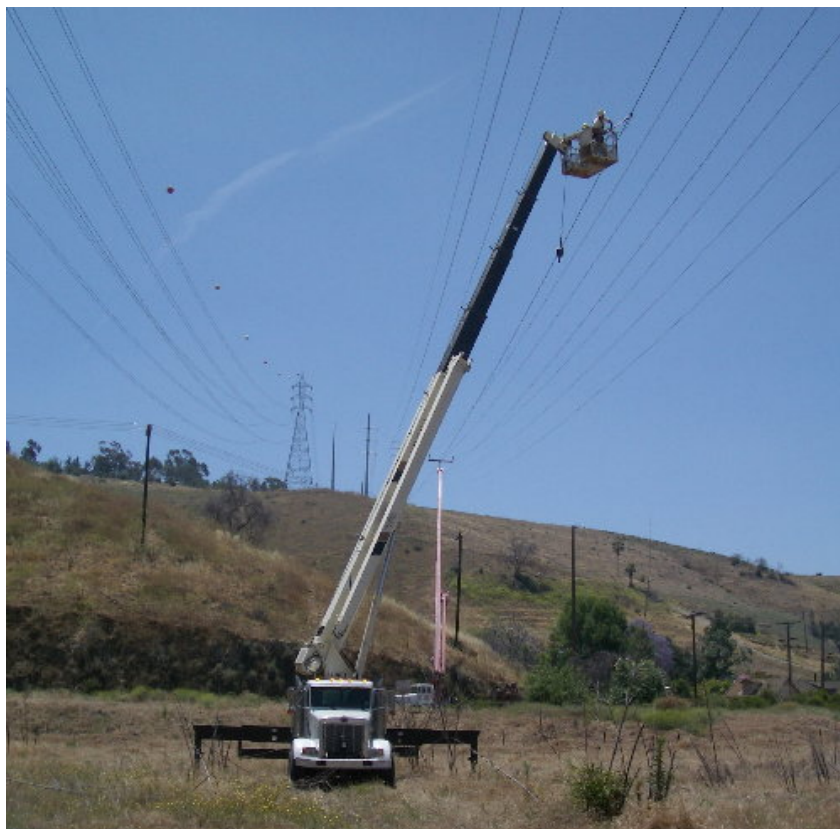
2. The CPUC EM was contacted by the Essex EI on emergency access between poles 1150 and 1160 to allow SDG&E and Wilson to inspect a damaged section of conductor. The CPUC EM met in the field and approved temporary access into the disturbed ruderal vegetation to park a man-lift for the inspection (see Figure 3). The SDG&E engineer inspected the damage to the conductor, determining that it was minor, and could be fixed in-place by the Wilson crew. The equipment was removed from the vegetation promptly and the entire operation was completed in under an hour. A crane truck was parked on El Monte Road as a temporary guard structure for the distribution line until the extent of damage to the conductor could be determined (see Figure 4).

**Figure 3** – Wilson and SDG&E inspecting the damaged conductor off El Monte Road.

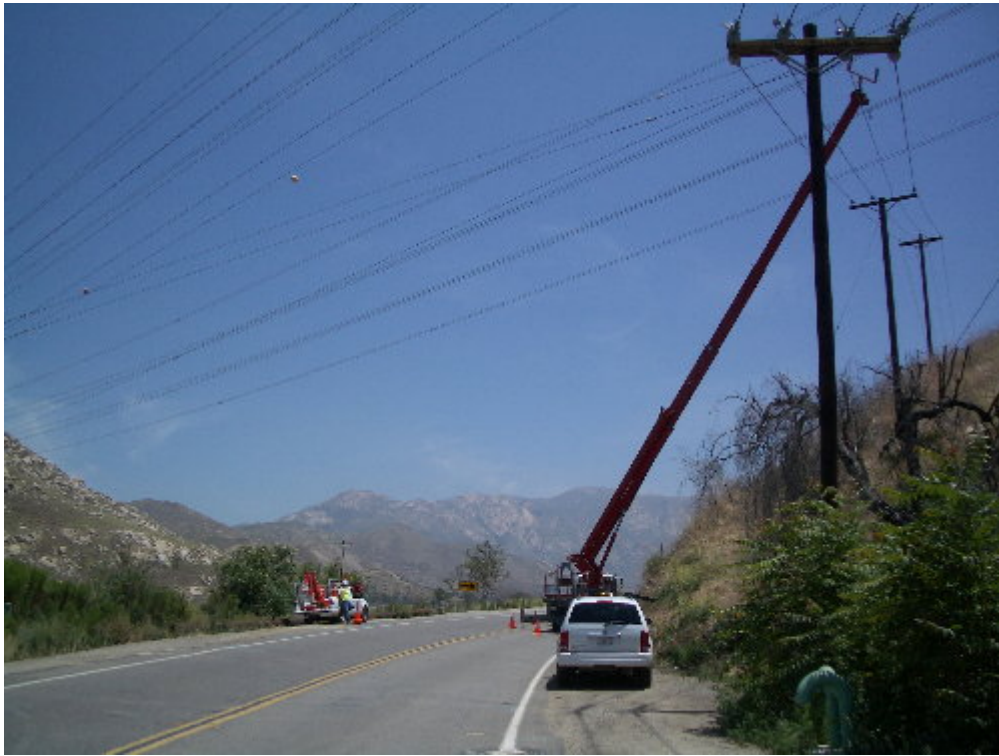
**Figure 4** – Temporary protection of the distribution line on El Monte Road during inspection of the damaged conductor.

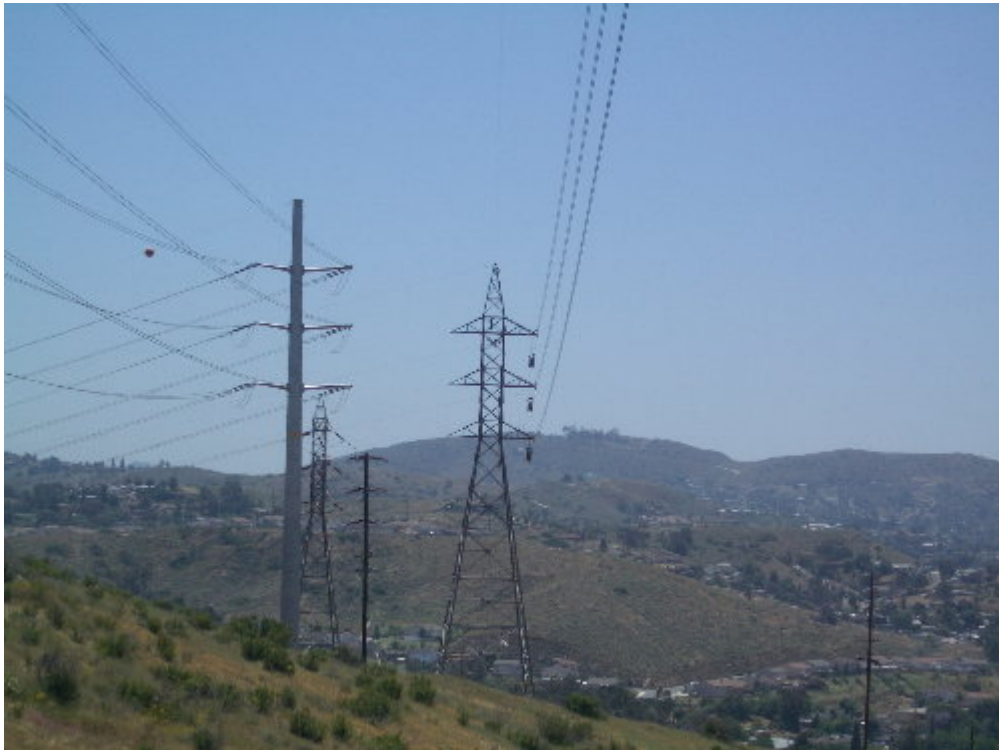
3. Wilson crews worked at dead-ending sections of conductor (see Figure 5). Cables are run from the last tower or pole to the ground to take up the strain of the conductor weight. Once the next section is strung, the cables are no longer necessary. The 230 kV conductor has been strung to the tower above the Los Coches Substation and will be strung across Lake Jennings Road the following week.

**Figure 5** – End of the permanent 230 kV conductor above the Los Coches Substation.

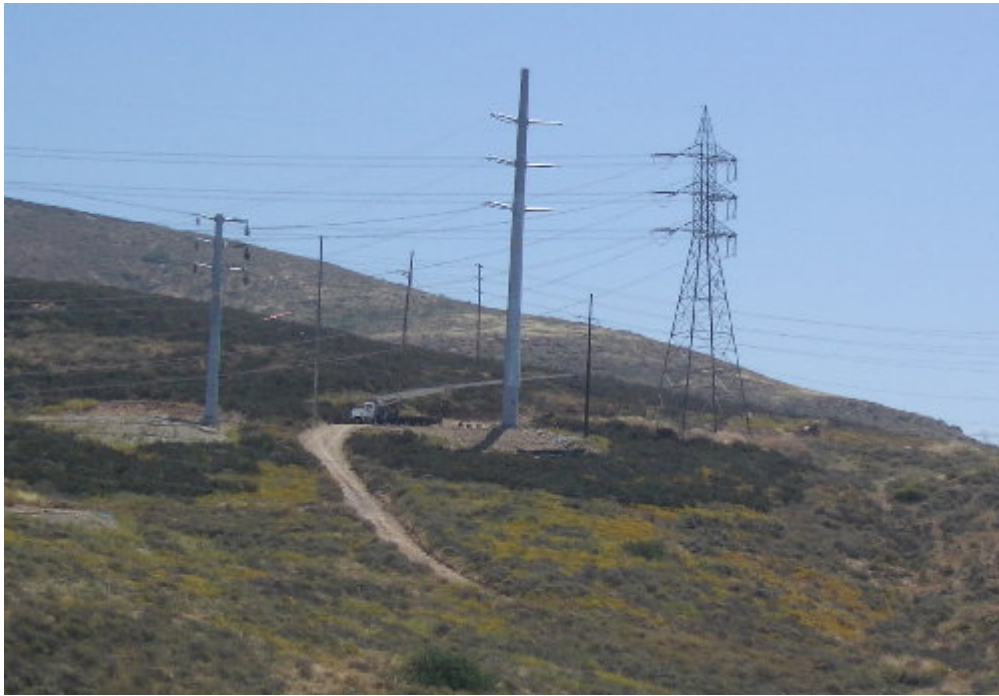
1. A PAR stringing crew worked to dead-end sections of conductor in the Sweetwater area during the site visit (see Figure 6). The work was conducted under the supervision of the Essex EI and a permitted gnatcatcher biologist. The work area was restricted to the area cleared of coastal sage scrub outside the gnatcatcher breeding season. No disturbance to the local gnatcatchers was observed during the work.

**Figure 6** – PAR stringing crew working on the temporary 230 kV system above the Miguel Substation.
