PROJECT MEMORANDUM PG&E NORTHEAST SAN JOSE TRANSMISSION REINFORCEMENT PROJECT

To: Roosevelt Grant, CPUC
From: Vida Strong, Aspen Project Manager
Date: January 15, 2003
Subject: Weekly Report #33: January 6, 2002 – January 12, 2003
CPUC Environmental Monitor (EM): Jody Fessler

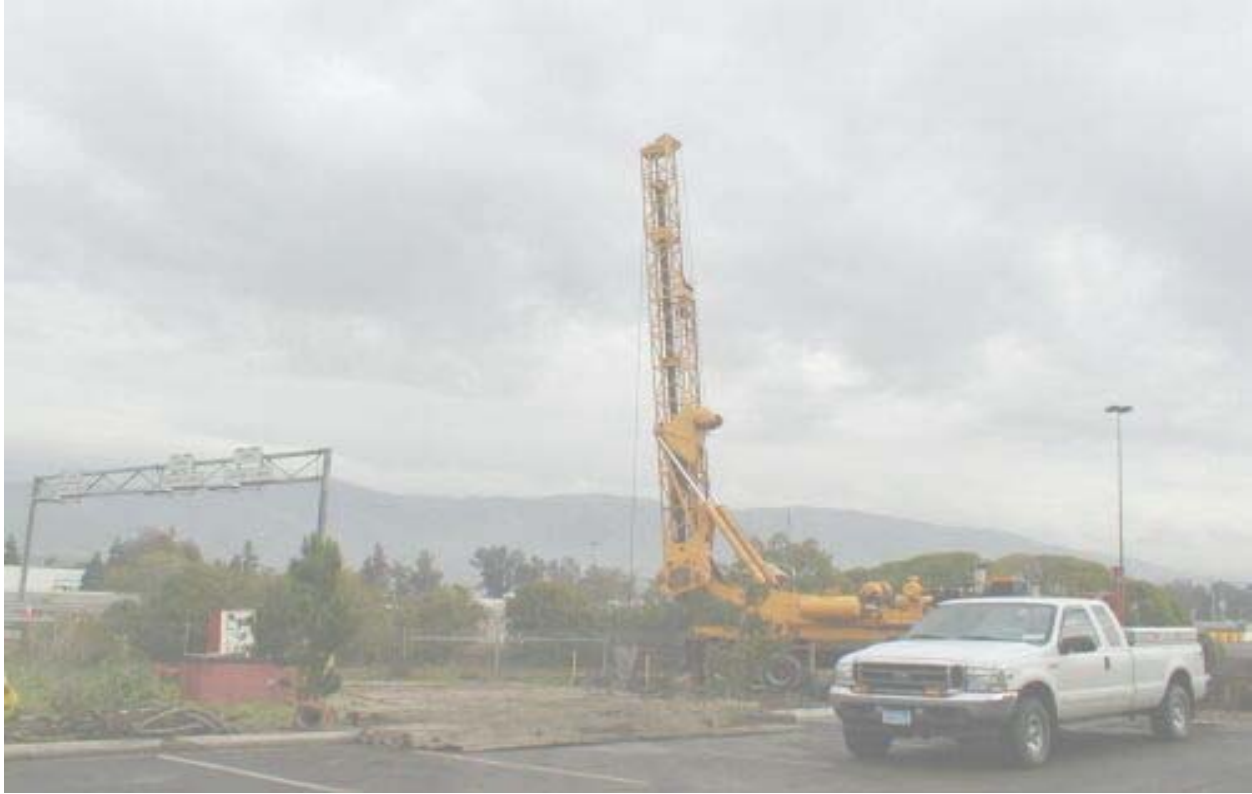
At pole foundation #4 (see Figure 1), the foundation pit had been drilled and crews were waiting for the cement trucks to arrive so that they could pour the foundation. The CPUC EM observed that pole foundation #3 was completed (see Figure 2). Tri-state Drilling finished foundation #3 yesterday. The CPUC EM spoke with the Essex EI regarding the trail of dirt in the parking lot between pole foundations #3 and #4. She said she would make sure they cleaned it up before leaving for the weekend (Tri-state Drilling does not work on Fridays).

Figure 1
Tri-State Drilling Waiting for Cement Trucks at Pole Foundation #4
January 9, 2003

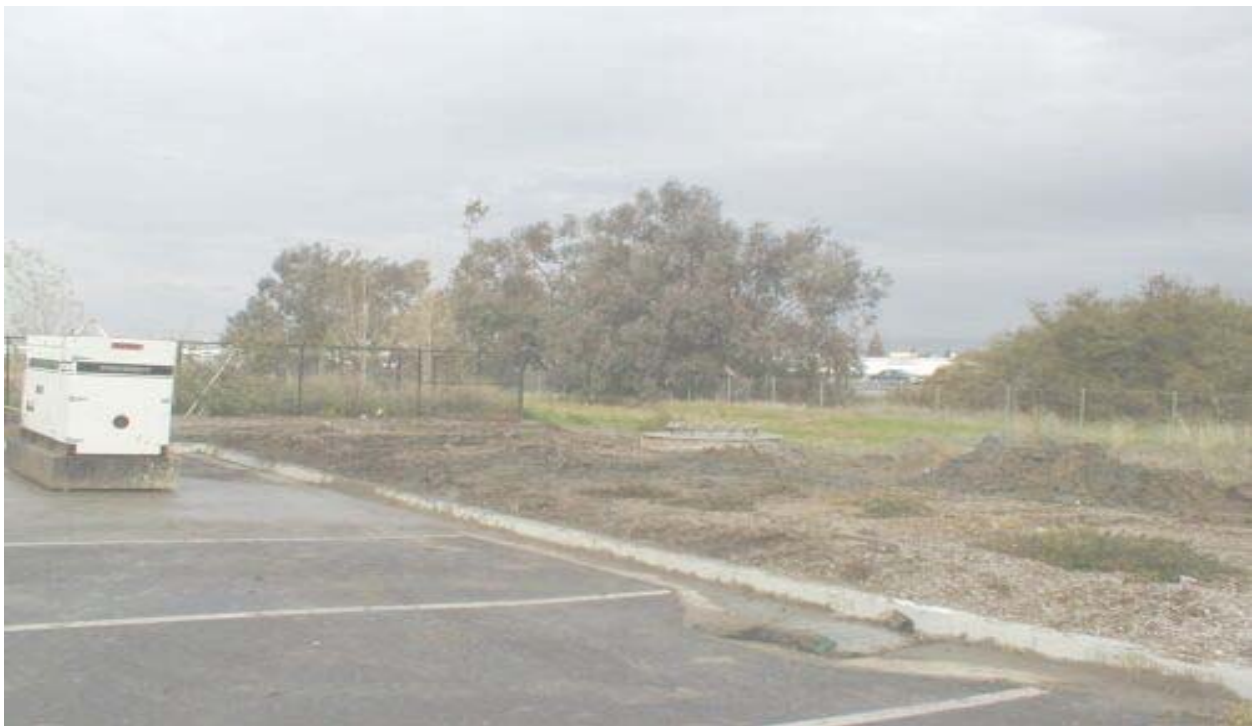
Figure 2
Pole Foundation #3 Completed
January 9, 2003

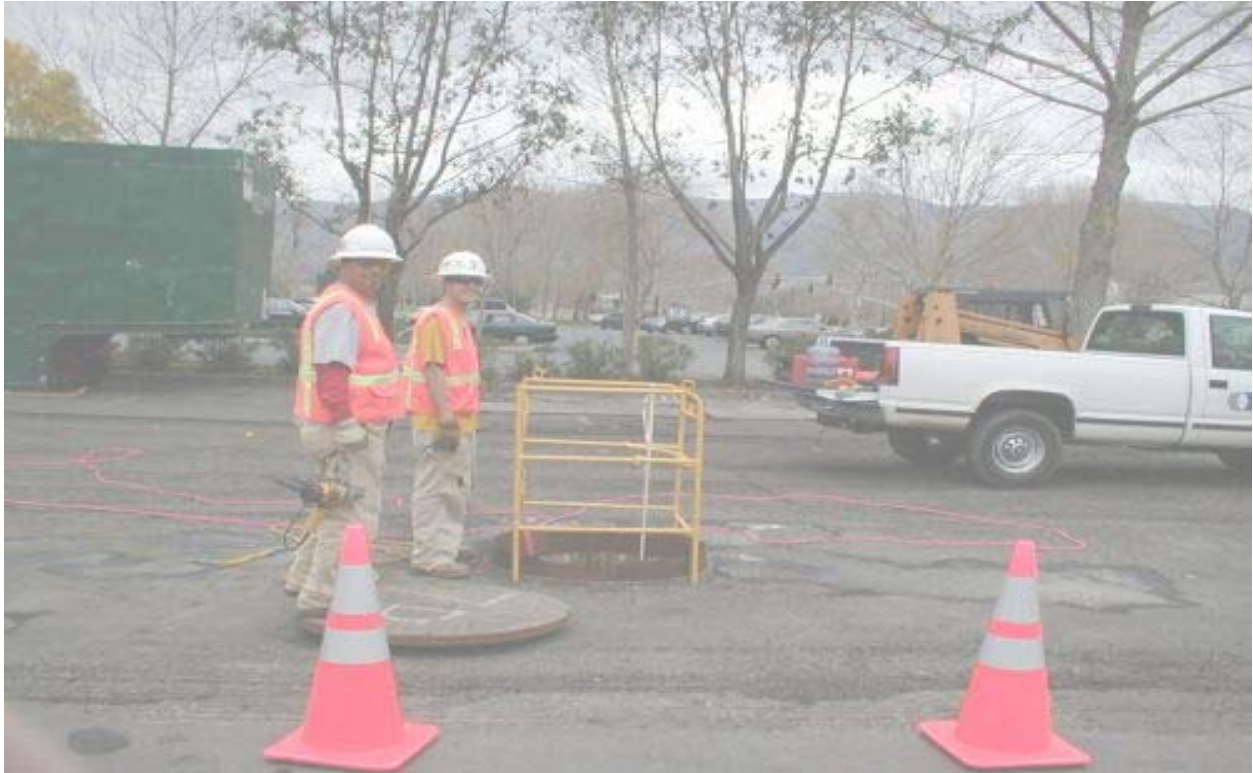
At Fremont Boulevard, the CPUC EM observed that there was some dirt on the road coming out of the entrance/exit gate to the staging area at the corner of Cushing Parkway and Fremont Boulevard. The CPUC EM left a message with the Essex EI regarding this issue. At man-hole vaults #7, crews were installing the racking within the vault (see Figure 3). Another crew was pouring cement driveways on either side of Gateway Boulevard where the trenching activities had torn up the old driveways into the two business parks. The cement crew also worked on some sidewalk repairs south of man-hole vaults #8 (pouring cement). The CPUC EM left another message with the Essex EI regarding the needed maintenance on some sandbags around two drains on the street just south of man-hole vaults #8. Crews were proofing conduit between man-hole vaults #8 and #9. At the Mervyn's overflow lot/staging area, gravel had been brought in and leveled out in order to support the weight of the cable wire coming in (the staging area had been very muddy and the ground very soft before the holidays). On Lakeview Boulevard at the very south end of Fremont Boulevard, crews were doing asphalt grinding in preparation to do the final paving in areas where trenching activities had gone through.

Figure 3
Crews Working on Racking at Man-Hole Vaults #7
January 9, 2003

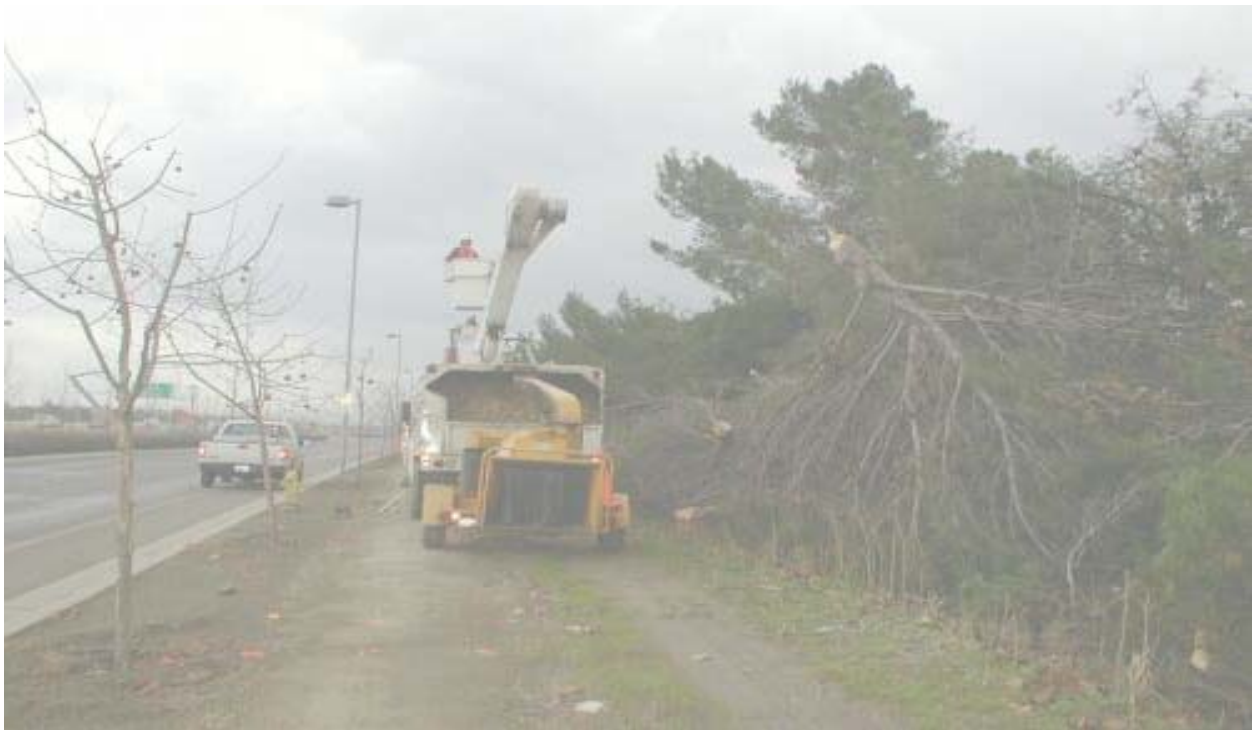
Later in the afternoon, the CPUC EM conducted a site visit of tree-topping activities within the right-of-way between pole foundations #16 and #17 along McCarthy Boulevard (see Figure 4). The CPUC EM noted that the soil pile had been removed from the pole foundation #17 area. The soil pile still remains near pole foundation #15 and the area is very wet.

Figure 4
Davey Tree Service Topping Trees Between Pole Foundations #16 and #17
January 9, 2003

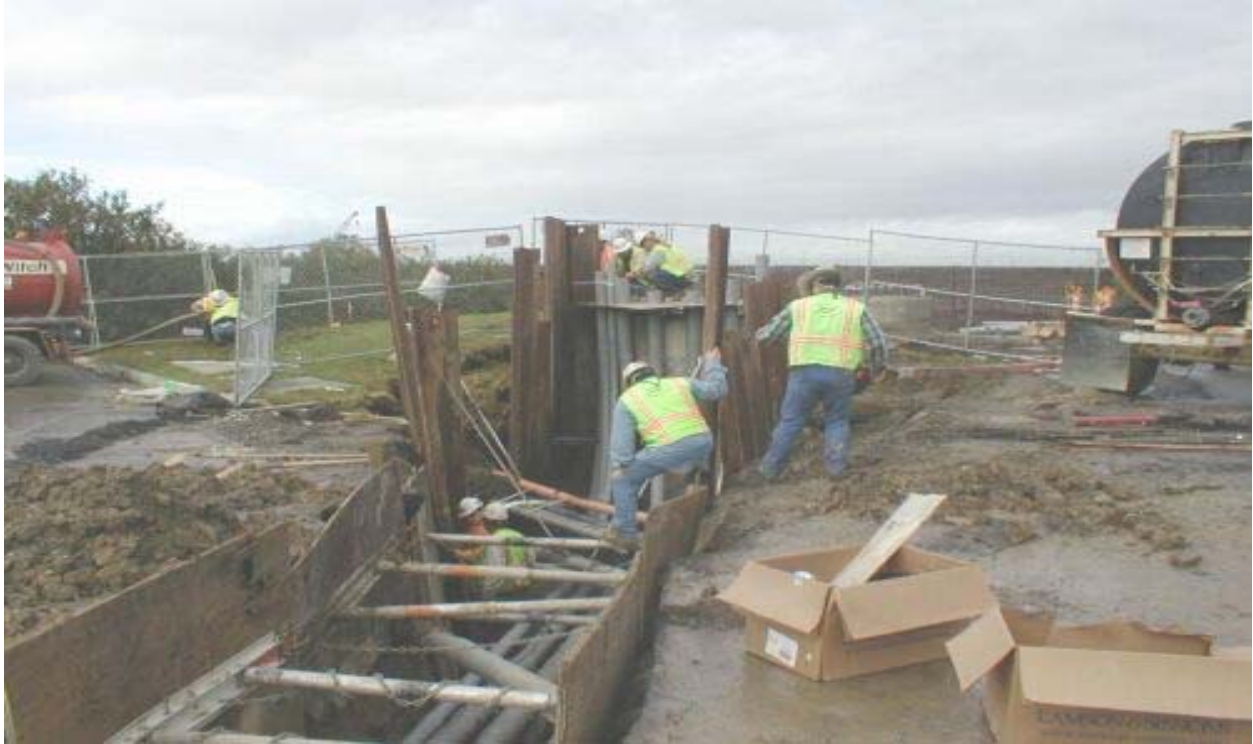
At the Catella property where pole #5 will be placed, the exclusion fencing and silt fencing for the access road were inspected. It was noted that the silt fence had been installed backwards and this information was forwarded onto the Essex EI later in the day. At the west end of Cushing Parkway, tie-in work was continuing connecting the underground segment to the overhead segment at pole foundation 9 (see Figure 5). Behind the business park, crews were installing racks at man-hole vaults #7. At the Mervyn's staging area, wire cable had been delivered and was being stored there.

Figure 5
Tie-in for Underground to Overhead at Foundation #9
January 10, 2003

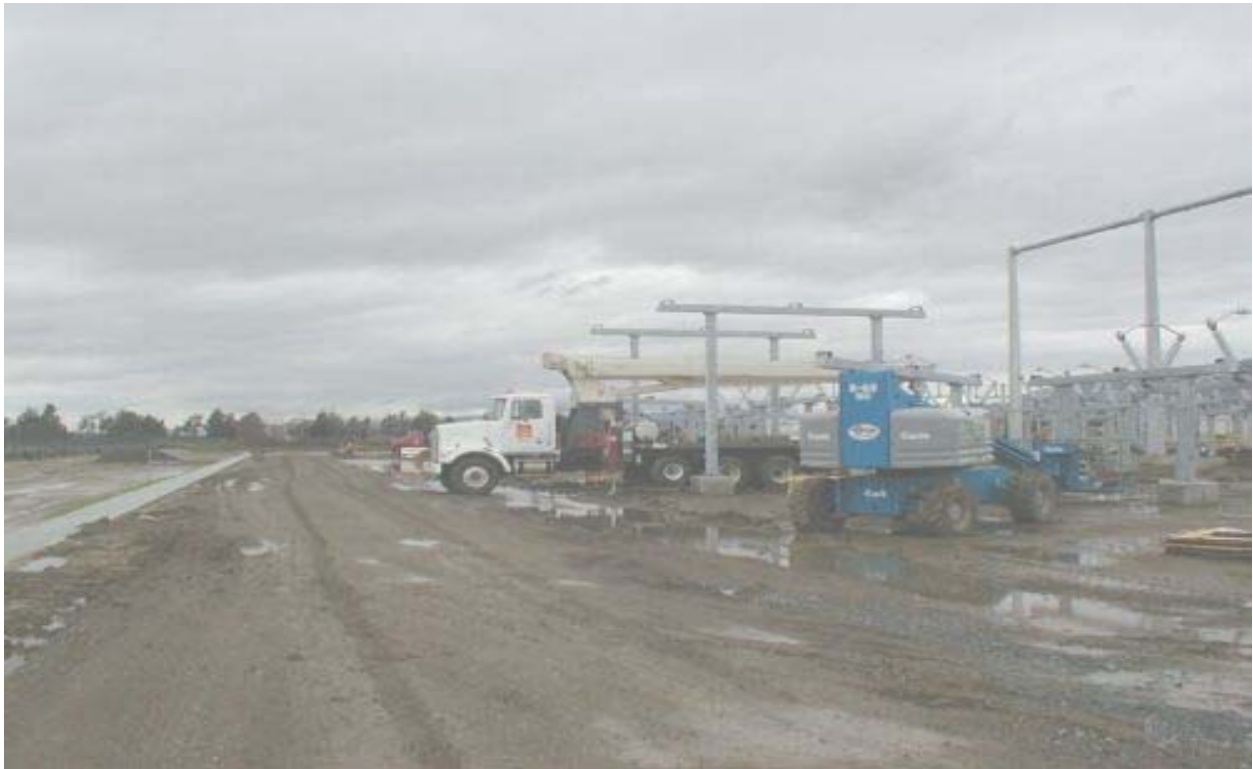
At the Los Esteros Substation site, crews were working on constructing the first transformer and insulators. The second transformer will be delivered Sunday night. The site's drainage system was observed to be working very well (see Figure 6). Conducted a site visit of the area southwest of the Los Esteros Substation where several burrowing owls have been seen. No burrowing owls were observed at the time of the site visit.

Figure 6
Los Esteros Substation – View of Drain Along West Side of Site
January 10, 2003
