## **PROJECT MEMORANDUM PG&E NORTHEAST SAN JOSE TRANSMISSION REINFORCEMENT PROJECT**

**To:** Roosevelt Grant, CPUC  
**From:** Vida Strong, Aspen Project Manager  
**Date:** January 2, 2003  
**Subject:** Weekly Report #31: December 23, 2002 – December 29, 2002  
**CPUC Environmental Monitor (EM):** Jody Fessler

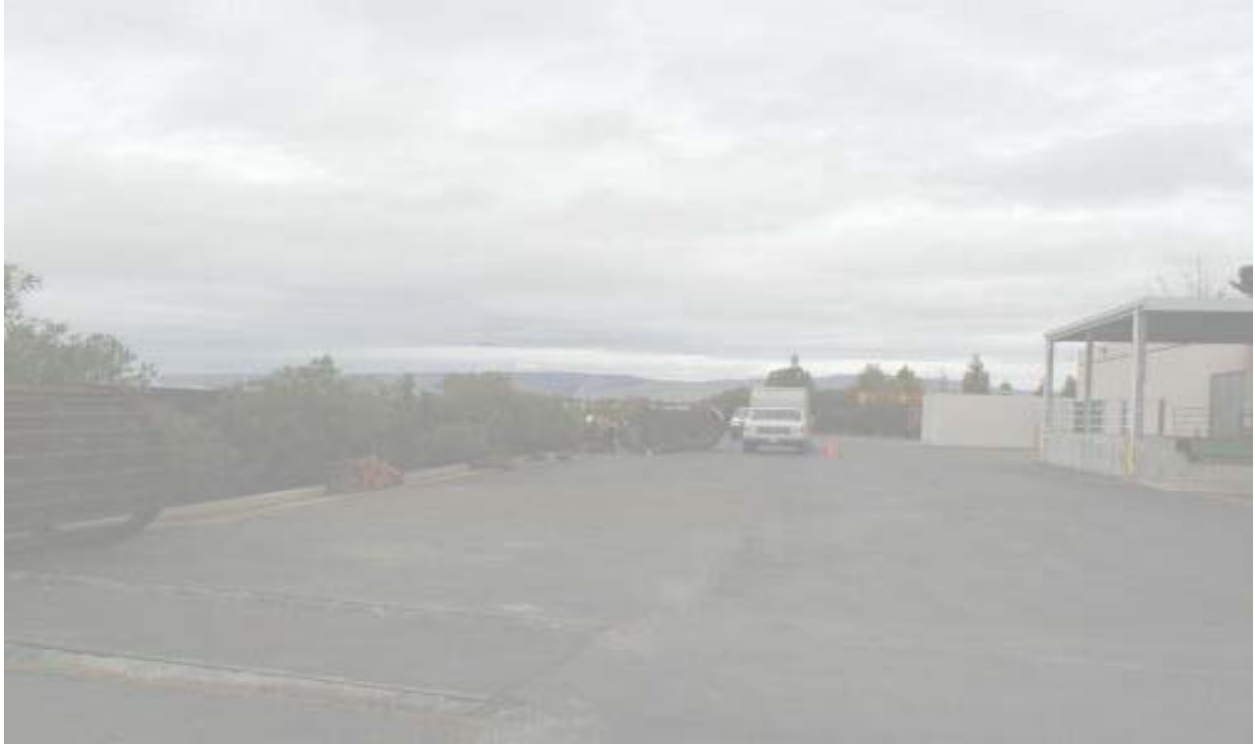
The CPUC EM conducted a site visit of the Catella Property where Pole #5 will be placed in the morning. No crews were observed working and no new work has been done since Essex EIs staked out the access road to the Pole #5 work area. At pole foundation area 9 (a) and (b), a tree service company was cutting tree stumps between pole foundations 8 and 9 and removing them (see Figure 1). The CPUC EM then conducted a site visit of pole foundation #7 and observed that the foundation had been poured. Later, the CPUC EM conducted a site visit of pole foundations 10 (L) and (R) and noted that the area had been cleaned up well (see Figures 2 and 3). At pole foundations #15 and #17 (both in agricultural fields) along McCarthy Boulevard, soil piles will have to be removed once the ground dries out a little more. There is nowhere for the soil to run off to since the areas are flat and are plowed agricultural fields.

Figure 1  
Tree Cutting Service Removing Stumps between Pole Foundations #8 and #9  
December 27, 2002

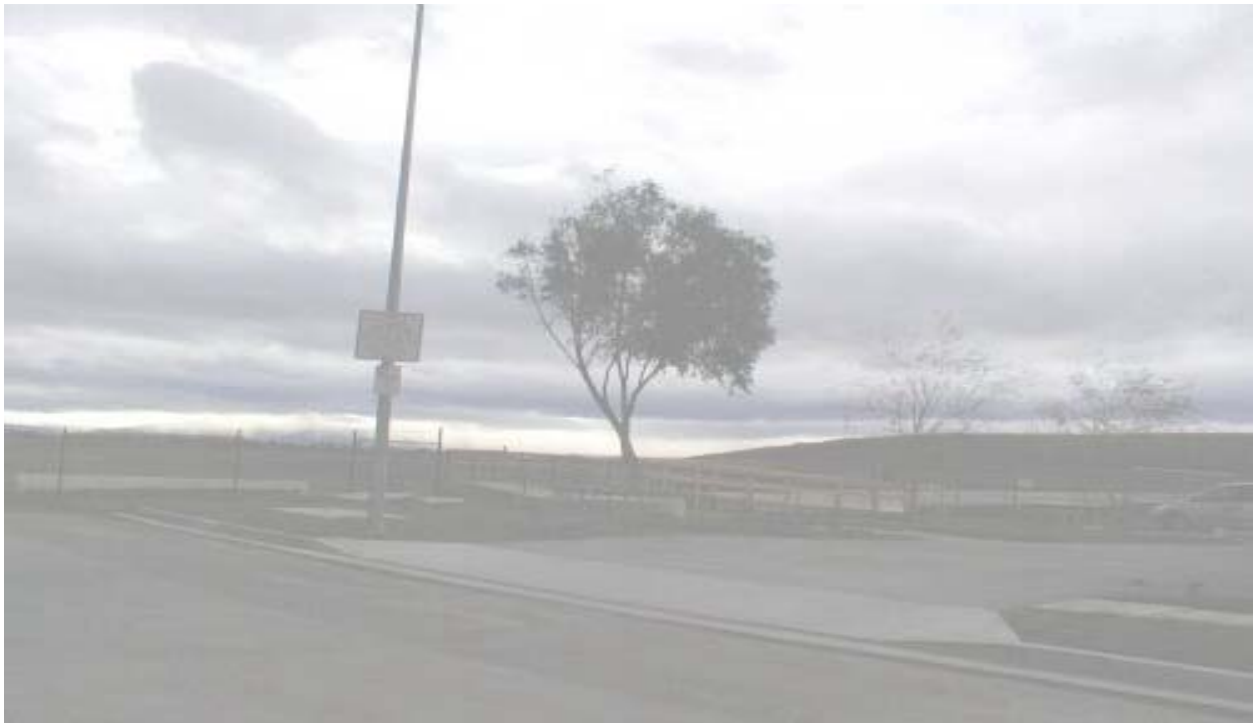
Figure 2  
Pole Foundation 10 (R) – Area Clean  
December 27, 2002

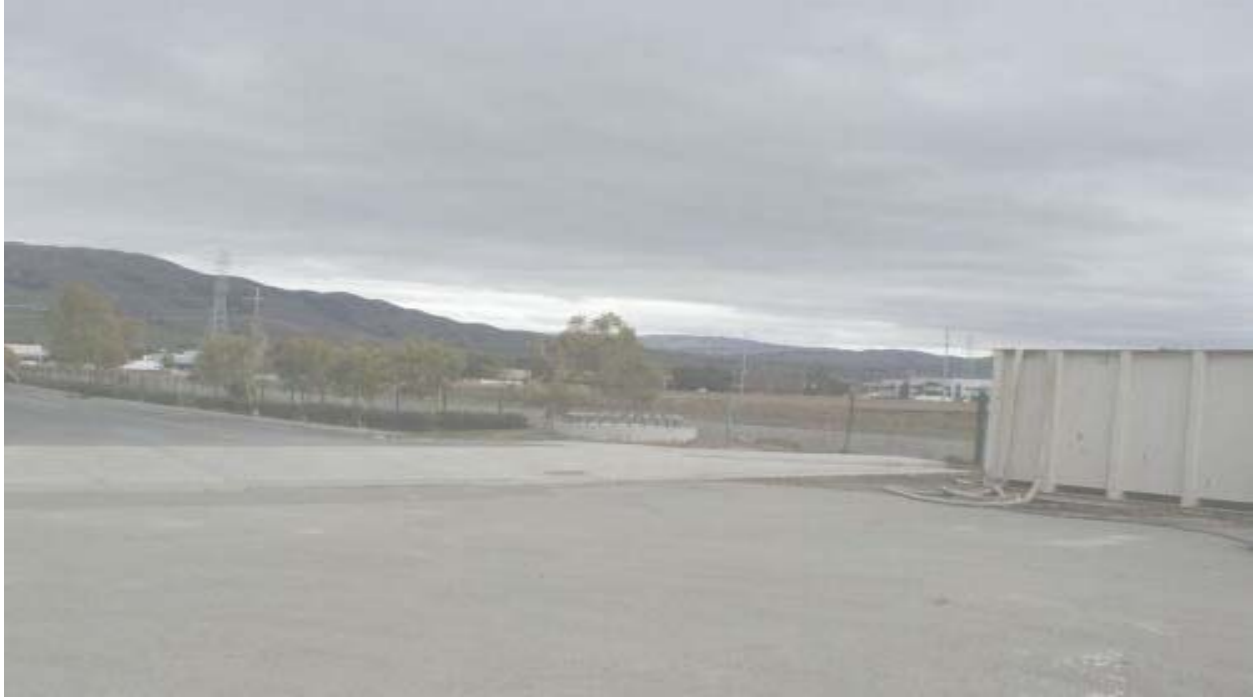
Figure 3  
Pole Foundation 10 (L) – Area Clean  
December 27, 2002

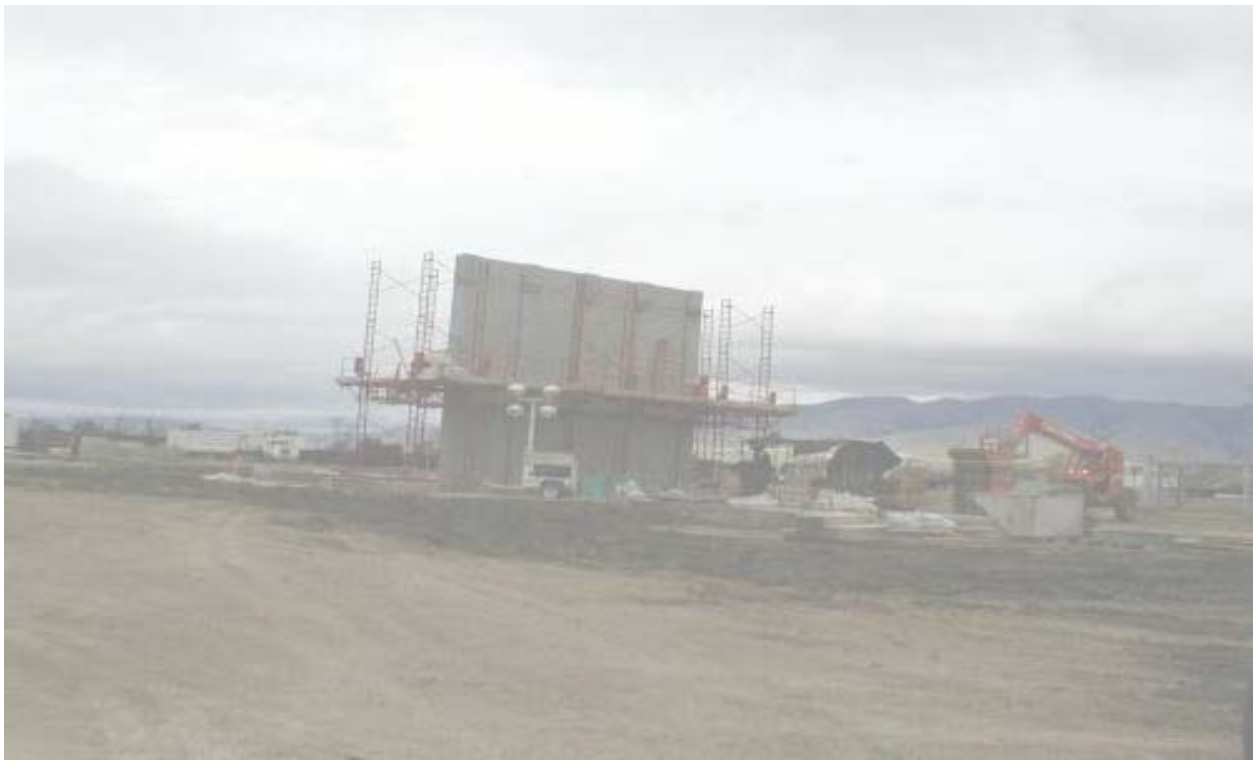
In the early afternoon, the CPUC EM conducted a site visit of the Los Esteros sub-station site. The site was wet, but draining well. The CPUC EM observed crews working on building the fire wall at the south end of the property (see Figure 4). The CPUC EM also observed that silt fences were being well maintained.

Figure 4  
Crews Building a Fire Wall at the Los Esteros Substation Site  
December 27, 2002
