**PROJECT MEMORANDUM  
SCE RIVERWAY SUBSTATION PROJECT**

**To:** Jensen Uchida, CPUC  
**From:** Vida Strong, Aspen Project Manager  
**Date:** September 11, 2009  
**Subject:** Construction Status Report # 12:

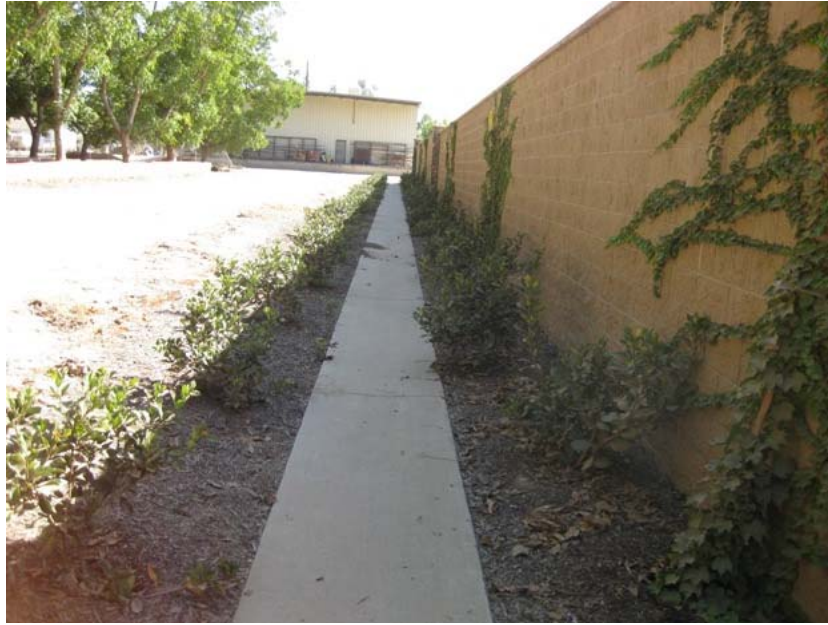
**Figure 1:** The shallow V-ditch outside the station on the eastern side is now surrounded by well-tended landscaping, including the climbing vine. The photograph faces southward.

On the September 9, 2009 site visit by the CPUC EM, the landscaping on the eastern, southern, and western perimeters appeared to be well cared for. The irrigation system was in place, the plants looked healthy, and there was evidence of weeding activity (see Figures 1, 2, and 3).

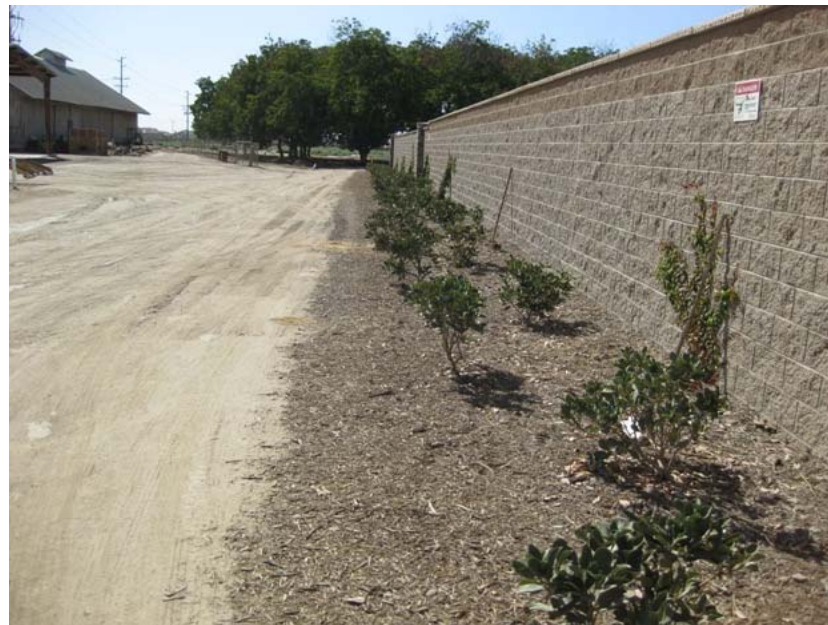
**Figure 2:** The perimeter of the southern side of the station contains landscaping, but by design, no drainage ditch. The photograph faces westward.

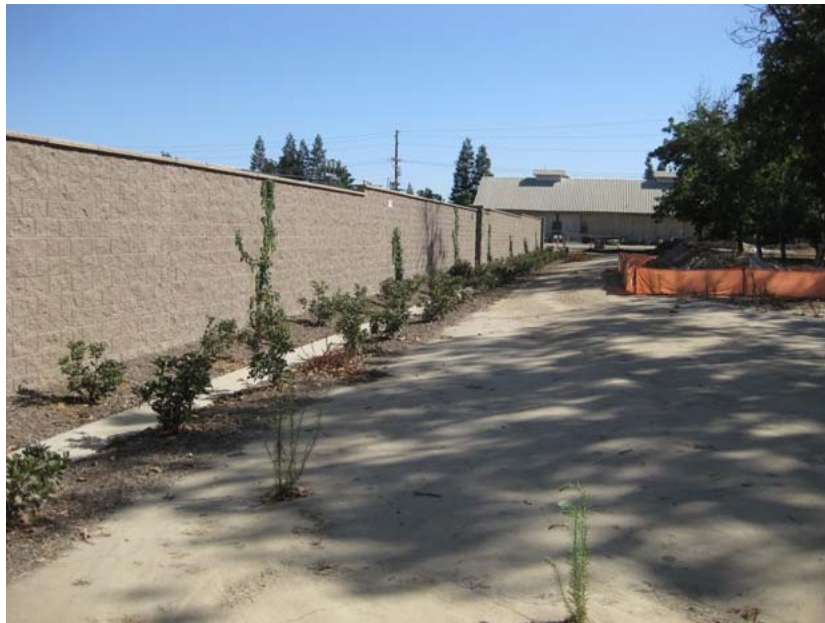
**Figure 3:** The perimeter of the western side of the station contains well-tended landscaping on both sides of the shallow V-ditch. A secured pile of material remains from the earlier landscaping work. The photograph faces southward.

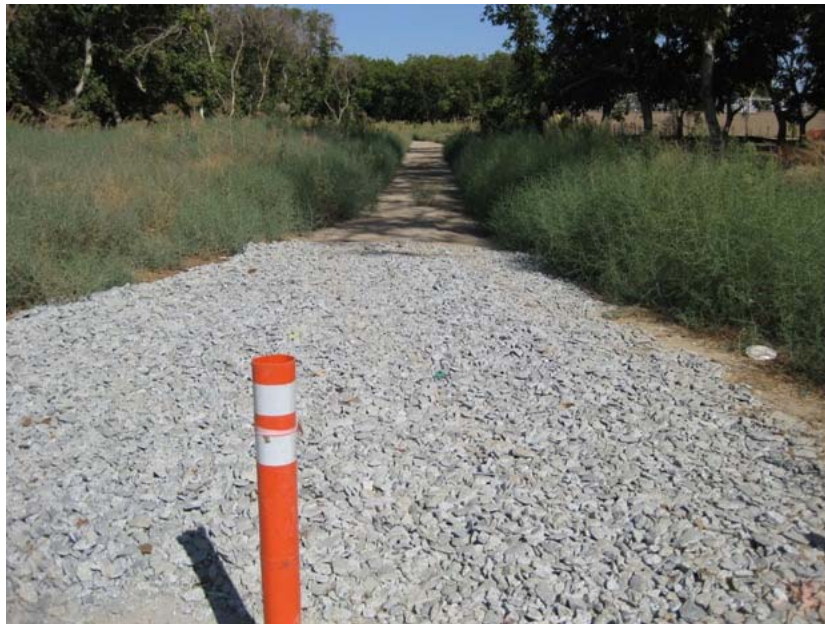
The uncompleted road on the north side of the station is grown over with weeds, mostly Russian thistle, *Salsola tragus* (see Figure 4). Although the weeds were still green at the time of the site visit, the area of the incomplete road could become a fire hazard in the near future.

Because of the incompleteness of the north side road and the retention basins, the storm water runoff system for the outside of the substation (road and the area surrounding the walls of the substation) remains nonfunctional.

**Figure 4:** The access road from Mooney Street (behind the photograph) remains unfinished. The western end of the road is gravelled. The road is used as access to the station, but is mostly clogged with Russian thistle. Apparently no work has been done on this road or the adjacent retention basins since August 2008. The substation lies to the right in the distance. The photograph faces eastward.
