**PROJECT MEMORANDUM  
SCE SONGS PROJECT**

**To:** Jensen Uchida, Project Manager, CPUC  
**From:** Vida Strong, Aspen Project Manager  
**Date:** March 4, 2009  
**Subject:** Status Report #2, January 20–February 16, 2009

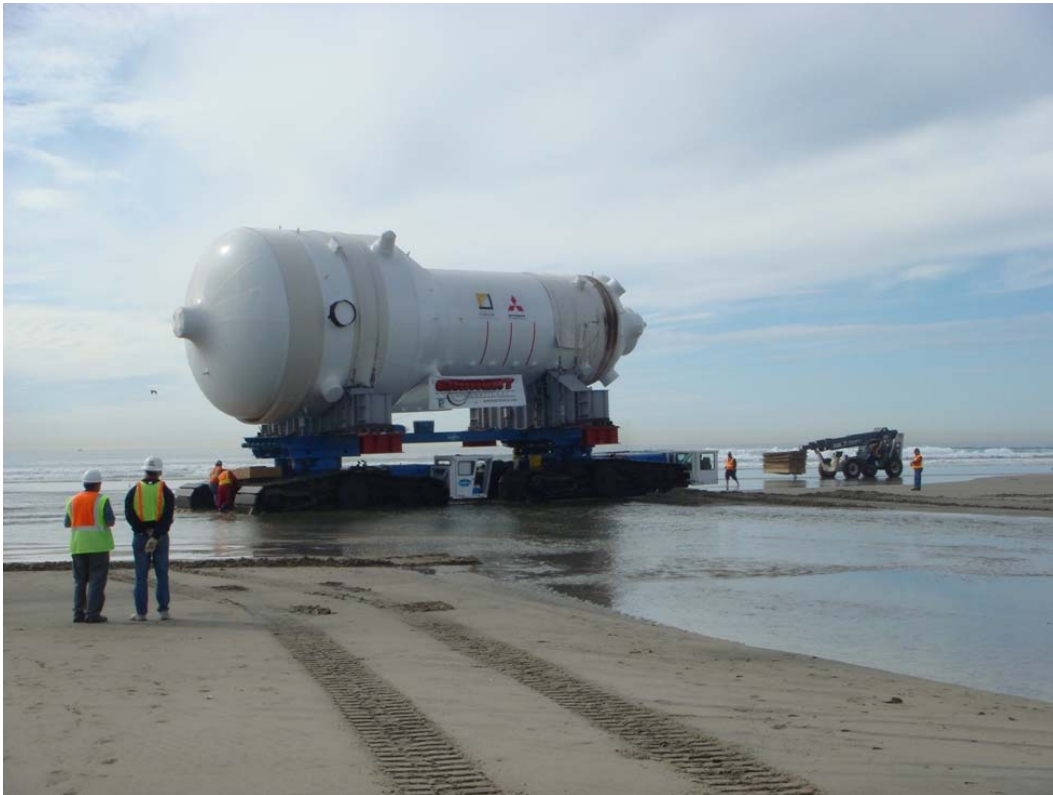
**Figure 1:** RSG on the crawler crossing the Santa Margarita River along the beach route on MCBCP.

1. Transport of the first RSG began on January 20<sup>th</sup> successfully crossing the Santa Margarita River (see Figure 1), and continued to the first layover area for overnight staging. The beach transport was conducted during low tides to stay below the mean high tide line. A grader and a bulldozer were ahead of the crawler creating a smooth, even driving surface for the crawler along the beach (see Figure 2). Transport of the first RSG along the beach route was completed in five days, using three beach layover areas for overnight staging (see Figure 3). Additional grading equipment was brought in to assist in the beach grading ahead of the crawler.

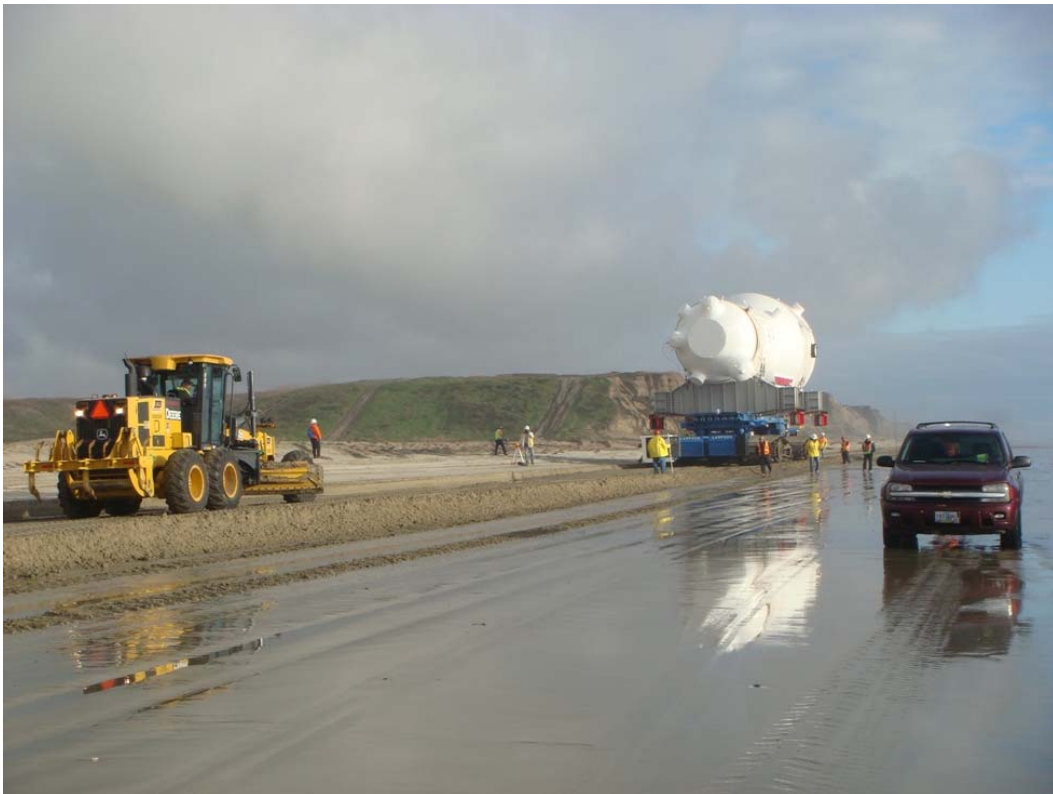
**Figure 2:** The beach route was prepared using graders and bulldozers below the mean high tide line to create an even driving surface for the crawler.

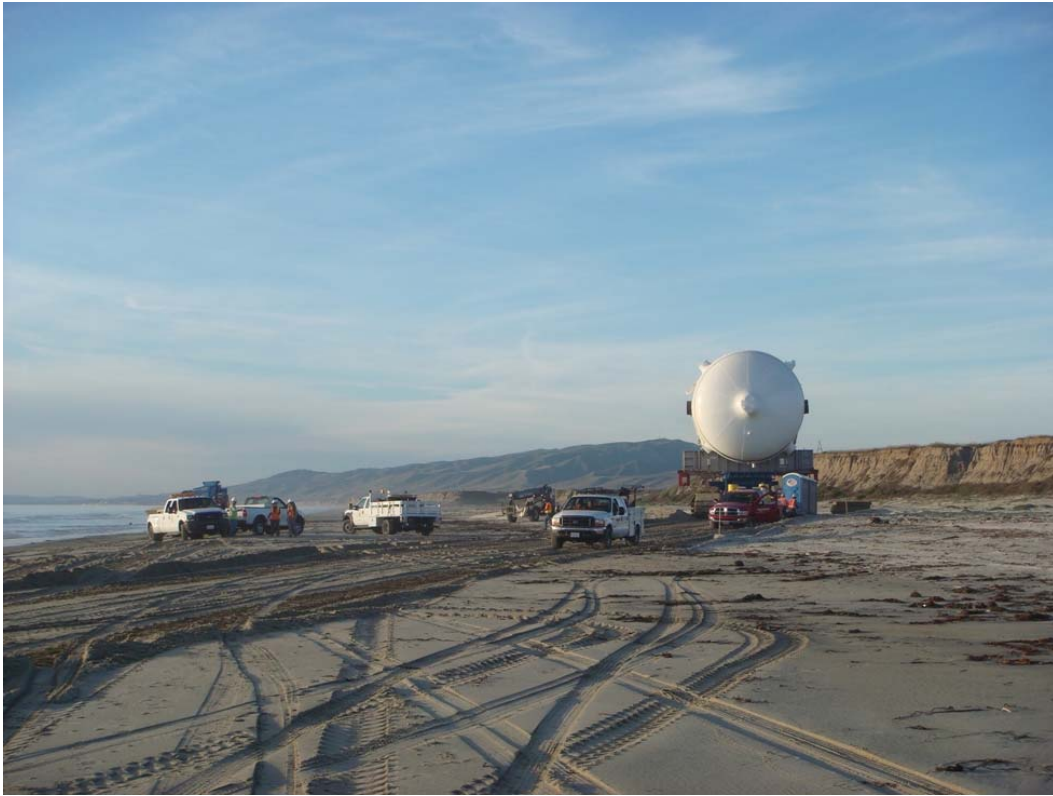
**Figure 3:** The RSG at a layover area above the mean high tide line along the beach route. The RSG was staged overnight in the layover areas and resumed transport during the next low tide.

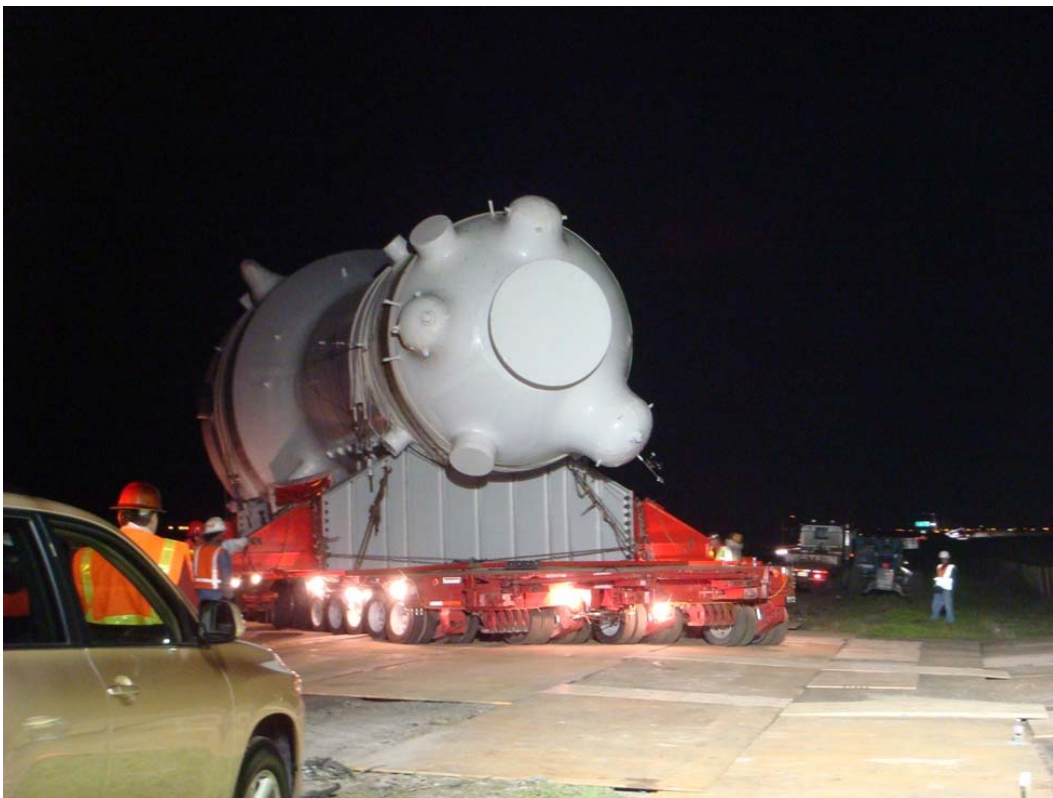
**Figure 4:** RSG transport along Interstate 5 on the Goldhofer. Steel plates were used to protect curbs and pavement.

3. Once the RSG was transported to the Las Pulgas staging area, it was transferred to the Goldhofer and prepared for road transport. Transport from Las Pulgas to the SONGS facility on the Goldhofer began on January 28<sup>th</sup>. Transport along the southbound lanes of Interstate 5 took place the night of the 28<sup>th</sup> and took approximately one hour to complete the ½ mile of freeway transport (see Figure 4). Cal Trans and California Highway Patrol were onsite to assist with the move and oversee traffic control operations. One lane of southbound traffic was open during the closure. The remainder of the

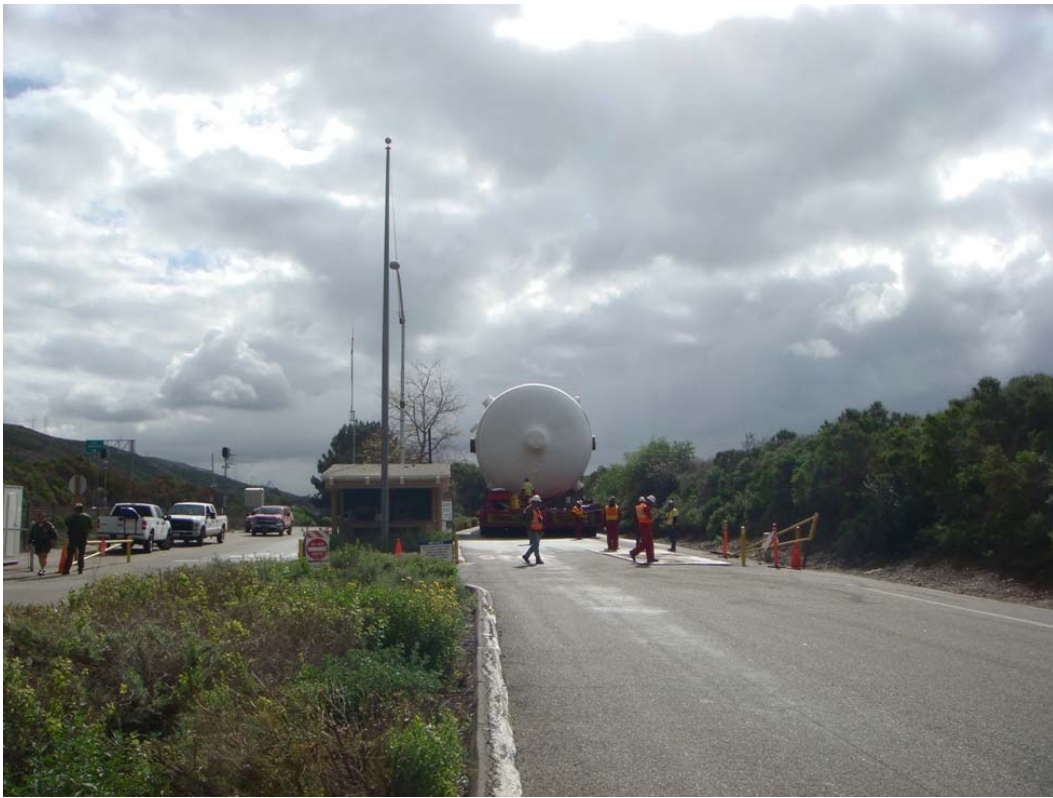
**Figure 5:** Transport of the RSG on the Goldhofer through San Onofre State Park.

transport route along dirt roads on MCBCP and on paved roads (old Highway 101 and through the San Onofre State Park) was completed on January 30<sup>th</sup> (see Figure 5). Minor grading was necessary to improve the dirt access roads on MCBCP due to heavy military equipment conducting training exercises on the same roads.

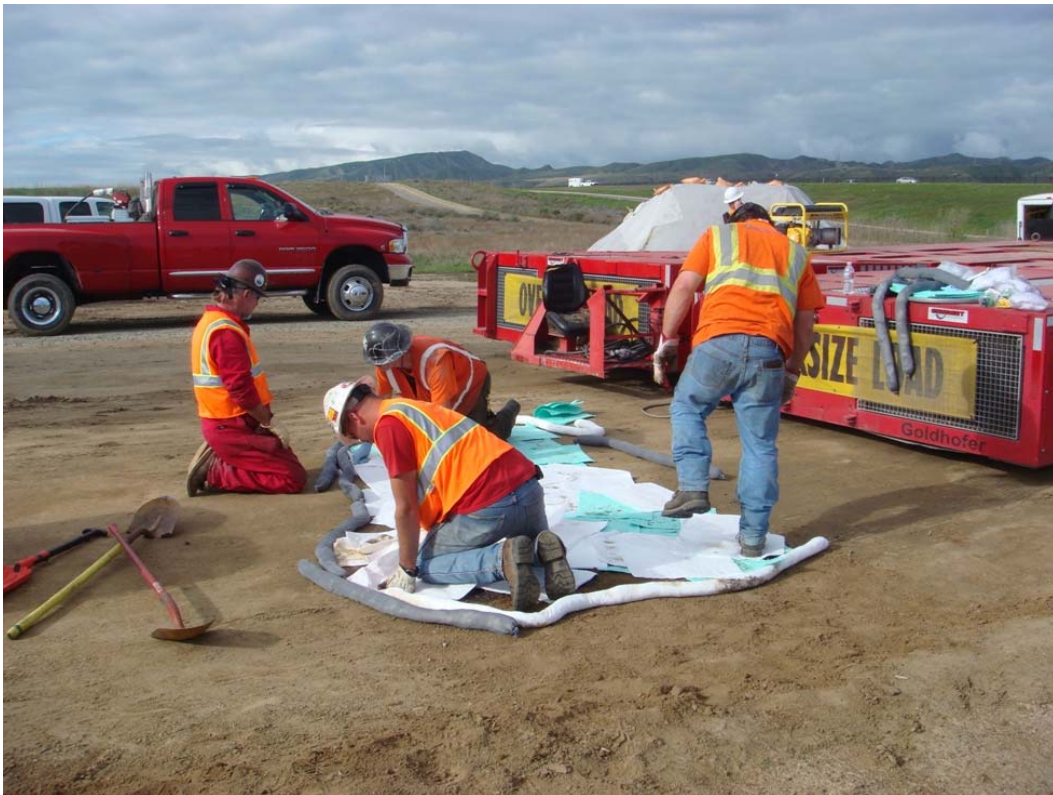
7. A 5-gallon hydraulic spill from the Goldhofer trailer was observed on January 24<sup>th</sup> while the trailer was mobilizing into position for RSG transfer at the Las Pulgas staging area. The approximate 60-square-foot affected area was removed by SCE Haz Mat crews and removed from the site (see Figure 6). The spill was within the criteria for a Tier 1 event and as a result, notifications were made to MCBCP.

**Figure 6:** SCE Haz Mat crews responded to a hydraulic spill from the Goldhofer at the Las Pulgas staging area.
