**PROJECT MEMORANDUM
PG&E SEVENTH STANDARD SUBSTATION PROJECT**

To: Monisha Gangopadhyay, CEQA Project Manager, CPUC
From: Vida Strong, Aspen Project Manager
Date: November 22, 2010
Subject: Report #17: November 7, 2010 – November 20, 2010

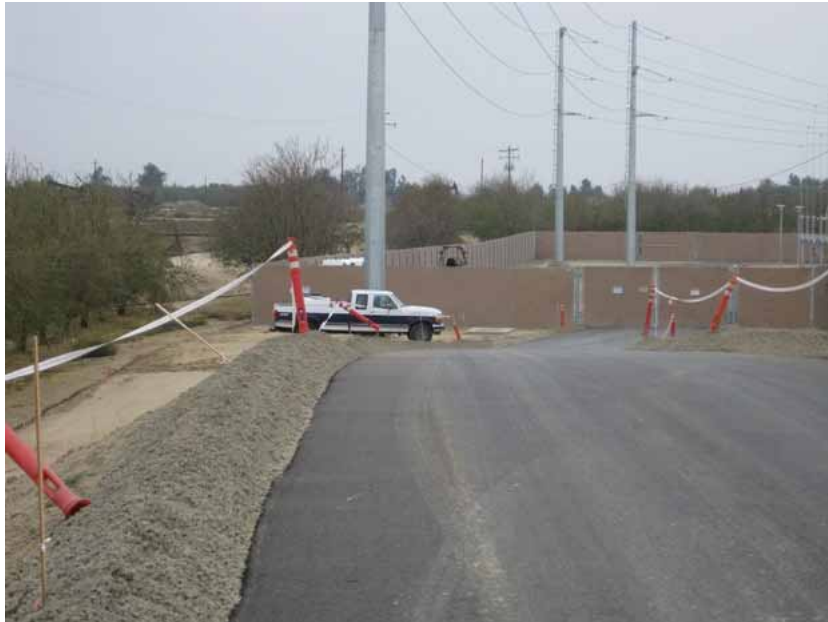
Figure 1: The substation was energized during the subject period. The entrance gate at the south end of the access road is maintained locked at all times, and entry is restricted. The photo faces southward with the eastern part of the substation in the background.

During the subject period, the substation was energized beginning November 17, 2010 (see Figure 1). Prior to and during energizing of different components of the substation, PG&E electrical testing crews continued work on site.

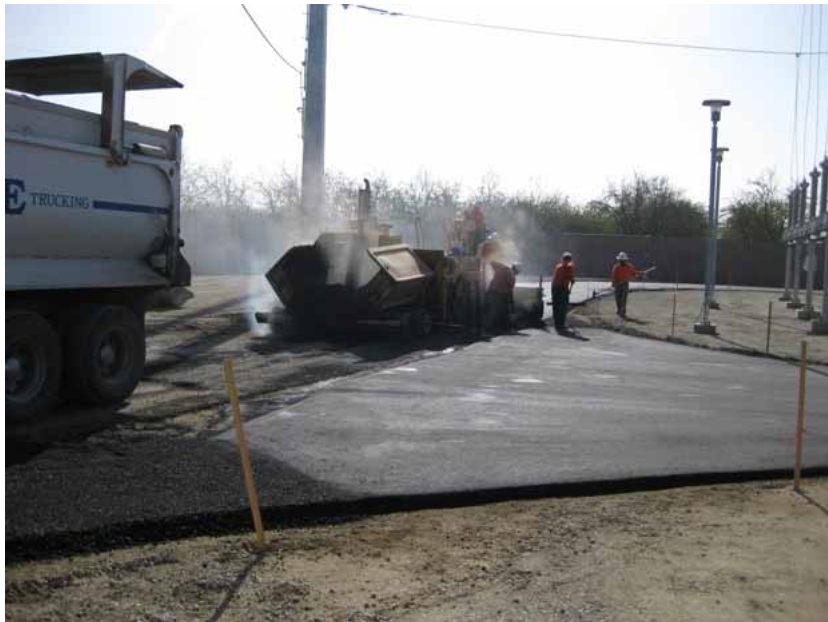
Figure 2: All roads within the site were paved during the subject period. The above section is part of the figure-eight through the substation. The photograph faces southward.

Final grading and placement of road base continued during the subject period. On November 16, 2010, all roads within the site were paved (see Figure 2), including the access road out to the junction with the yet-to-be-completed Seventh Standard Road reconstruction (see Figure 3). The paved roads include the center portion of the access (see Figure 4), a road along the northern border of the site, and a figure-eight within and surrounding the electrical structure.

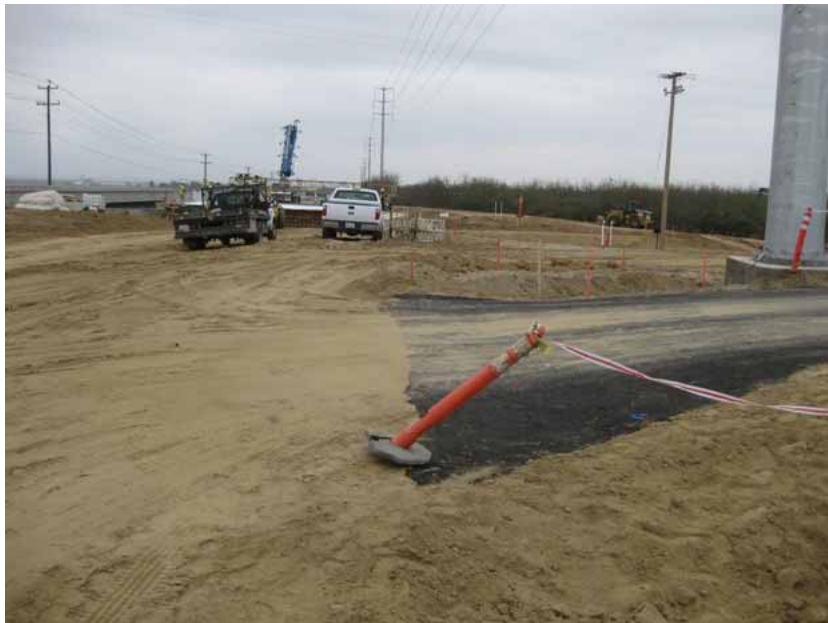
Figure 3: The access road (on the right) was paved out to the edge of the yet-to-be-completed Seventh Standard Road. The photograph faces eastward along Seventh Standard Road.

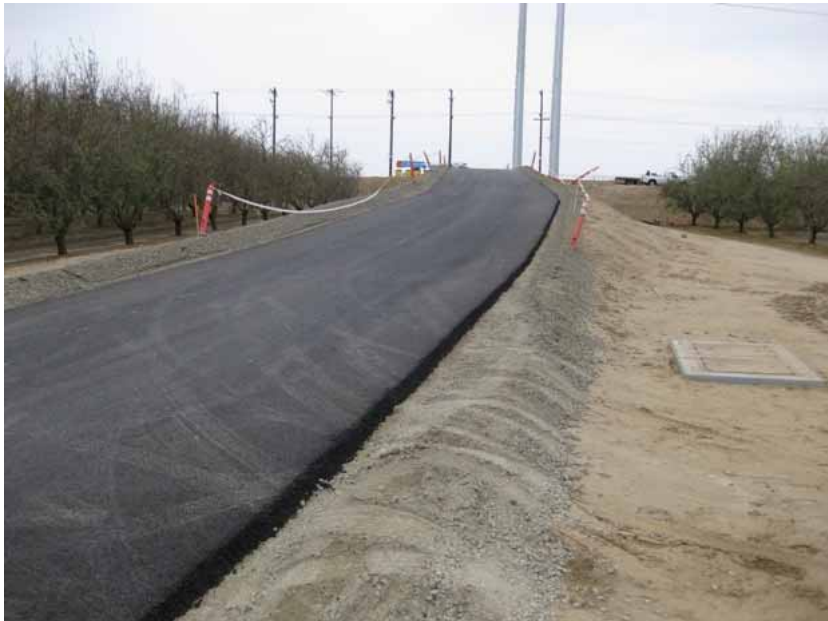
Figure 4: The center portion of the access was paved. The edging remains to be completed. The photograph faces northward towards Seventh Standard Road.

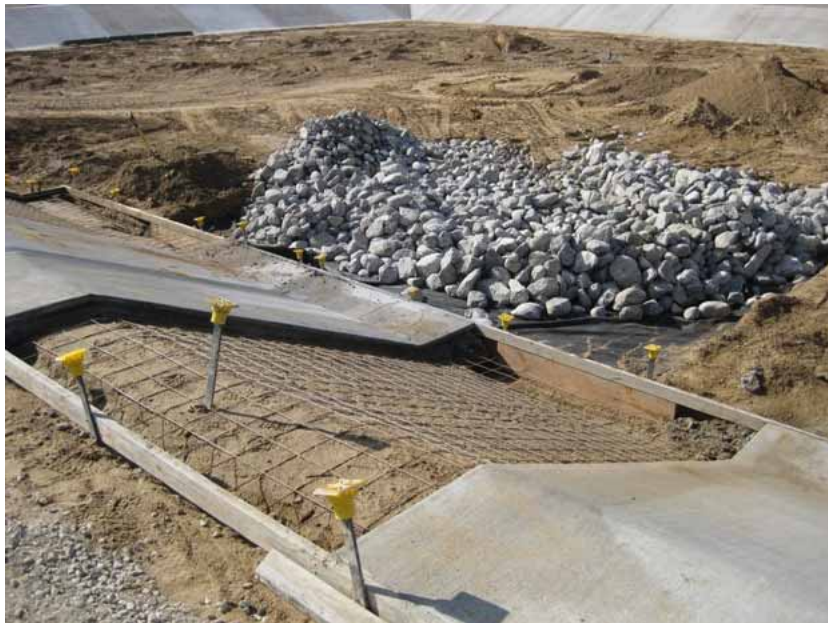
Figure 5: placement of the concrete slopes of the retention basin continued. A rock apron was placed within the basin below the spillway. The photograph faces southwestward.

Work continued during the subject period on the retention basin. Work continued on the concrete slopes of the basin (see Figure 5). A spillway for incoming run-off was constructed (see Figure 6). The entire site has been graded to bring all runoff to the spillway which flows into the retention basin. The basin is floored with native material which will percolate the stored water. The basin also will contain any oil

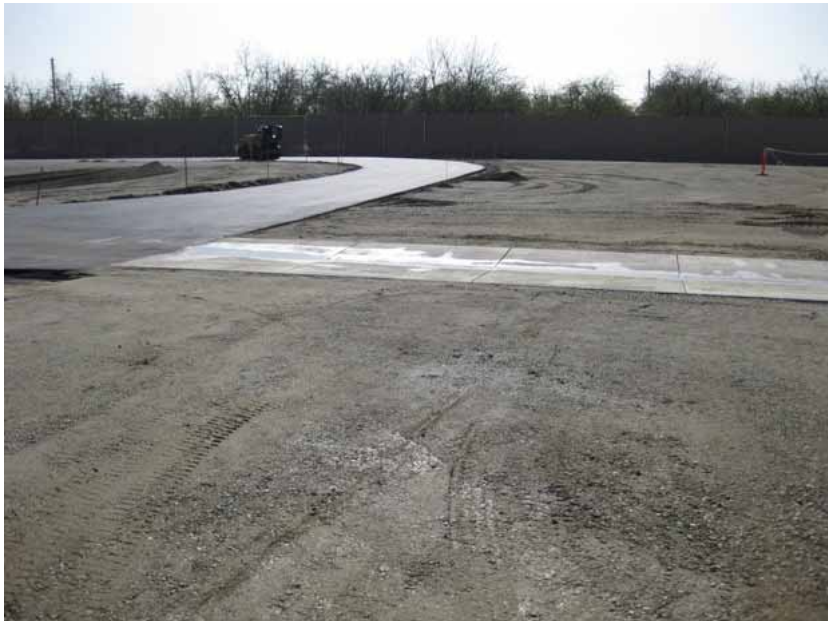
Figure 6: A concrete spillway was constructed to direct run-off water into the retention basin to the right of the photograph, which faces southward.
