**Figure 3.14-25a (Revised)**  
**Existing Conditions**  
**for KOP-Center-10**  
**Eastbound Angeles Crest**  
**Scenic Byway**  
**(Alternative 2, Segment 6)**

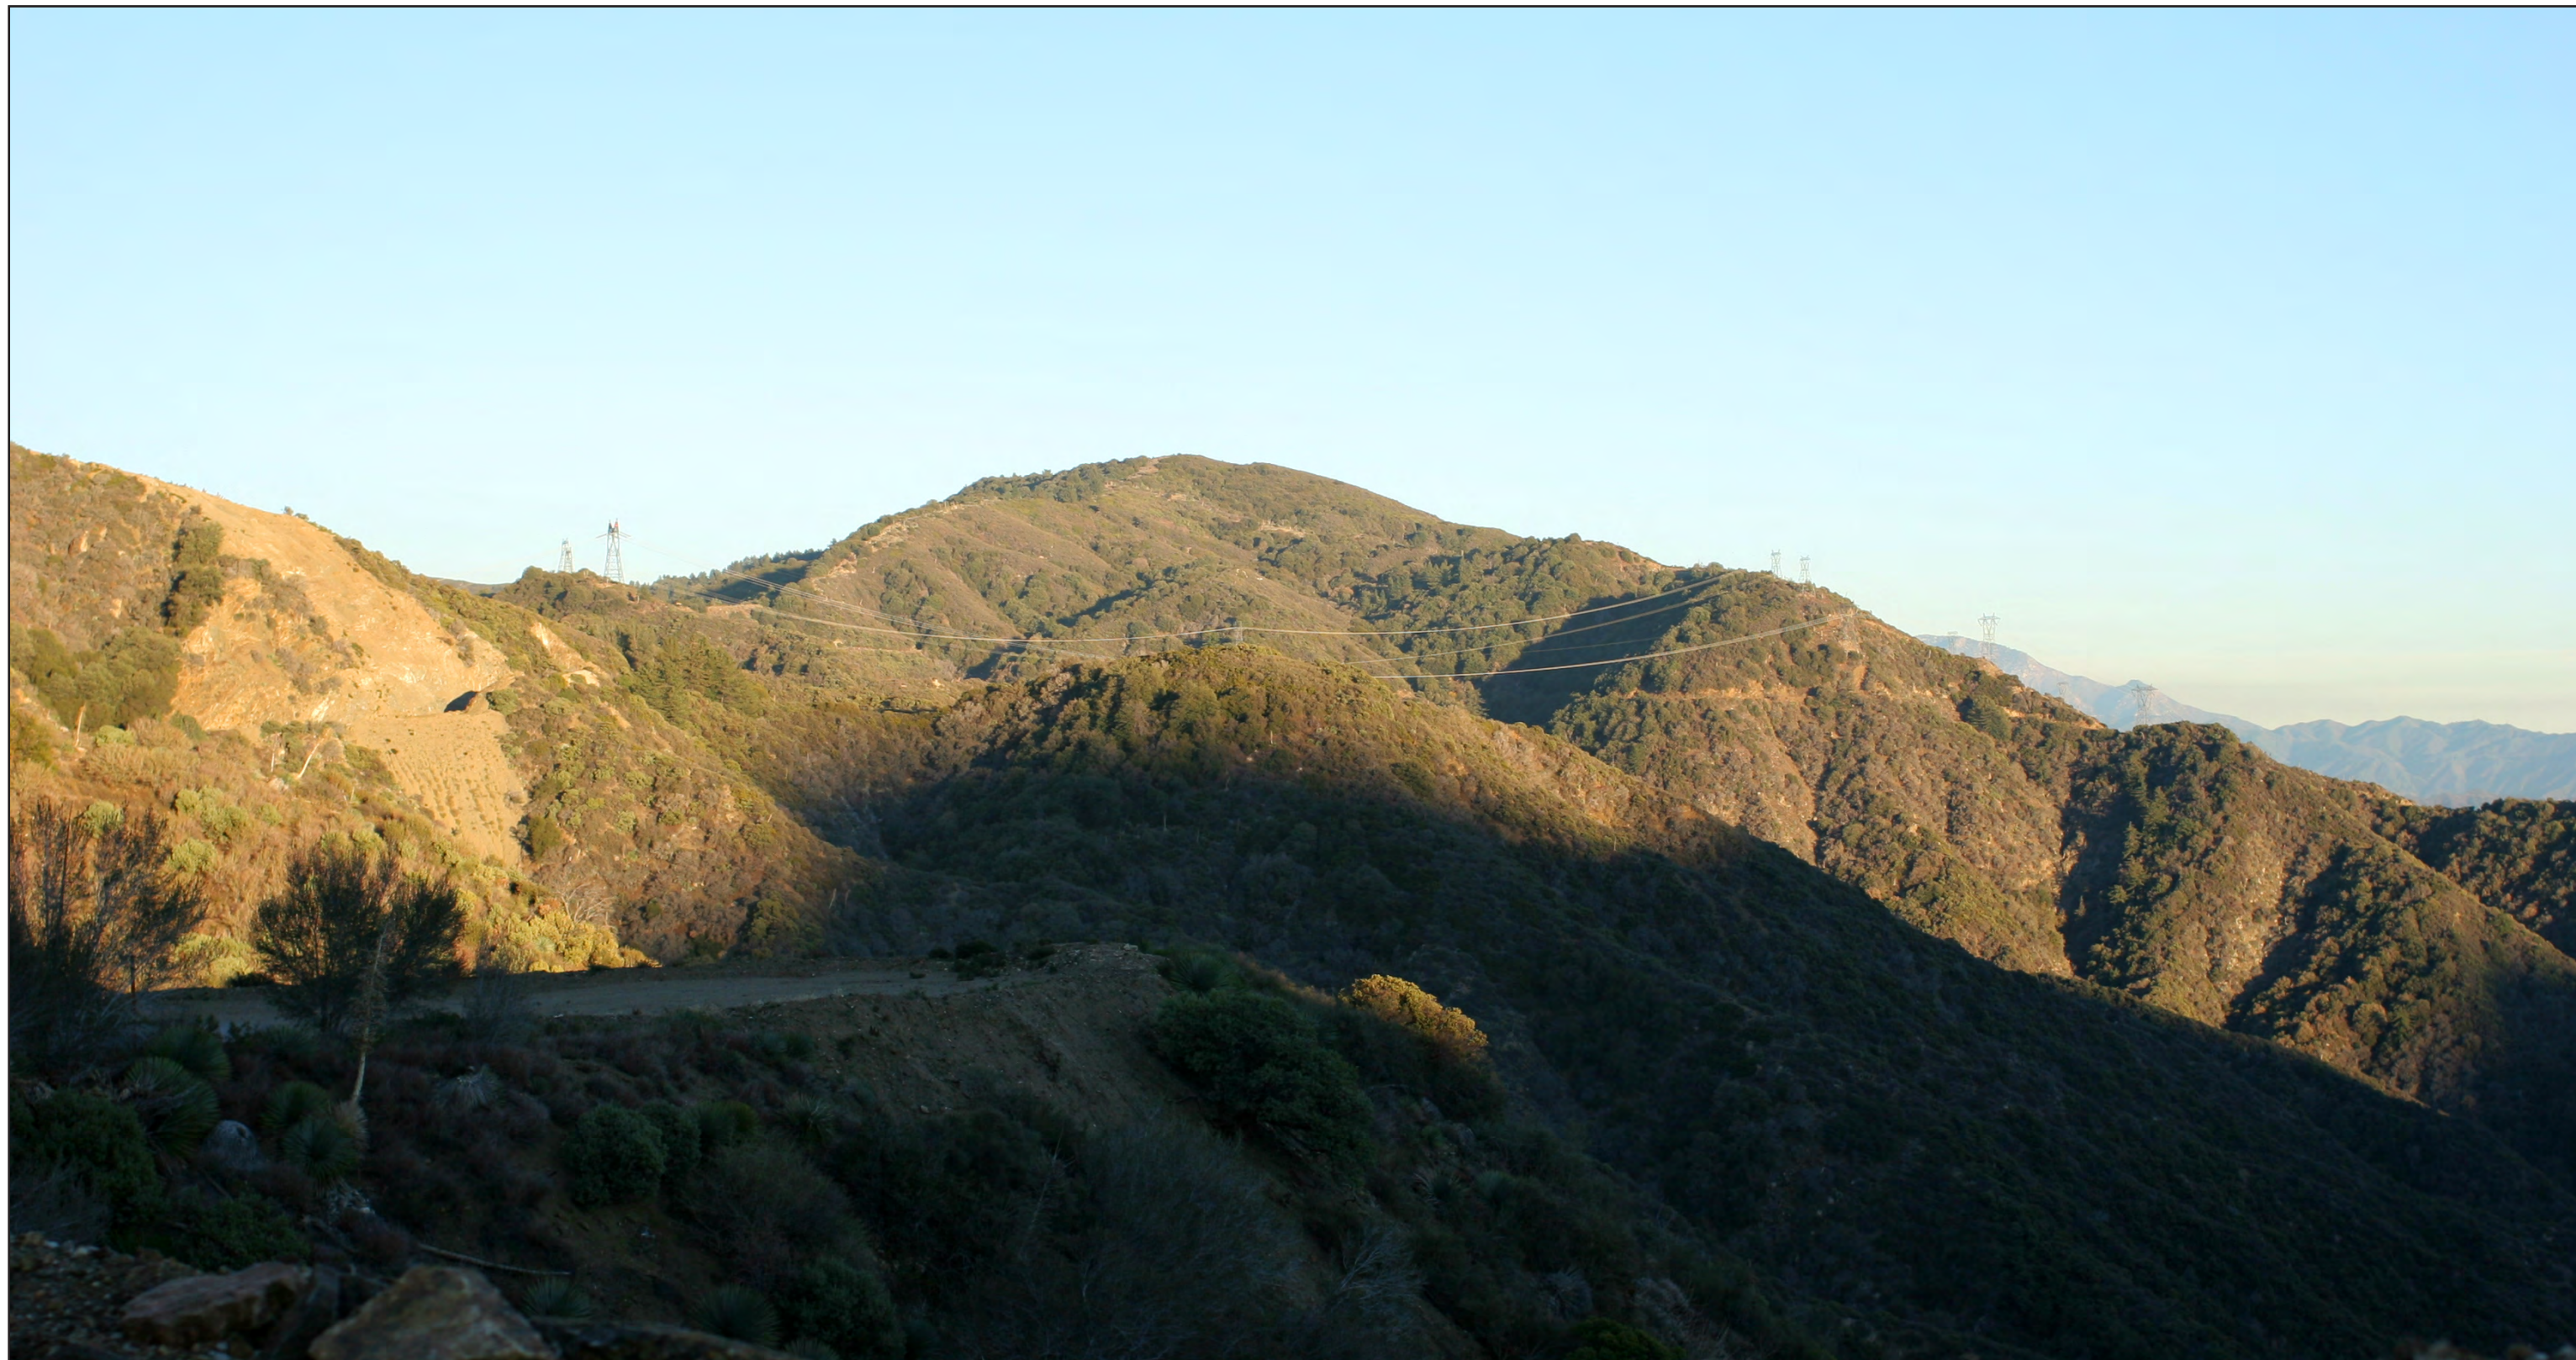
**Existing Scenic Integrity: High, with Areas of Low.** KOP-Center-10 is located on the Angeles Crest Scenic Byway approximately 1.5-miles west of the Shortcut Saddle Area, looking east at Segment 6, near sunset. The landscape visible from the Angeles Crest Scenic Byway in general, and KOP-Center-10 specifically, is predominantly natural-appearing, consisting of foreground and middleground landscapes with dense, dark green chaparral-covered mountainsides and scattered stands of evergreen trees. There are interesting vegetative patterns in this landscape view that are created by the folded terrain and shadows in the landscape. The natural landscape exhibits a high degree of intactness and scenic integrity, except for the highly discordant transmission line structures, which make the landscape character appear moderately altered. They detract from the otherwise high scenic integrity, leading to a rating of low scenic integrity for the utility corridor.

**Scenic Integrity Objective: High.** In the 2005 Forest Plan, the entire landscape in this vicinity is mapped as High SIO, where the management direction states that human activities should not be visually evident. Human-caused deviations may be present but must repeat the form, line, color, texture, and pattern common to the natural landscape character so completely and at such a scale that they are not evident.
