**Figure 3.14-77a (Revised)**

**Existing Conditions  
for KOP-Center-14  
Pacific Crest Trail  
(Alternative 6, Segment 11)**

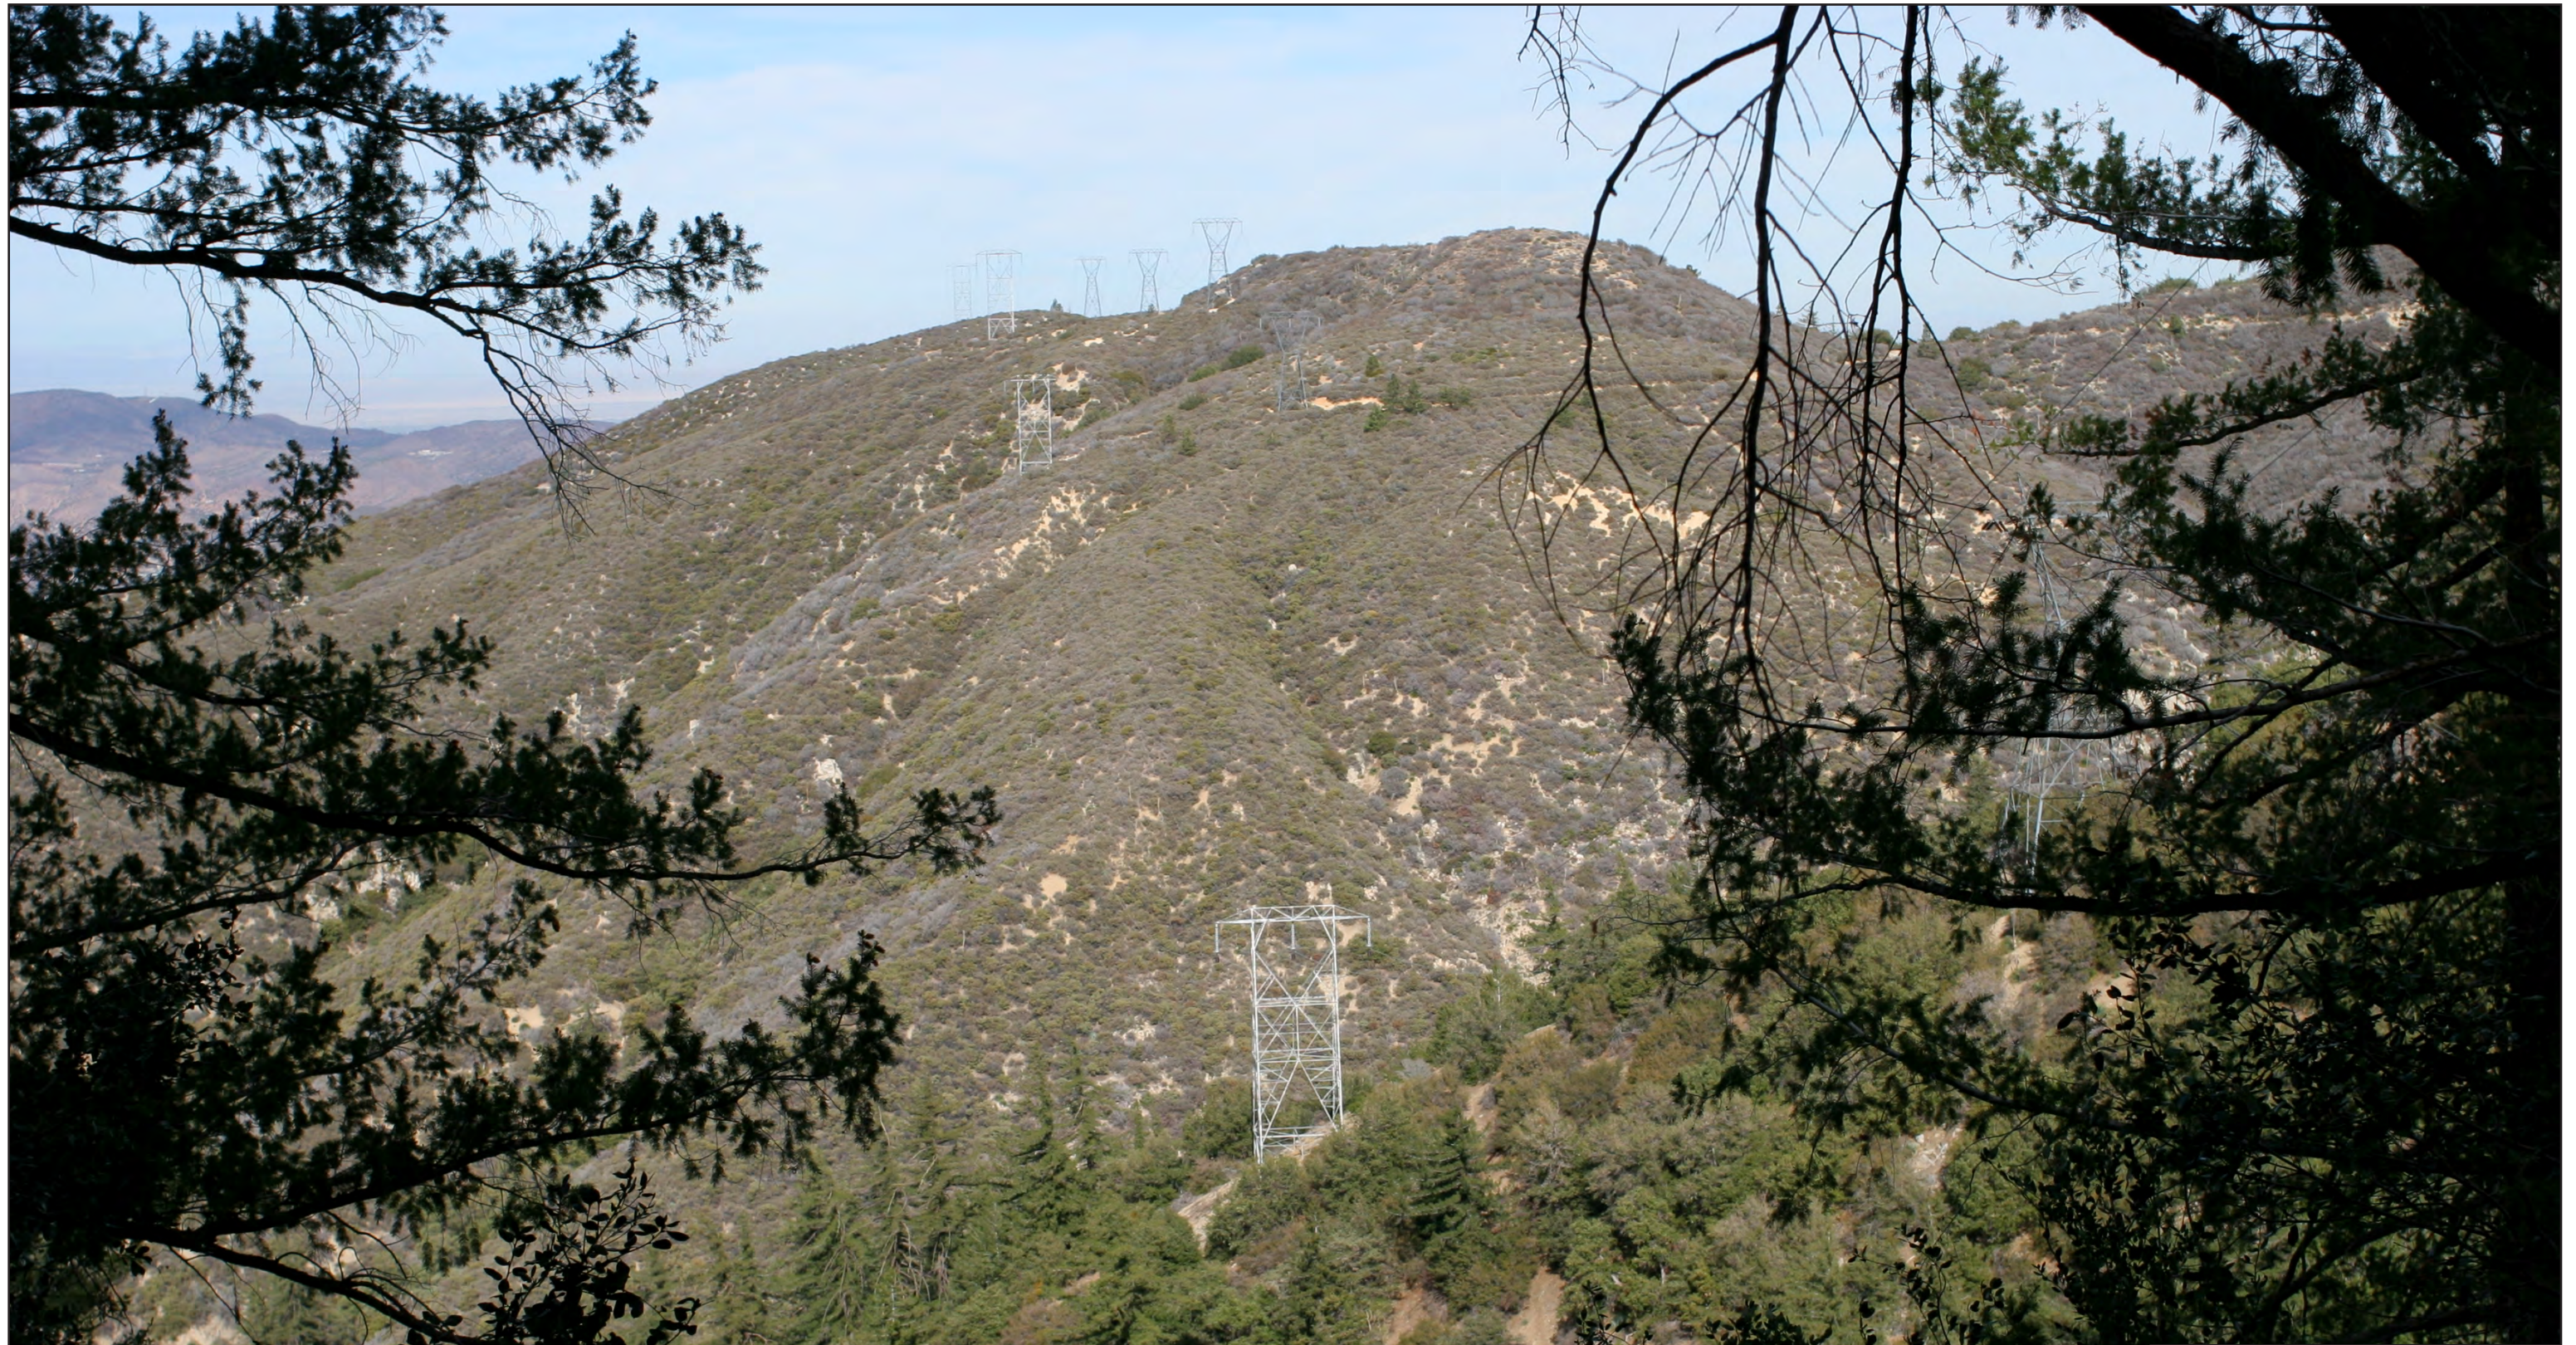
**Existing Scenic Integrity: High, with Areas of Low.** This existing landscape view is from the Pacific Crest National Scenic Trail about ¼ miles west of Big Buck Camp, looking north. The landscape visible from the PCT is predominantly natural-appearing, consisting of a foreground and middleground landscape with dense, dark green Douglas fir, oak, and pine trees on north-facing slopes and chaparral shrubs with widely scattered pine trees on south-facing slopes, creating a mosaic of patterns scattered across these steep mountainsides. The natural landscape has a good coherence of form and character with substantial visual variety. The natural landscape exhibits a high degree of intactness, or scenic integrity, except for the few distinct manmade features – the transmission lines with industrial-character, tall, geometric lattice towers. Access and spur roads to the existing towers are evident and attract attention. When viewed for long durations in the foreground or middleground, as when hiking on the PCT, the existing transmission line towers are very evident as vertical, angular structures that create glare and contrast with the natural landscape. These discordant features attract attention from the harmony of the natural form and character of the landscape, especially transmission towers that are in the foreground or are silhouetted against the skyline in the middleground. These discordant elements do not borrow form, line, color or texture from the natural-appearing landscape, and create a moderately altered landscape. Therefore, the existing transmission line towers meet the definition of low scenic integrity.

**Scenic Integrity Objective: High.** In the 2005 Forest Plan, the entire landscape in this vicinity is mapped as High SIO, where the management direction states that human activities should not be visually evident. Human-caused deviations may be present but must repeat the form, line, color, texture, and pattern common to the natural landscape character so completely and at such a scale that they are not evident.
