**Figure 3.14-80a**  
**Existing Conditions**  
**for KOP-Center-17**  
**Northbound Angeles Forest**  
**Highway (Alternative 6,**  
**Segment 11)**

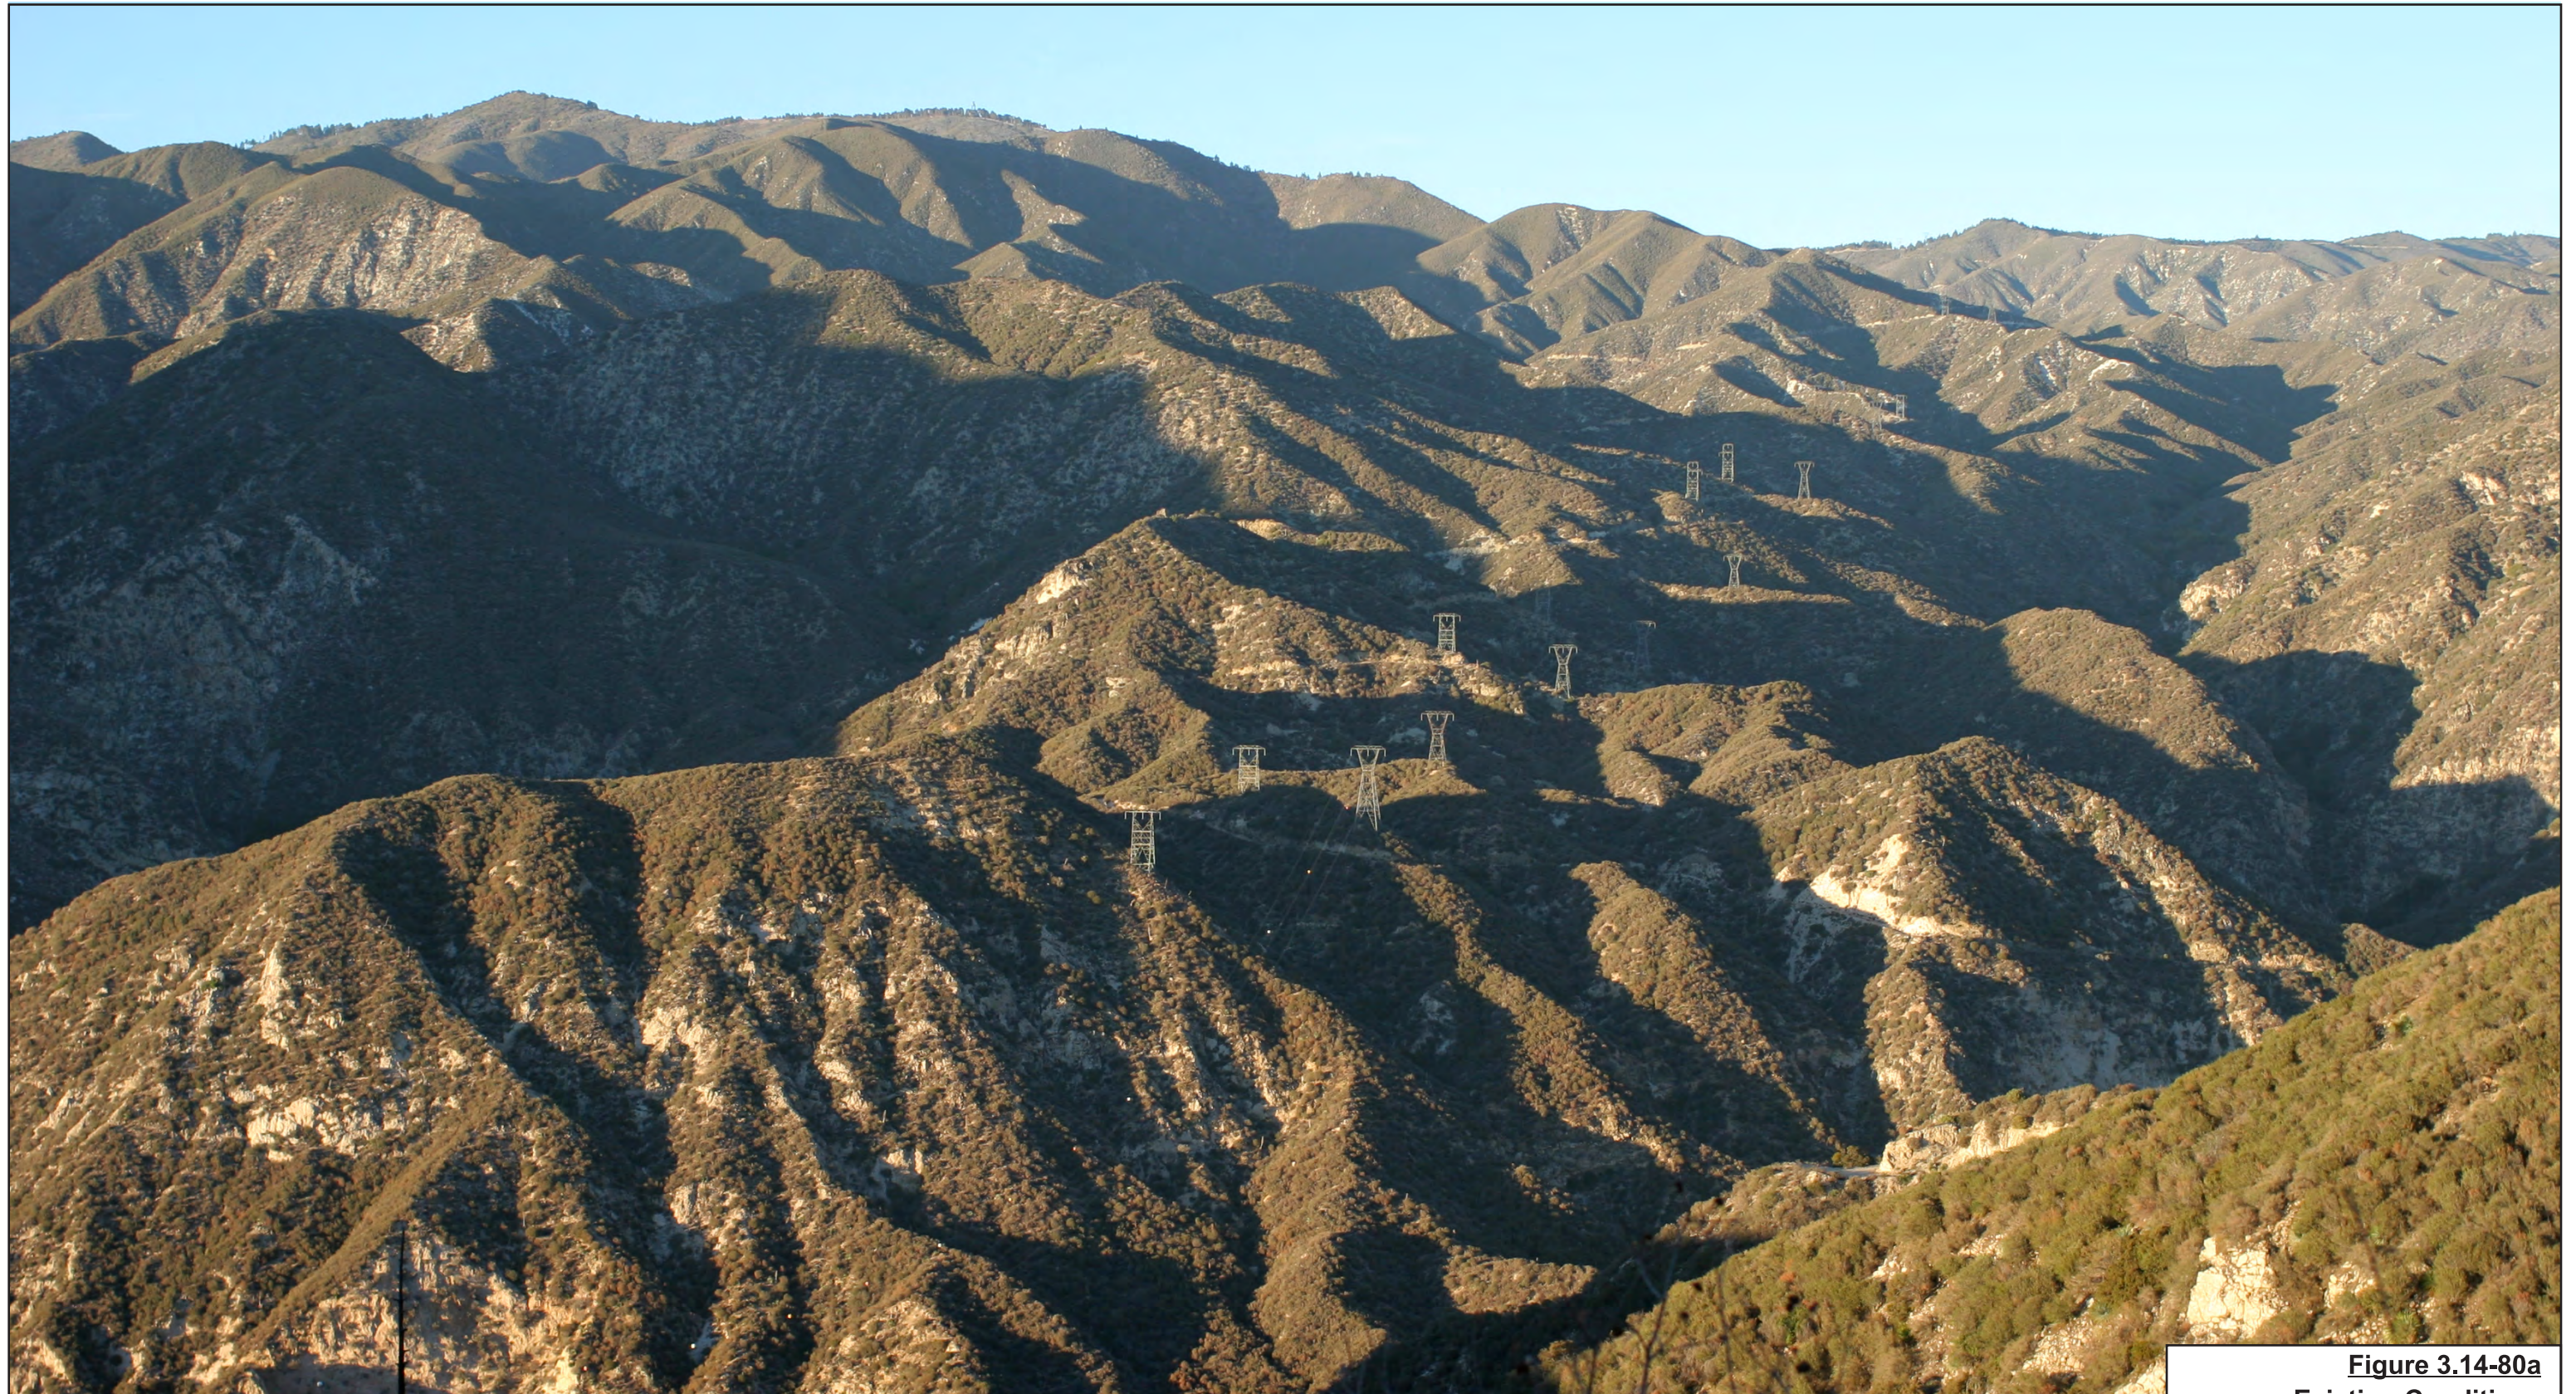
**Existing Scenic Integrity: High, with Areas of Very Low.** KOP-Center-17 is located on the Angeles Forest Highway approximately 3-miles north of its intersection with the Angeles Crest Scenic Byway, as seen by people driving north and down into the Big Tujunga Canyon on their way to Palmdale, Lancaster, and the Antelope Valley. The landscape visible from the Angeles Forest Highway in general, and KOP-Center-17 specifically, is predominantly natural-appearing, consisting of foreground, middleground, and background landscapes with interesting patterns of dense, dark green chaparral-covered mountainsides. The folded terrain and shadows create interesting patterns in this landscape view. The natural landscape exhibits a high degree of intactness and scenic integrity, except for the highly discordant transmission line structures, which detracts from the high scenic integrity. The utility corridor appears heavily altered and visual deviations (human-made structures) strongly dominate the view, leading to a rating of very low scenic integrity for the utility corridor.

**Scenic Integrity Objective: High.** In the 2005 Forest Plan, the entire landscape in this vicinity is mapped as High SIO, where the management direction states that human activities should not be visually evident. Human-caused deviations may be present but must repeat the form, line, color, texture, and pattern common to the natural landscape character so completely and at such a scale that they are not evident.
