**PROJECT MEMORANDUM
SDG&E'S SUNRISE POWERLINK PROJECT**

To: Billie Blanchard, Project Manager, CPUC
From: Vida Strong, Aspen Project Manager
Date: July 22, 2011
Subject: Weekly Report 43 – July 10 to July 16, 2011

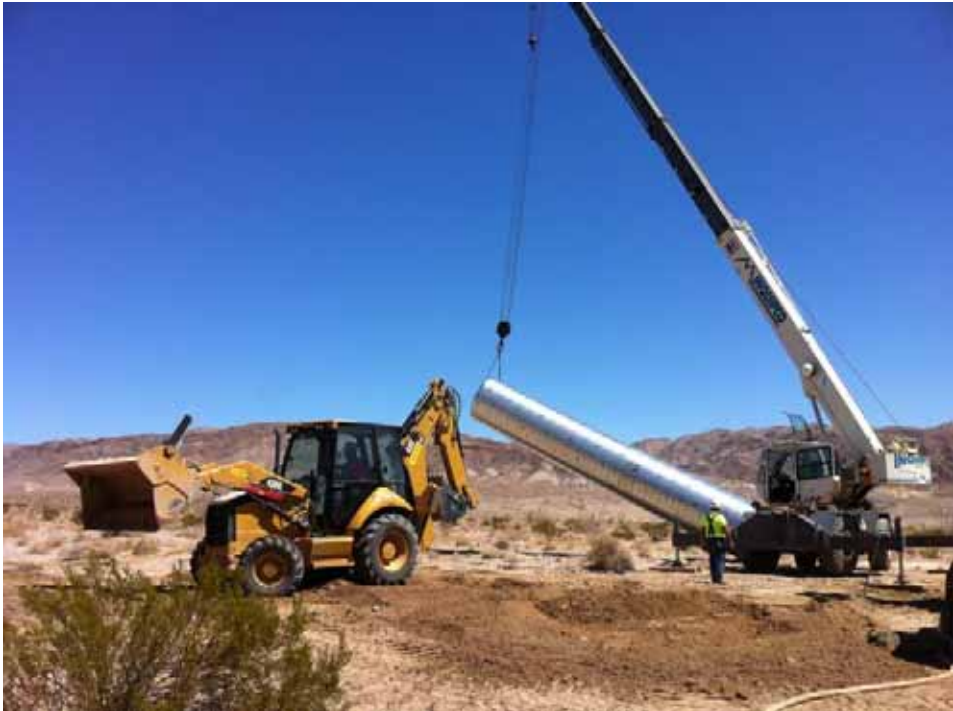
Figure 1: Setting corrugated pipe to stabilize the hole at EP298, Link 1.

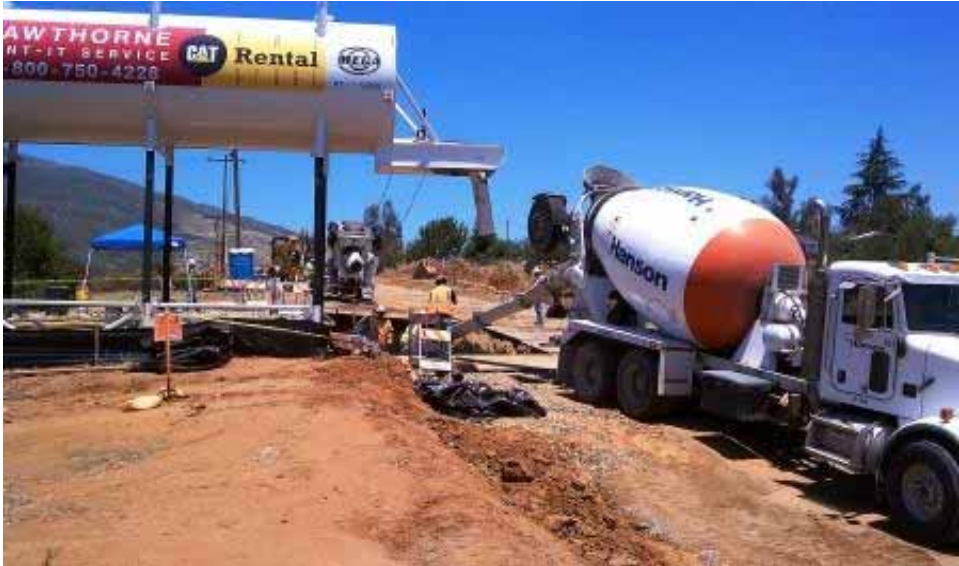
- A vault was set at V20R (see Figure 2).
 - Cable pulling (and cable testing) occurred from V4L to V6L.
 - The Interstate 8 bore site (Caltrans bore site) was demobilized.

Figure 2: Installation of Vault 20R. (Link 4)

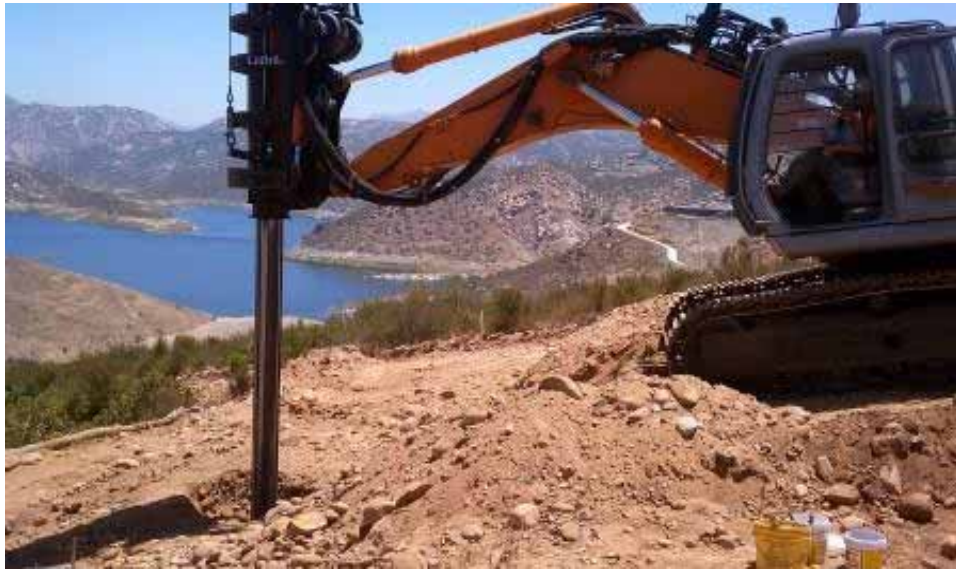
4. Link 5:
- Non-Federal Lands, 220 kV Overhead Transmission Line:
- Grading occurred on the access road leading to CP20 through CP24.
 - Conventional drilling occurred at CP20 and CP41-2 (see Figure 3).

Figure 3: Conventional drilling at CP 41-2; San Vicente Reservoir in the background. (Link 5)

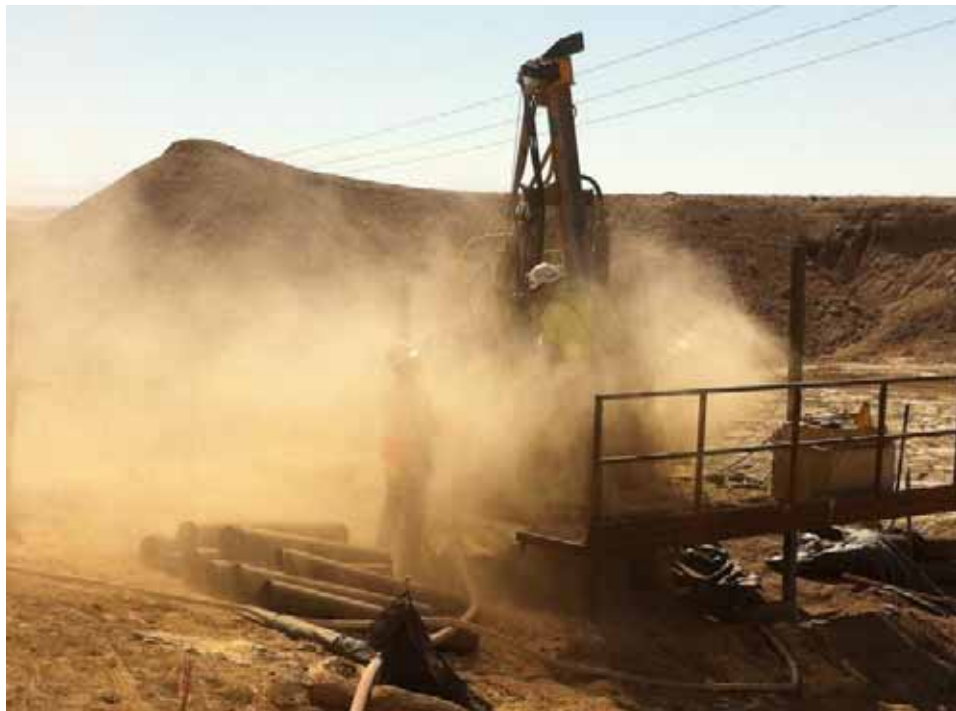
10. It was noted to the Link Lead that plumes of dust were observed at EP312 as a result from micropile drilling (see Figure 4). Immediate corrective action was taken to reduce dust. (Link 1)

Figure 4: Dust from micropile drilling at EP312, Link 1.

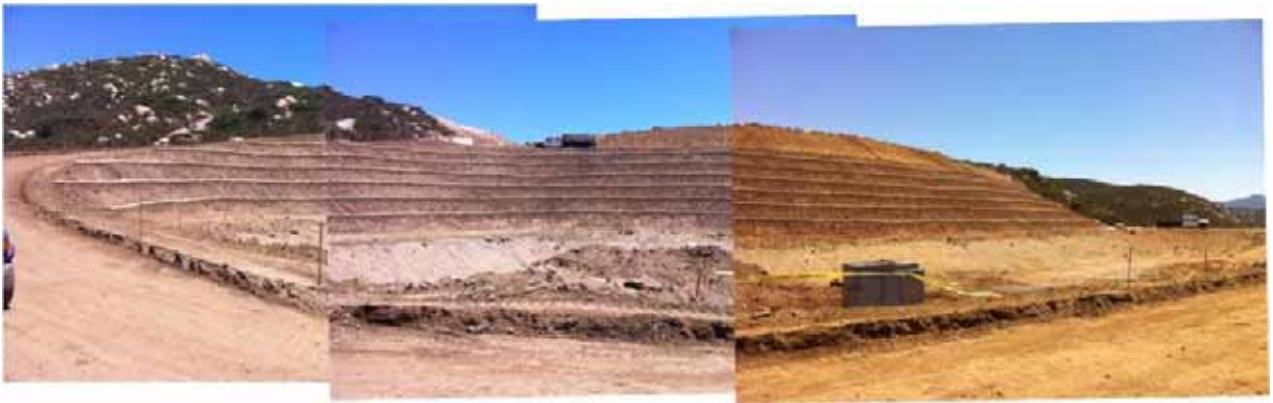
1. All applicable Biological, Cultural, Paleontological, and Native American monitors have been present during ground disturbing activities at all substations.
2. Wattles were installed for slope stabilization on completed sections of the substation pad (see Figure 5). (Link 3)
3. One flat-tailed horned lizard (*Phrynosoma mcalli*) was relocated from the Imperial Valley Substation. (Link 1)
4. One Barn owl (*Tyto alba*) was found dead at the Sycamore Substation.

Figure 5: BMP installation on finished slope at Suncrest Substation, Link 3.

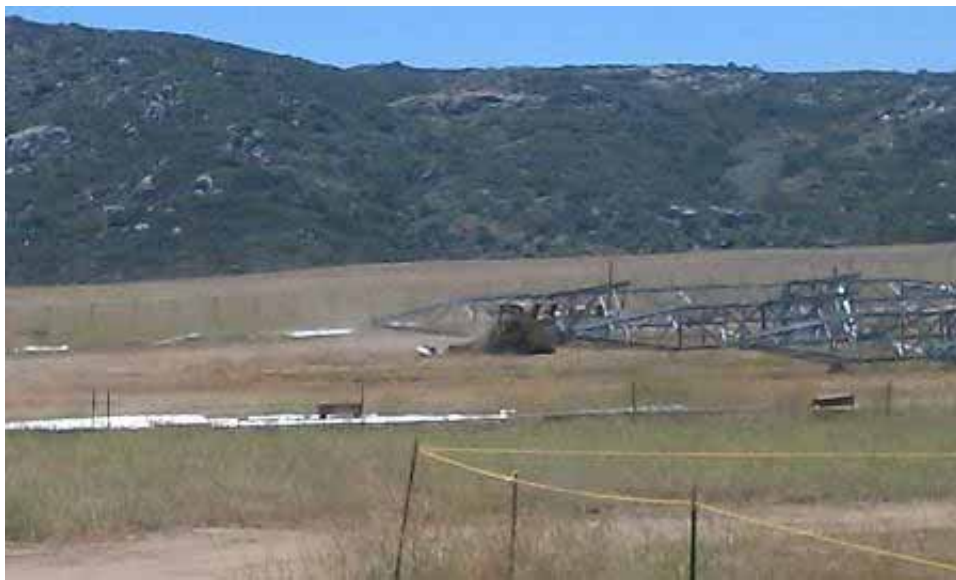
Figure 6: Mowing for weed maintenance at Bartlett-Hauser Construction Yard. (Link 2).

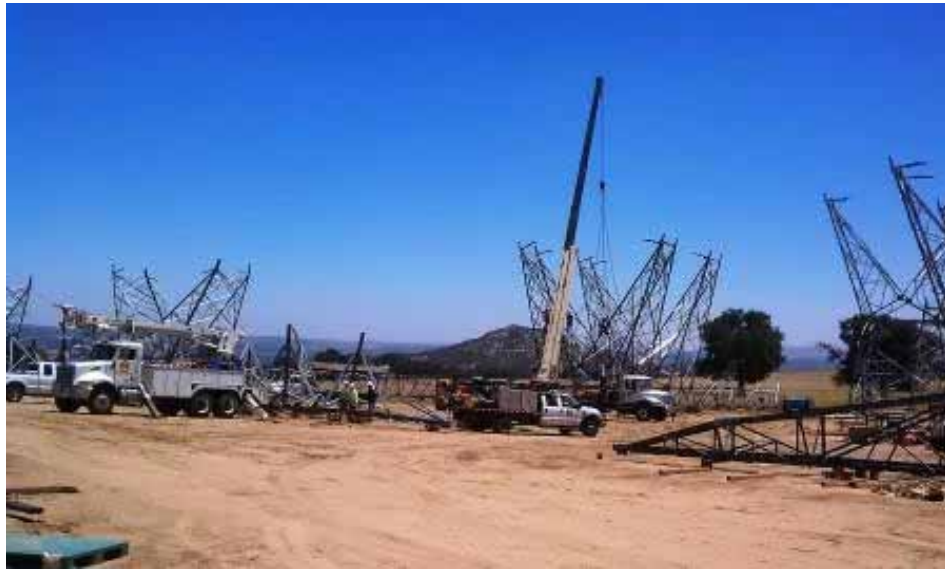
Figure 7: Tower assembly at Bartlett-Hauser Construction Yard. (Link 5)

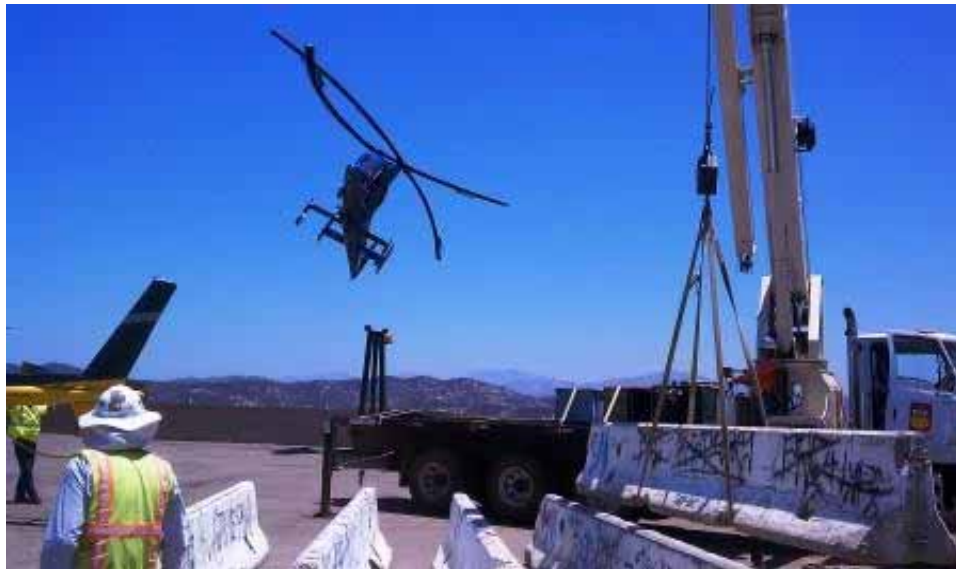
Figure 8: K-Max helicopter leaving Sycamore Construction Yard. (Link 5)

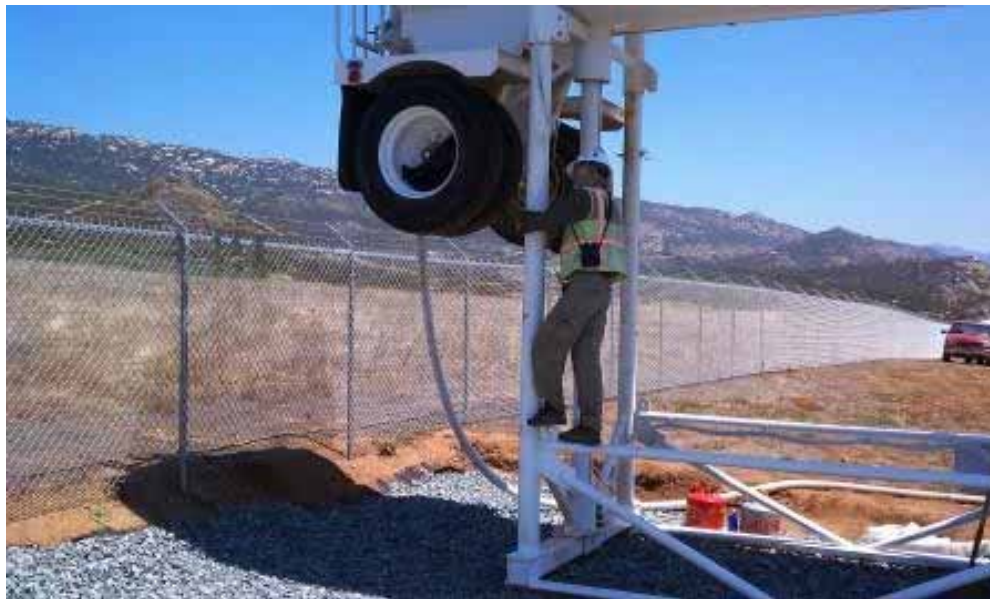
1. Biological, Cultural, and Native American monitors have worked with crews at the construction yards to define approved work areas and sites to avoid (see Figure 9).

Figure 9: A biologist inspects a water tower for bird nests at SWAT Construction Yard. (Link 2)

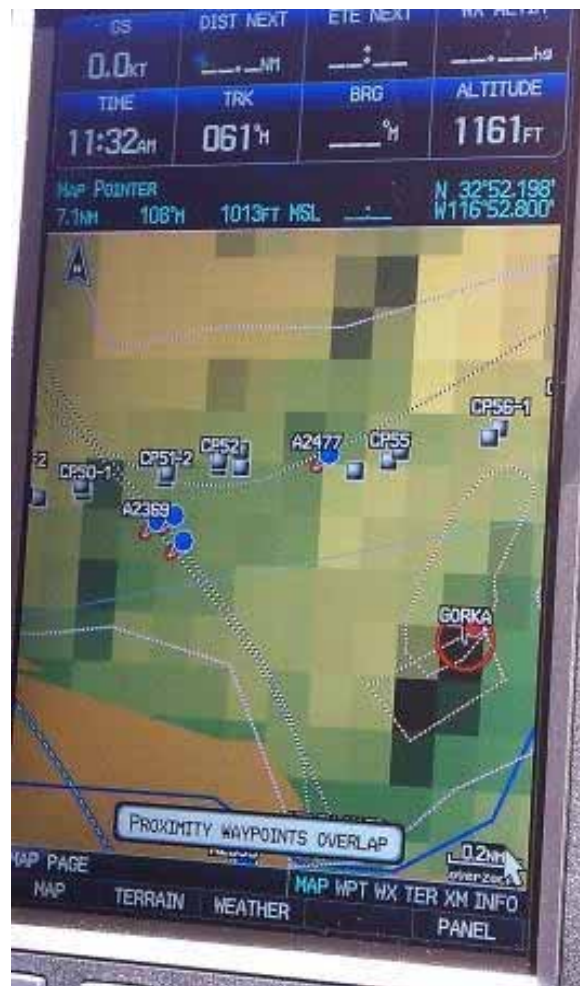
5. One western fence lizard was relocated at the Sycamore Construction Yard. (Link 5)
6. Helicopters avoided sensitive land owners by use of their GPS units, which are updated daily to reflect any changes in sensitive areas along the alignment (see Figure 10).

Figure 10: GPS unit display in helicopter showing tracks to Helix Construction Yard and avoidance of sensitive land owner property. (Link 5)
