**PROJECT MEMORANDUM  
SDG&E'S SUNRISE POWERLINK PROJECT**

**To:** Billie Blanchard, Project Manager, CPUC  
**From:** Vida Strong, Aspen Project Manager  
**Date:** December 8, 2011  
**Subject:** Weekly Report 61 – November 13 to November 19, 2011

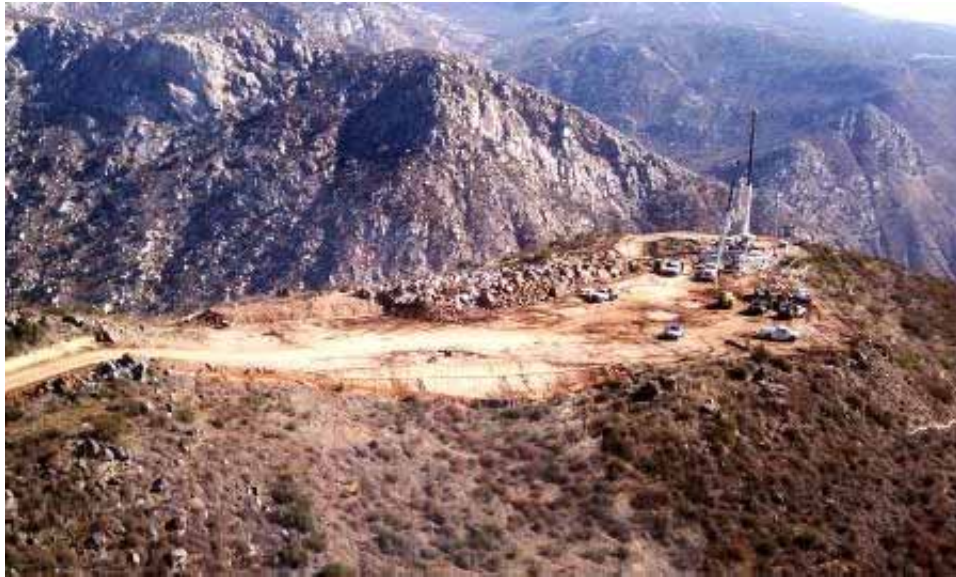
**Figure 1:** Helicopter view of tower erection at EP42 looking east toward the mile span and EP43. (Link 2)

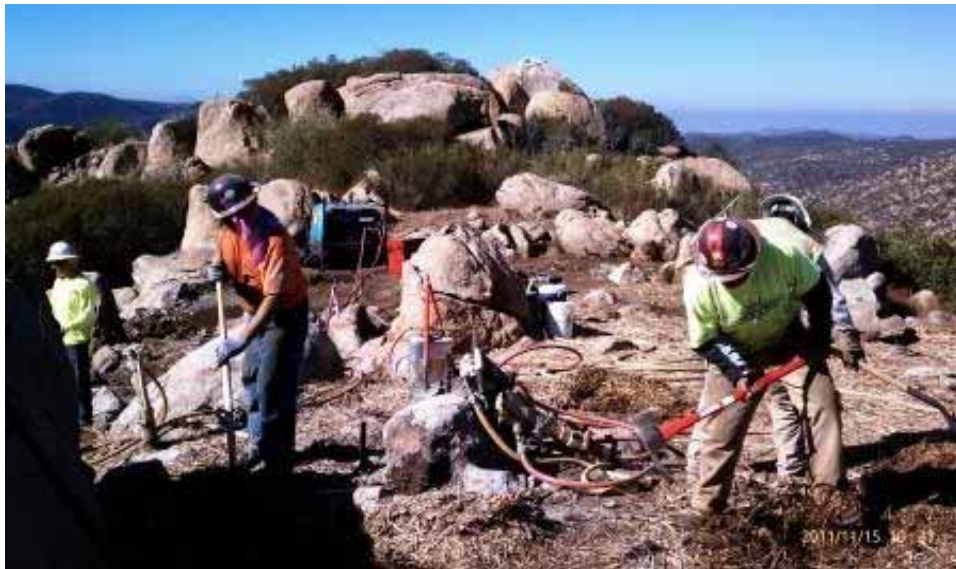
- Vegetation clearing occurred at EP9-1, EP9-1-N, EP9-1 pull site, EP2-3 TSAP, EP3-3 TSAP, EP4-3 TSAP, EP5-2 TSAP, EP6-1 TSAP (see Figure 2), EP7-1 TSAP, EP8-2 TSAP, EP10-2, EP13-3 TSAP, EP16-1, EP16-1 TSAP, EP18, EP18 TSAP, EP19-1, EP19-1 TSAP, EP22-1, EP22-1 TSAP, EP24-1, EP24-1 TSAP, EP57-2, EP57-2 TSAP, EP105-2-E-A, and EP105-2-E-B.

**Figure 2:** Brush clearing/boulder busting crew at EP6-1 TSAP. (Link 2)

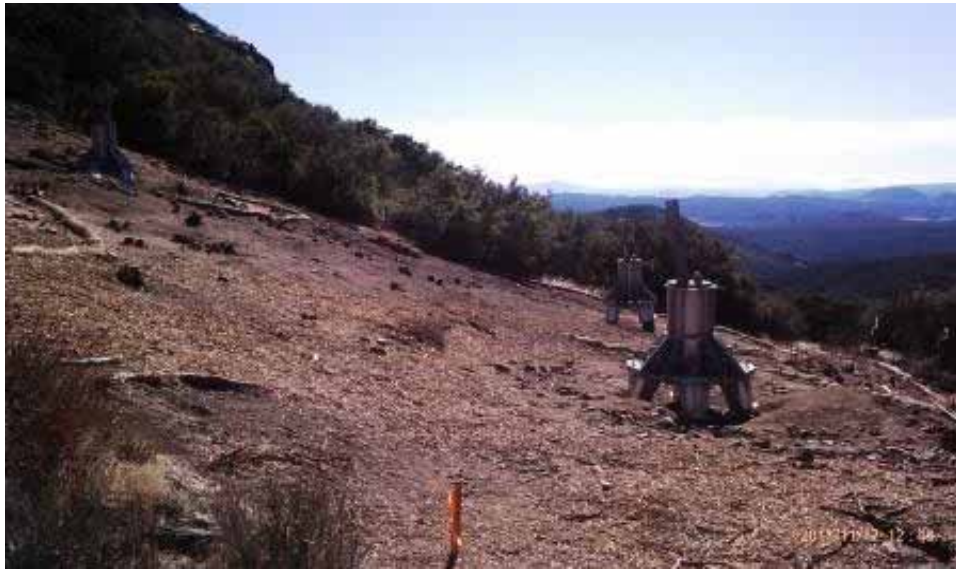
- Tree trimming occurred at EP12-3 and EP13-3.
- Micropile drilling occurred at EP2-3, EP3-3, EP4-3, EP6-1, and EP8-2.
- Various micropile work (capping, pile surveys, site benching, etc.) occurred at EP132-2 (GE), EP134-1 (GE), EP135 (GE), EP136 (GE), EP137 (GE), EP138-2 (GE), EP139-1, and EP140-1 (see Figure 3).

**Figure 3:** EP140-1 with micropile caps installed. (Link 2)

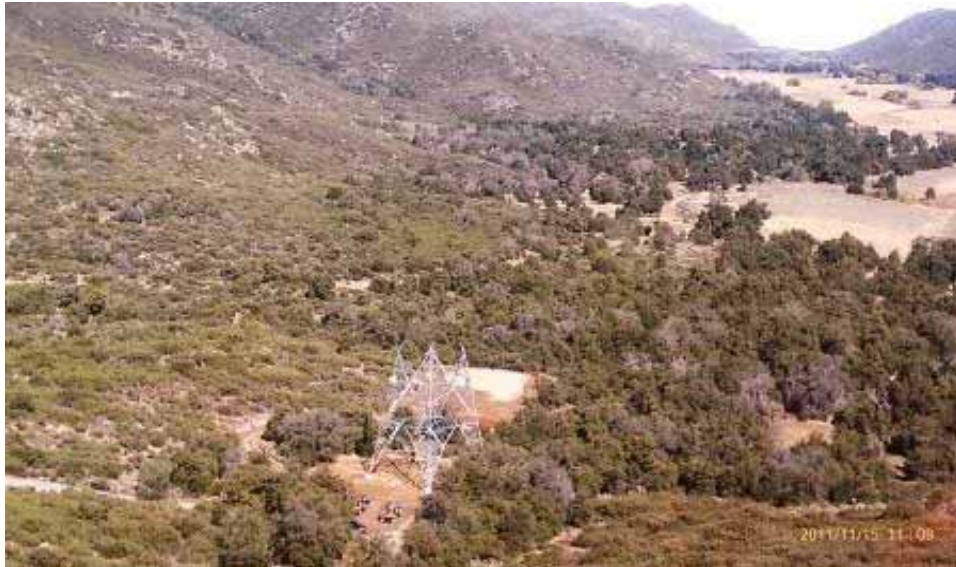
- Ground resistance testing occurred at EP141.
- Driveway construction occurred at EP9-1-N, EP105-2-E-A, and EP116-1.
- Tower assembly occurred at EP131, EP132-2 (GE), EP134-1 (GE), EP135 (GE), EP136 (GE), EP137 (GE), EP138-2 (GE), EP139 1, EP140, and EP141 (see Figure 4).

**Figure 4:** Helicopter view looking north to Tower EP141 and pull site. (Link 2)

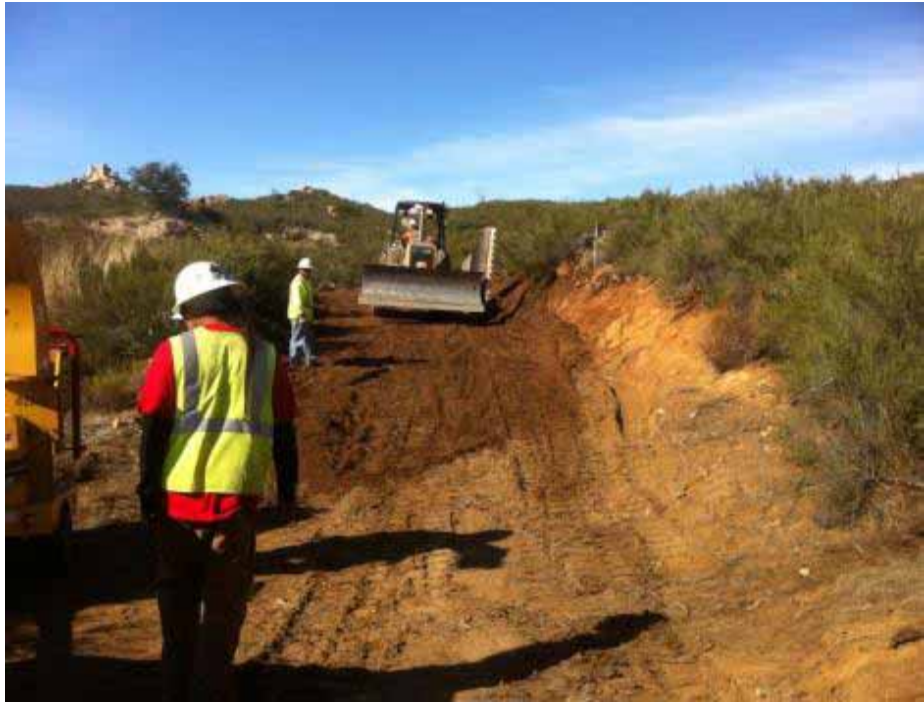
- Access road construction took place at CP31-2-E, CP31-2-N, CP31-2-PS-E, CP49-1-PS-E, CP49-1-PS-N, CP56-1-E-A, CP64-2-E, CP65-1-PS-N, CP98-N-B, CP99-N, and CP106-1-N (see Figure 5).

**Figure 5:** Grading access road to CP106-1. (Link 5)

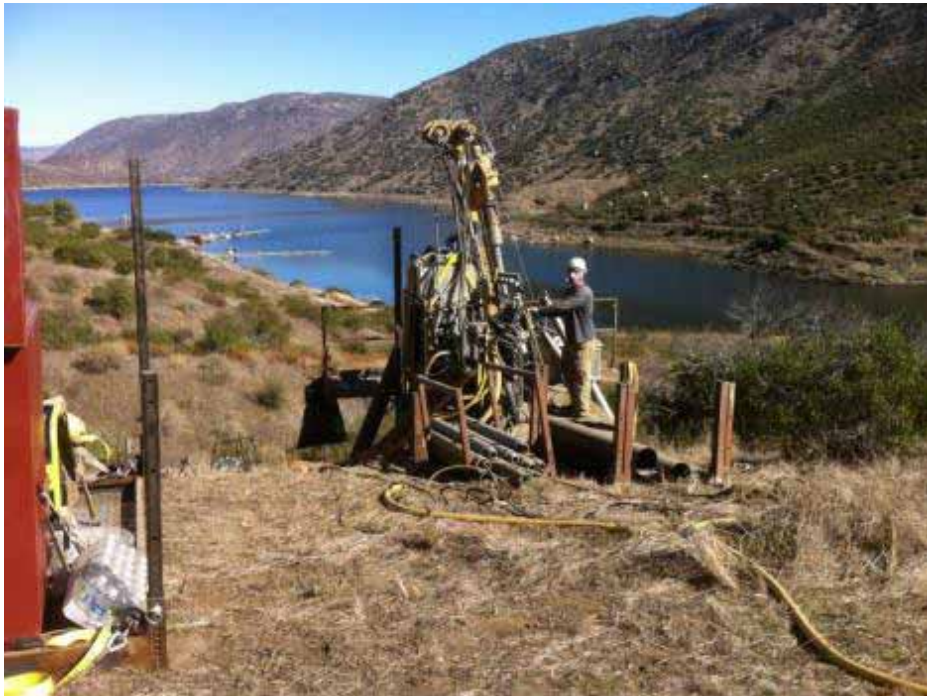
- Concrete was poured at CP70-3.
- Form cleanup occurred at CP70-3.
- Micropile drilling was conducted at CP78-2, CP79-1, CP80-2, CP81-1 (see Figure 6), and CP82-1.

**Figure 6:** Micropile drilling at CP81-1. (Link 5)

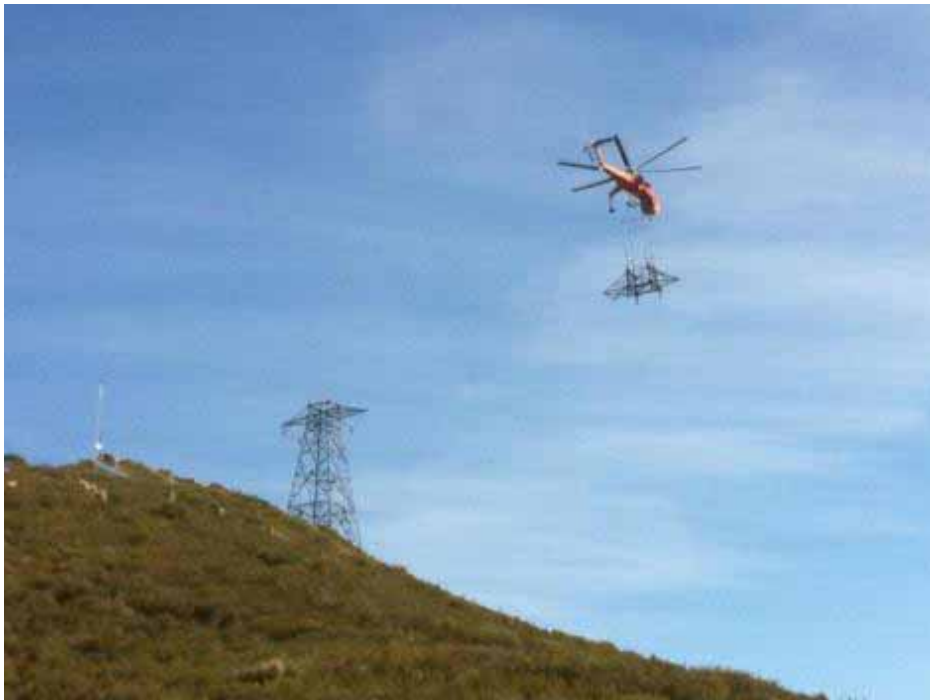
- Tower assembly took place at CP71, CP72-2, CP73-2, CP74-2, CP75-1, CP106-1 (GE), CP107 (see Figure 7), CP108, and CP109-1.
- Ground rod testing occurred at CP74-2.

**Figure 7:** Aircrane setting bridge at CP107. (Link 5)

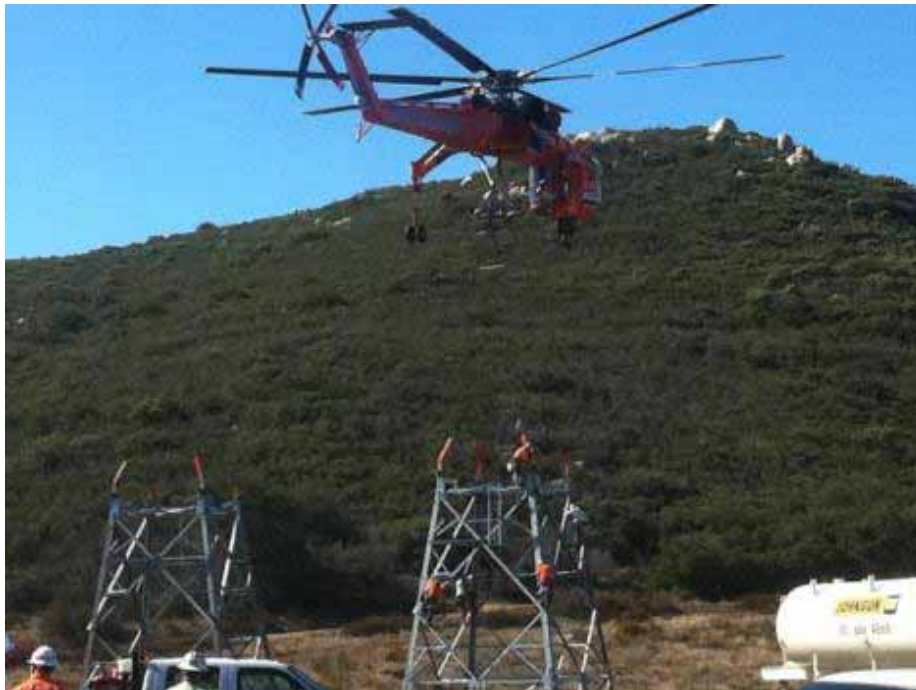
**Figure 8:** Aircrane getting ready to pick a tower at Wilson Yard. (Link 3)

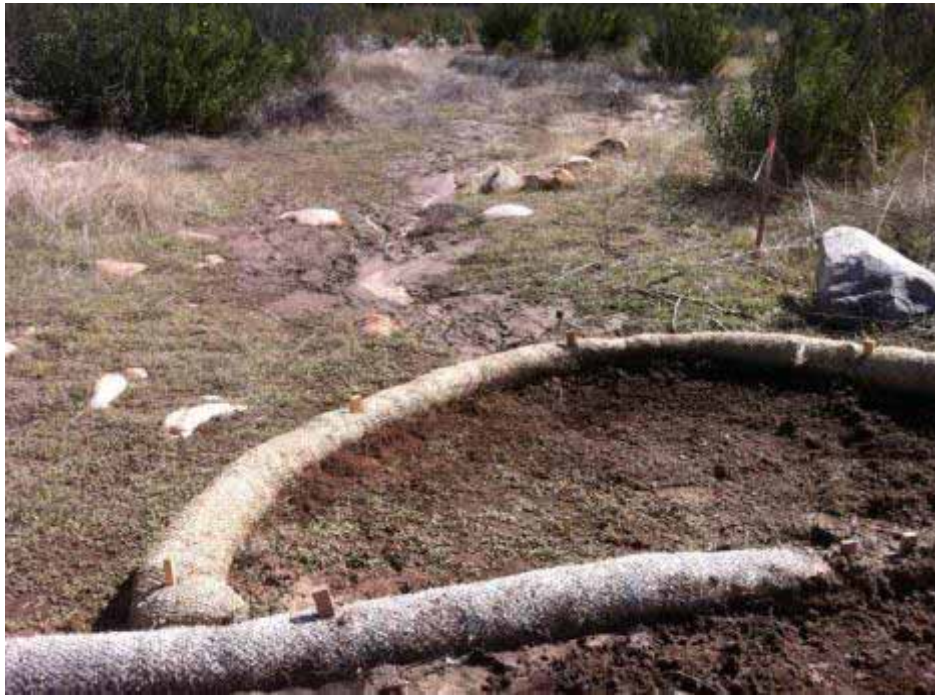
8. Minor leaks, drips, and releases on USFS lands were submitted to the USFS in a weekly HazMat log. (Link 2)
9. On November 14, 2011 it was noted to the Link Lead that there were large plumes of dust coming from micropile drilling at CP78. It was also noted that BMPs were breeched in several locations and that sediment was carried offsite (see Figure 9). (Link 5)

**Figure 9:** Breached BMPs with sediment going offsite at CP70-3. (Link 5)

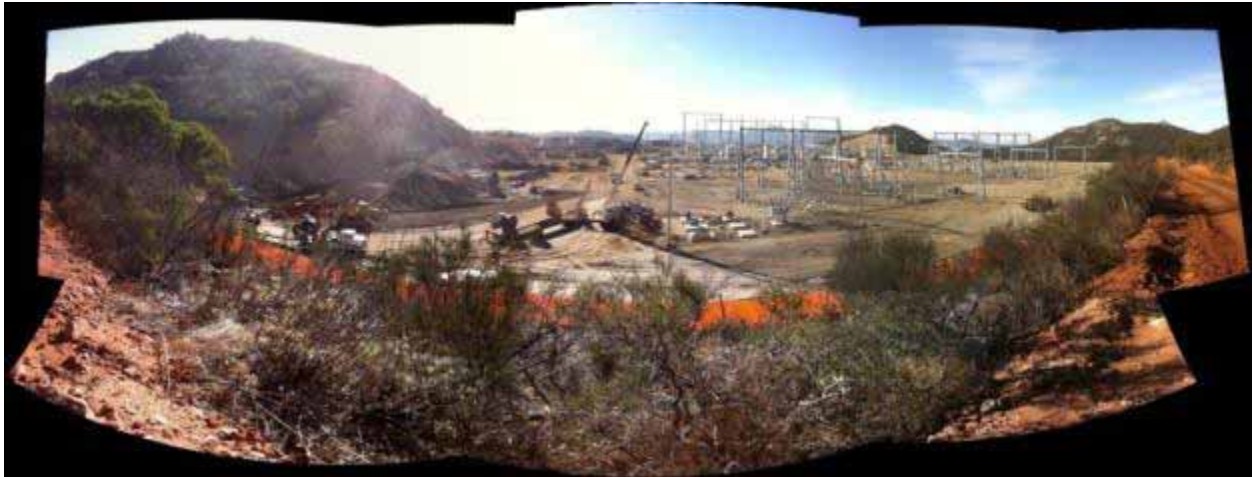
1. Suncrest Substation, Link 3 (non-federal lands): Bell Bluff Truck Trail (BBTT) was widened and repaved (including minor vegetation clearing) east of the gate. Pavement was ripped up east of the guard shack and the area was re-compacted. Material was removed east of the guard shack and final grading and placement of Class 2 base took place. Grading occurred on the northwestern section of the pad. Rock was crushed for select fill material. Utility trenches leading down to the entrance of the substation pad were excavated and backfilled. Pads were formed and concrete was poured. Trenching for conduit and the ground grid occurred in the southwest quadrant. Finish grading and Class 2 base was placed in the northwest quadrant of the pad. Work on the irrigation system on the south end of the substation occurred. Steel erection and transformer work was conducted on the pad (see Figure 10).

**Figure 10:** Panoramic view of Suncrest Substation. (Link 3)

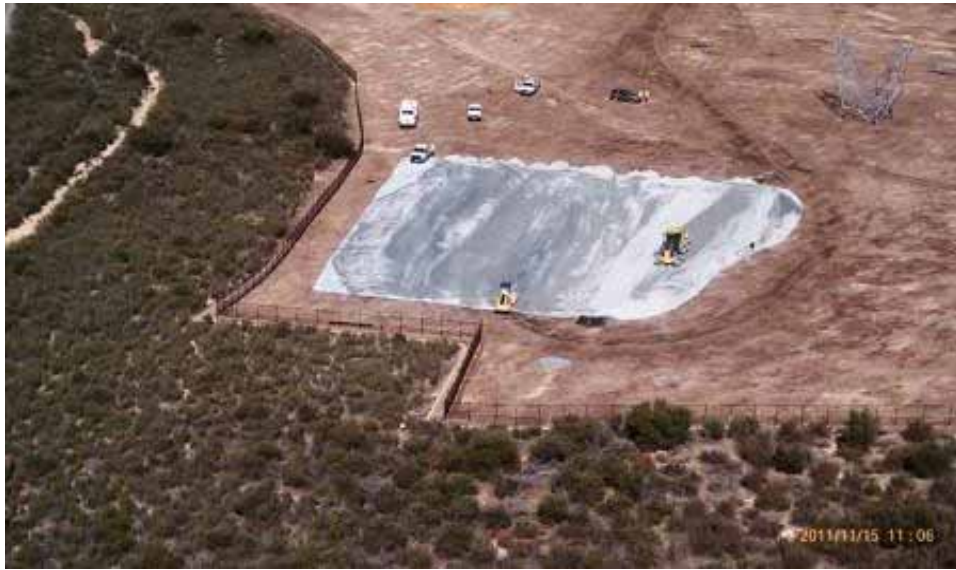
20. Thing Valley Yard – Steel delivery, helicopter pad construction (see Figure 11) and completion, rigging of towers, and minor grading for a water tank pad occurred.

**Figure 11:** Helicopter pad construction at Thing Valley Construction Yard. (Link 2)

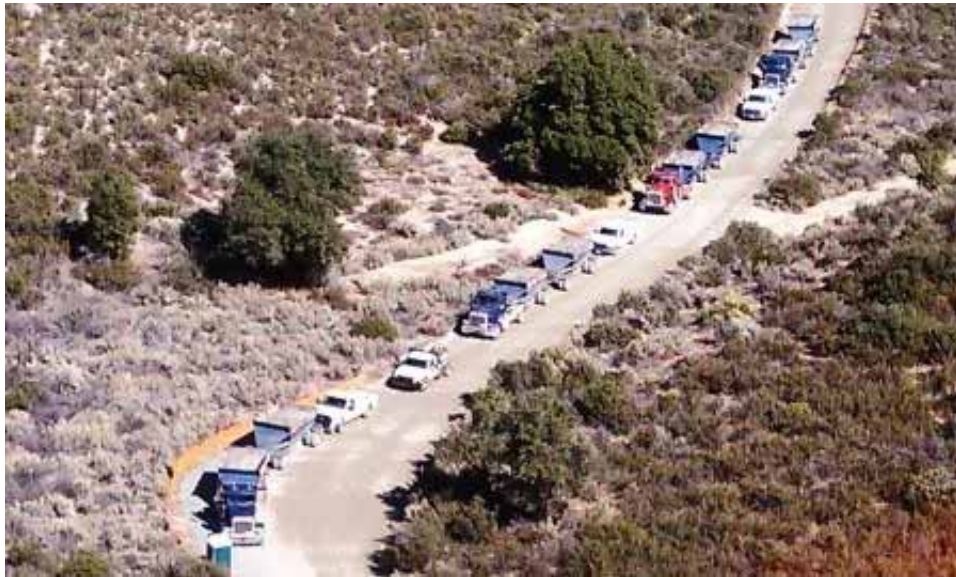
**Figure 12:** Traffic control on USFS land along La Posta Road. (Link 2)
