PROJECT MEMORANDUM PG&E – TRI-VALLEY 2002 CAPACITY INCREASE PROJECT

To: Roosevelt Grant, CPUC
From: Vida Strong, Aspen Project Manager
Date: February 21, 2003
Subject: Weekly Report #22: February 10, 2003 – February 16, 2003
CPUC Environmental Monitor (EM): Anne Sweet

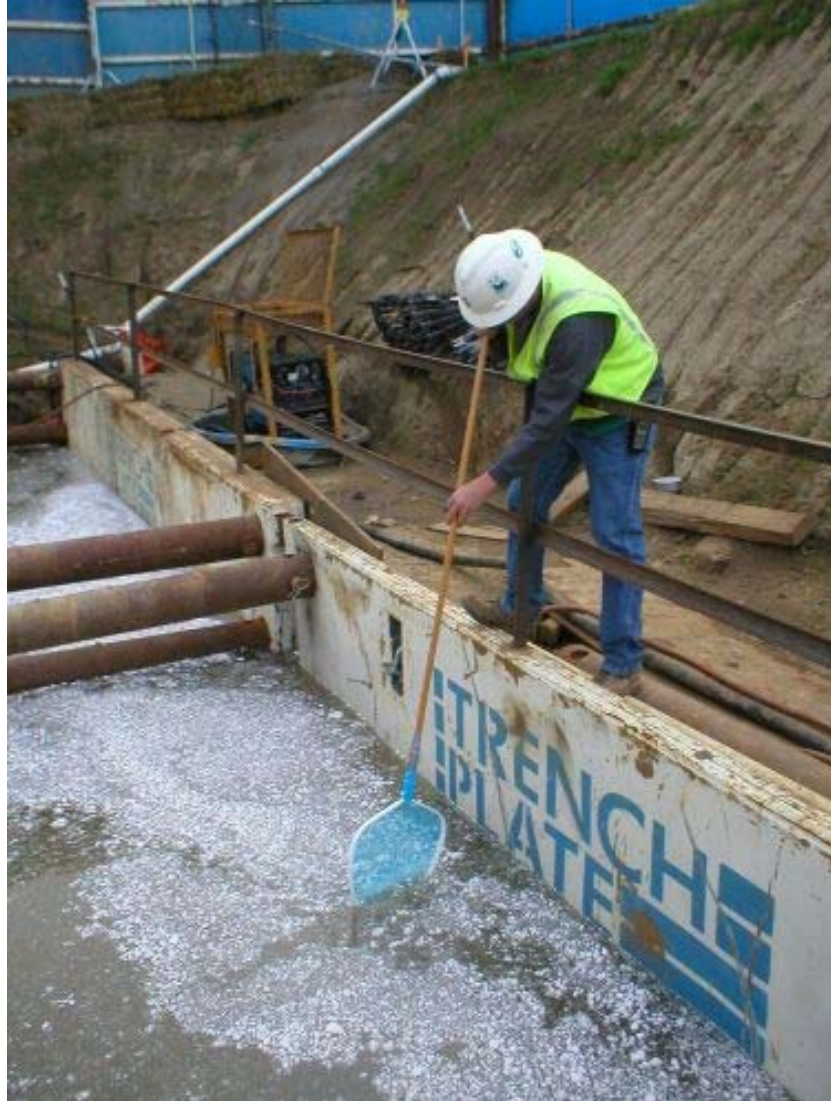
Figure 1

Hydrocarbon spill in the Arroyo del Valle northern bore pit. Oil absorbent flocculent was added to the tank to remove the contaminant sheen.

On Saturday, February 8, a diesel/motor oil spill occurred at the Arroyo del Valle northern bore pit site. Contaminated water was then pumped to the Baker tank on-site and to the discharge hay bale structure. Boring operations were stopped. Water samples were taken for analyses. Overland discharge activities recommenced, but were not compliant with RWQCB protocol. All overland discharge activities were halted. The RWQCB requested submittal of all daily monitoring reports and water quality test results. In

order to continue necessary de-watering of the northern bore pit, PG&E brought three 20,000 gallon Baker tanks to the site to contain the groundwater.

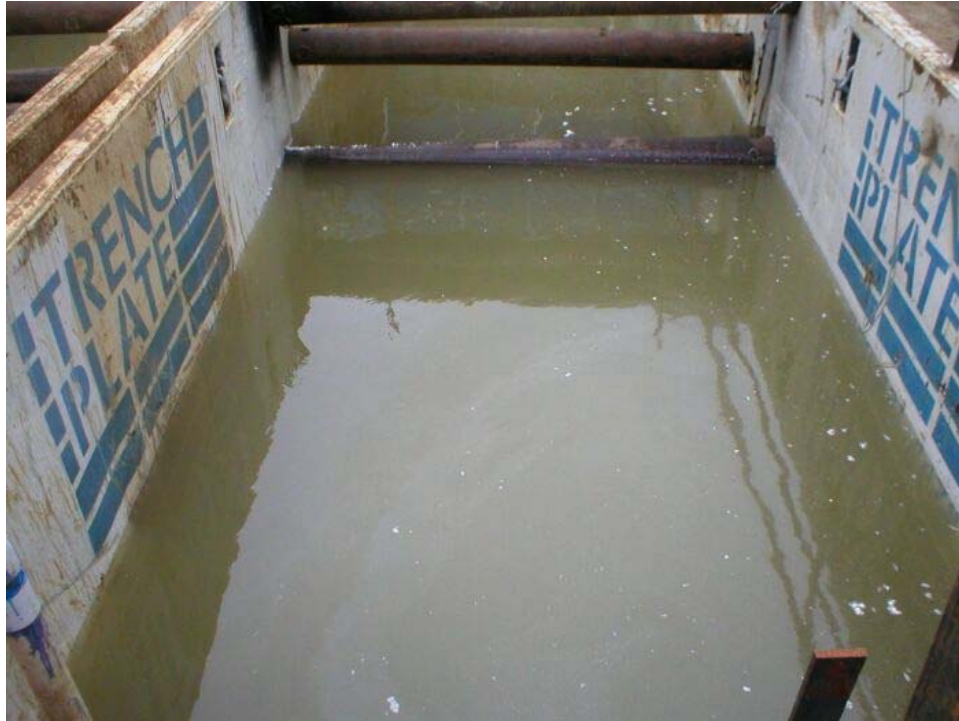
Figure 2

Hydrocarbon spill in the Arroyo del Valle northern bore pit. The photo was taken after the oil absorbent flocculent was removed, yet a contaminant sheen is still visible atop the water.

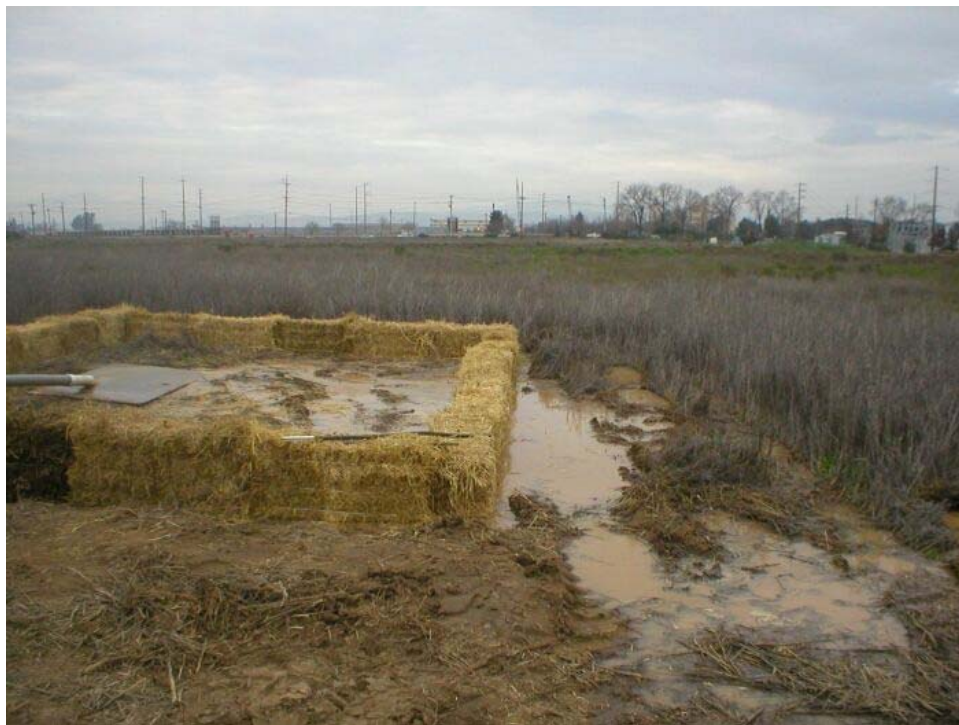
Figure 3

Dewatering to the new hay bale structure.

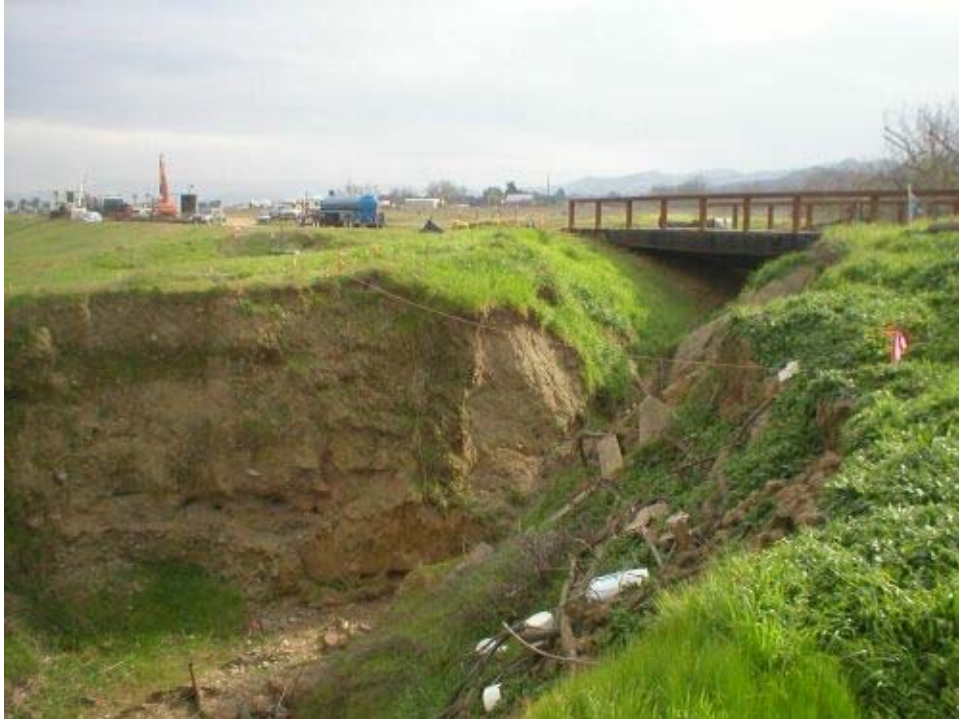
A directional drill was set up at the bridged unnamed tributary along New Vineyard Road (see Figure 4). Frac-out Contingency Plans and equipment were checked. Numerous sand bags, as well as two vacuum trucks were on site. The CPUC EM noted to the bore crew Foreman that the hose to the vacuum truck should be assembled and ready for usage. The Foreman was also asked about what monitoring for frac-outs will be done. There was some question as to how the work across the drainage relates to the project CDFG Streambed Alteration Agreement. The CPUC EM left a message with Janis Gan of the CDFG regarding the new work. On February 13, Buck Jones the PG&E planner called the CPUC EM with information that directional drilling operations at the unnamed tributary have been suspended until a Streambed Alteration Agreement has been granted by the CDFG for work associated with the crossing.

Figure 4
Unnamed tributary along New Vineyard Road. PG&E has set up equipment to directional drill under the crossing.
