PROJECT MEMORANDUM PG&E – TRI-VALLEY 2002 CAPACITY INCREASE PROJECT

To: Roosevelt Grant, CPUC
From: Vida Strong, Aspen Project Manager
Date: July 23, 2003
Subject: Weekly Report #44: July 14, 2003 – July 20, 2003
CPUC Environmental Monitor (EM): Anne Sweet

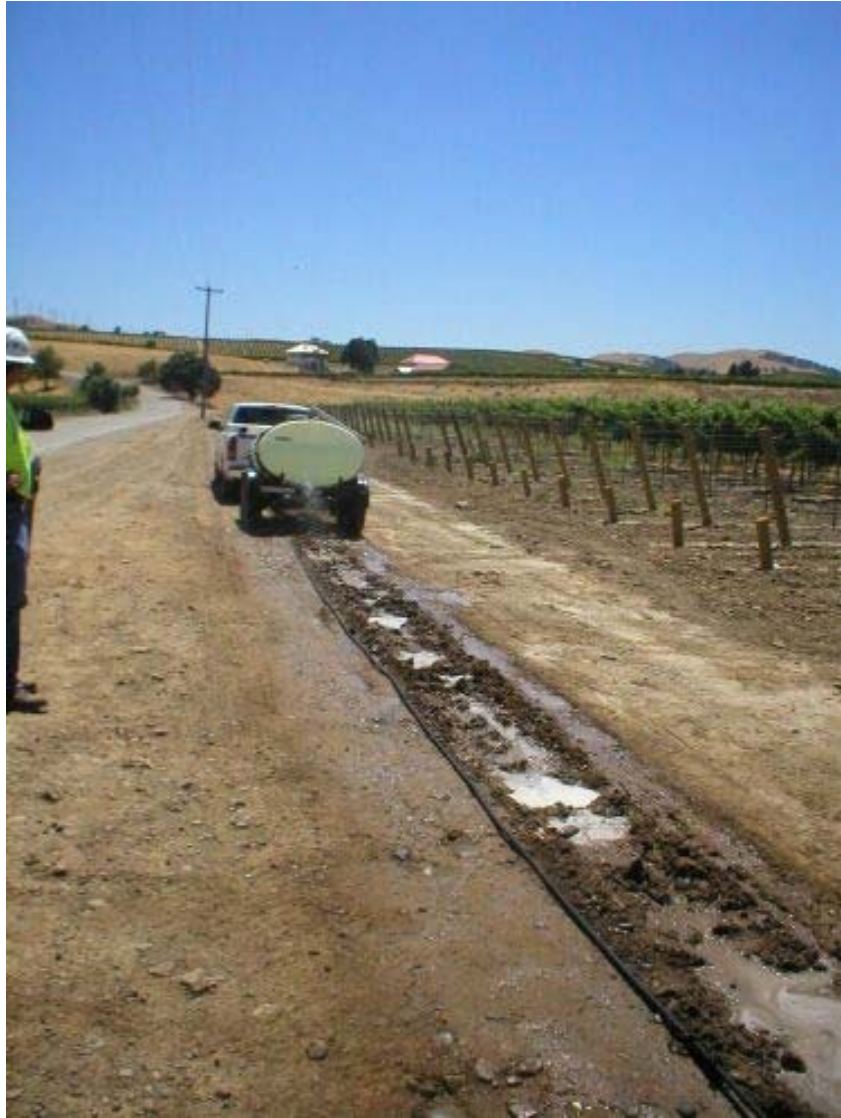
Figure 1 – Diesel spill remediation area near Vault 4, Phase One.
Note the water truck being used to maintain soil moisture.

The Essex EI has returned to the diesel spill area near the Vault 4 location. After reviewing soil test results taken from the spill site, it was determined that further clean-up efforts are required. The Essex EI contacted the bio-remediation company Micro Blaze and found out that the original application of the bio-remediation product at the site was improperly executed. Crews disked the spill area and re-applied the product on July 10; per product instructions the soil needs to be kept moist. Crews have continuously watered the site to maintain soil moisture (see Figure 1). During the subject week Universal Environmental Inc. collected composite soil samples, which will undergo Petroleum hydrocarbon testing. Results should be in early next week.

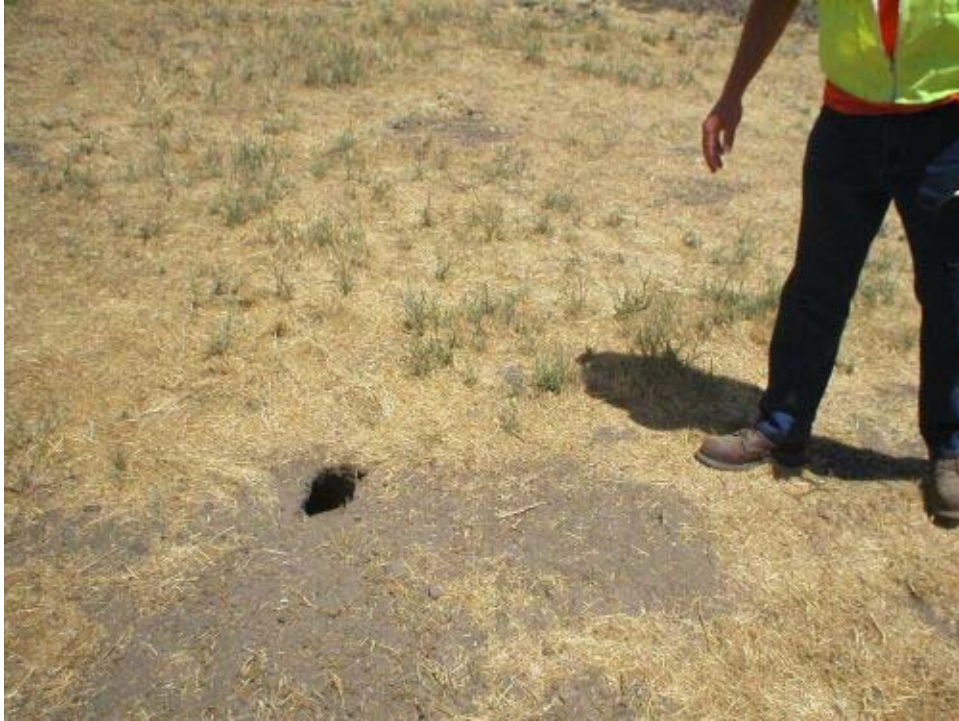
On Monday, July 14, the Essex EI called to inform the CPUC EM that a borrowing owl was spotted in the PSD lay down yard. The bird had appeared to be foraging, and eventually left the site. Later that afternoon the CPUC EM toured the PSD lay down yard. Upon arriving on-site, the CPUC EM observed that a contractor affiliate had a dog on-site. The Essex EI had had informed them to keep the dog inside the truck; however, the CPUC EM observed that the truck window was open and the dog was trying to get out. The CPUC EM told the Essex EI that per environmental regulations, dogs are not allowed on-site, especially considering that a borrowing owl had been observed at that location. At the environmental training conducted the previous week it was stated explicitly to all contractor supervisors that dogs are not permitted on the construction site.

Figure 2 – PSD lay down yard, Phase Two.
Note the existing borrow lower left of center in the photo.

On July 15, Jones and Stokes conducted a survey to determine the location of the owl borrow. The borrow was located approximately 325-feet from the yard site and contained two adult owls and seven young (official survey data has not yet been provided). On July 17, the Essex EI informed the CPUC EM that the burrowing owls have been spotted numerous mornings in the PSD yard foraging and perching on the transmission line reels. The young birds will be leaving the parent nest soon and will be looking for nearby borrows to take up residence. Within the PSD yard numerous borrows already exist (see Figure 2). Current mitigation states that unoccupied borrows near construction activities may be collapsed. If the owls take up habitation in the yard, a 250-foot buffer will need to be enforced which could impact project activities.
