PROJECT MEMORANDUM PG&E – TRI-VALLEY 2002 CAPACITY INCREASE PROJECT

To: Ken Lewis, CPUC
From: Vida Strong, Aspen Project Manager
Date: December 17, 2003
Subject: Weekly Report #65: December 8, 2003 – December 14, 2003
CPUC Environmental Monitor (EM): Anne Sweet

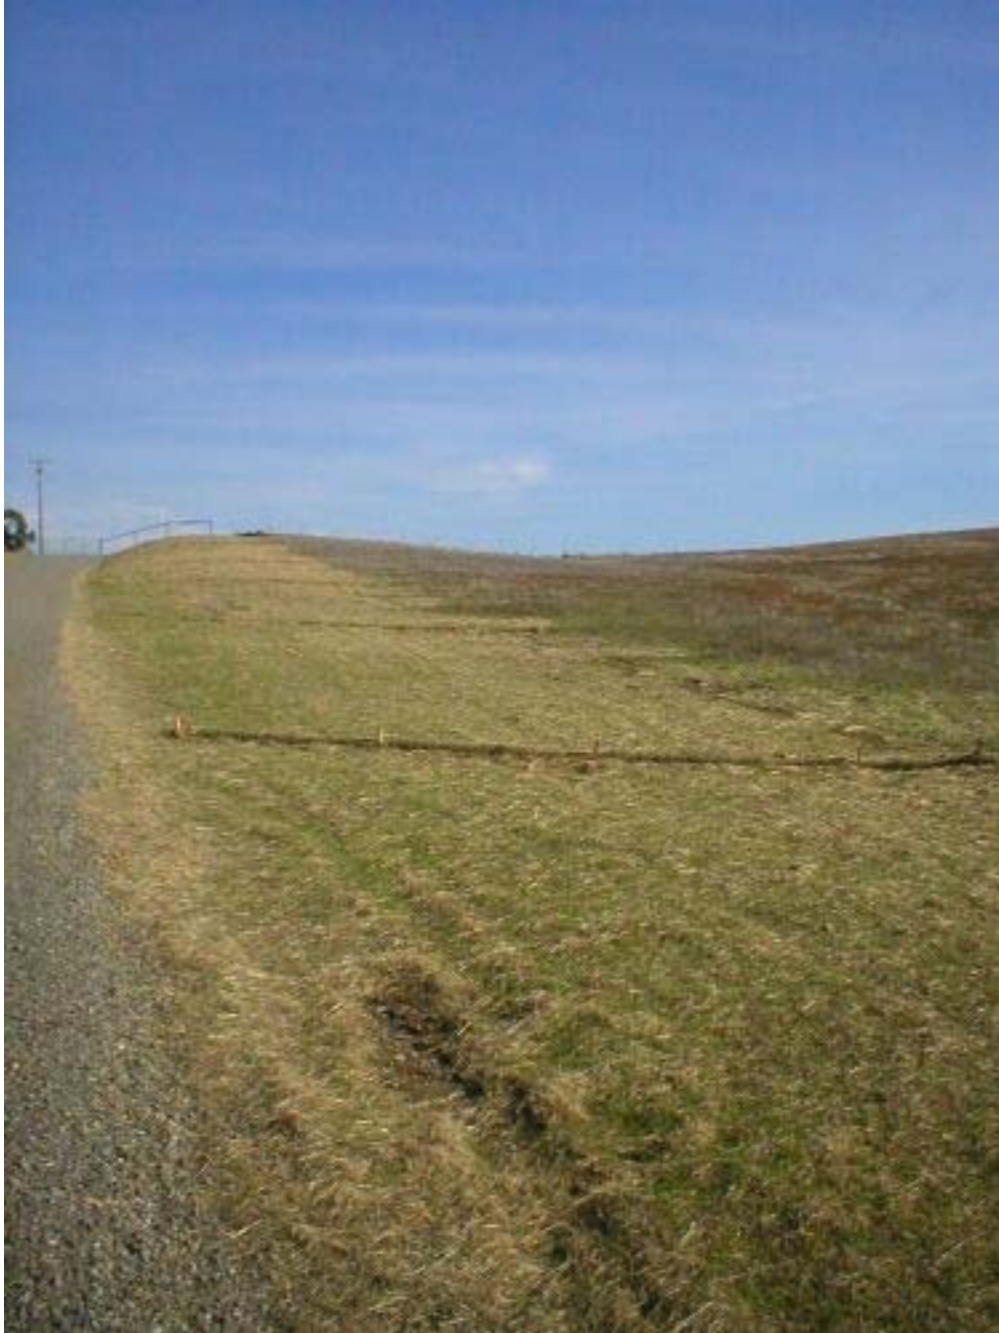
Figure 1 – Straw waddle waterbars have been installed and staked along the previously hydro-seeded steep slope along the access road leading to the Transition Station, Phase Two

and upgrading the culverts, as previously requested by CDFG and HT Harvey and Associates (wetland mitigation site planners). The HT Harvey Project Manager also requested that PG&E leave the construction fencing in place around designated borrows and drainages. Crews have installed additional erosion controls including jute netting and hay bales within the drainage areas. The contractor has disked the disturbed right-of-way and has hydro-seeded all of the disturbed areas. After the seed application, crews then applied mulch, then tackifier. The recent rains have promoted growth of the applied seed. During the subject week the contractor installed straw waddles across the steep slope between Stations 15+00 and 21+00 (see Figure 1).

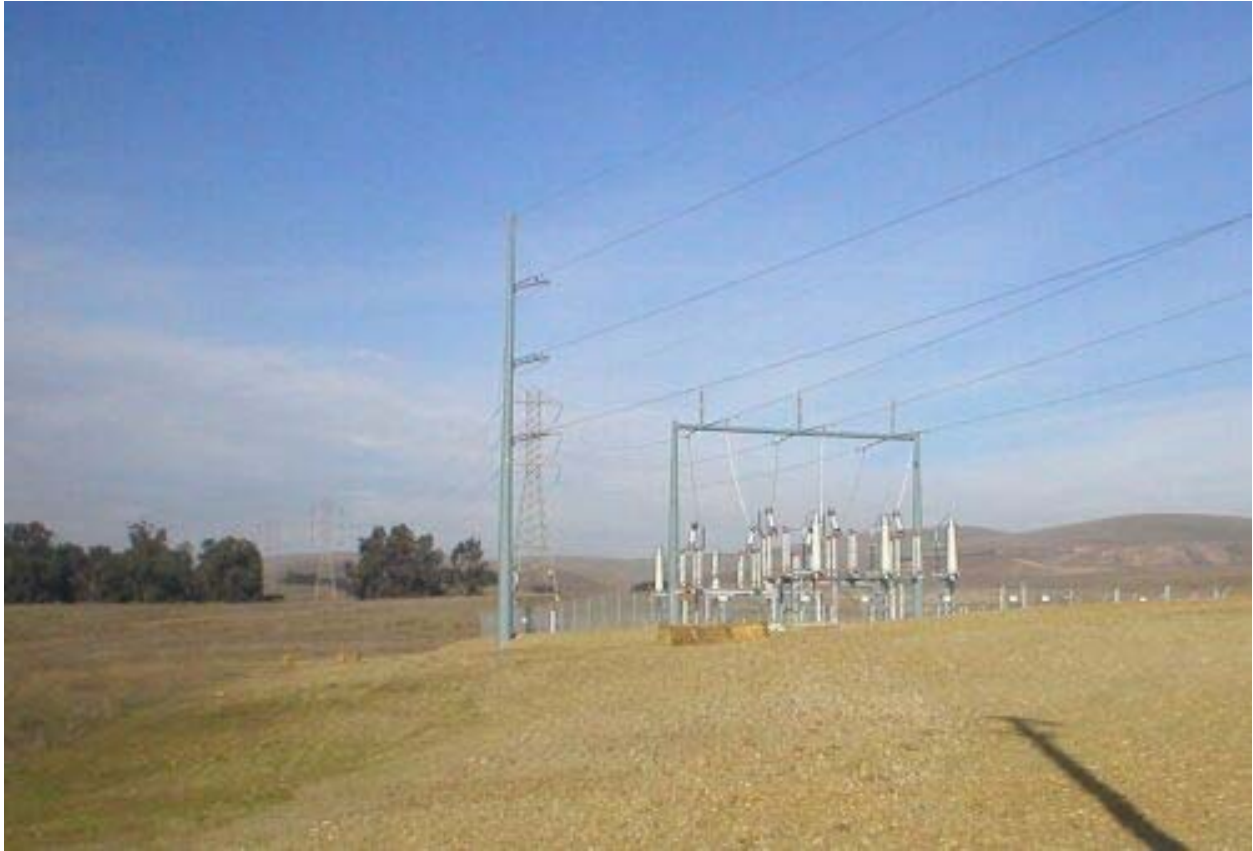
Figure 2 – Hay bales have installed for added erosion control around the previously hydro-seeded area surrounding the Transition Station, Phase Two

At the Transition Station, crews have finished installations. The surrounding area has been hydro-seeded. Crews have installed a chain link fence with barbed wire around the station pad. Locked gates have been installed at the entrance road to the station. During the subject week crews installed hay bales around the station area (see Figure 2).
